American Vibracore Services 1215 Wallace Drive Delray Beach, FL 33444					Easting (X, ft):	974663.797
												Northing (Y, ft):	905753.525
												Horizontal System:	NAD 1983
												Vertical System:	NAVD 88

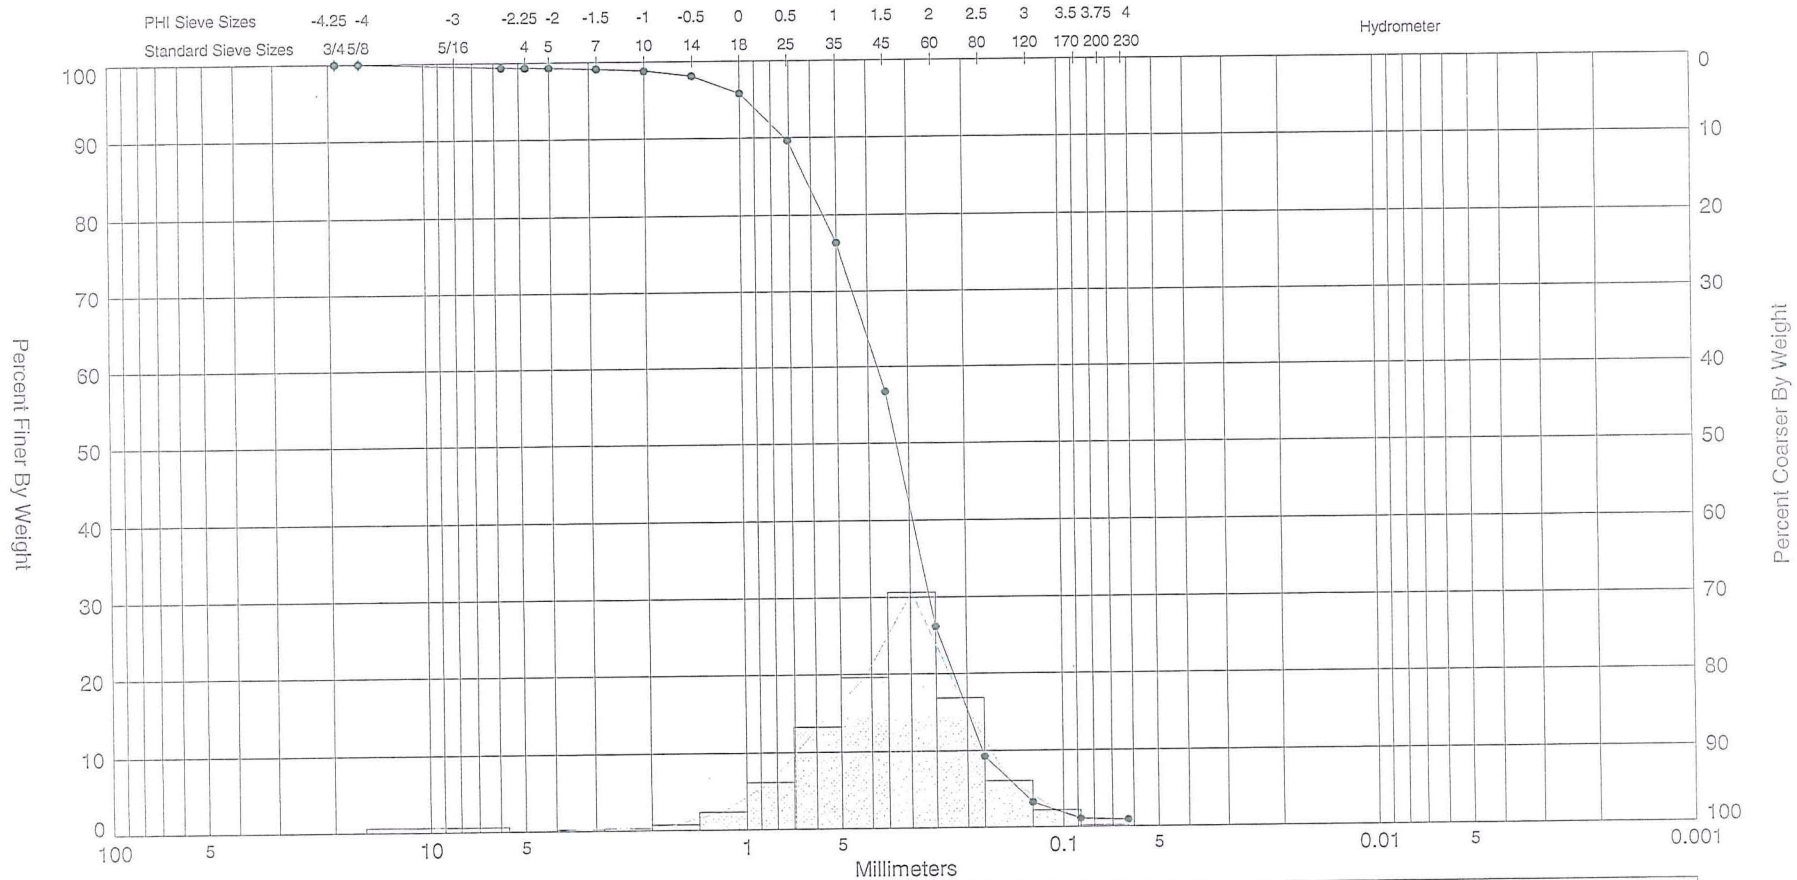
Sample	Symbol	Elev. (ft)	USCS	% Fines	% Organics	% Carbonates	Median	Mean	Skew	Kurt	Sort	Sample Information	
SIVC-12-4 #S-1 (1')		-70.4	SW	#230 - 0.88		66.10	1.61	1.49	-1.29	7.94	0.88	Project Name:	Singer Island 2012
Comments:												Analysis Date:	03-29-12
Depths and elevations based on measured values												Analyzed By:	ER

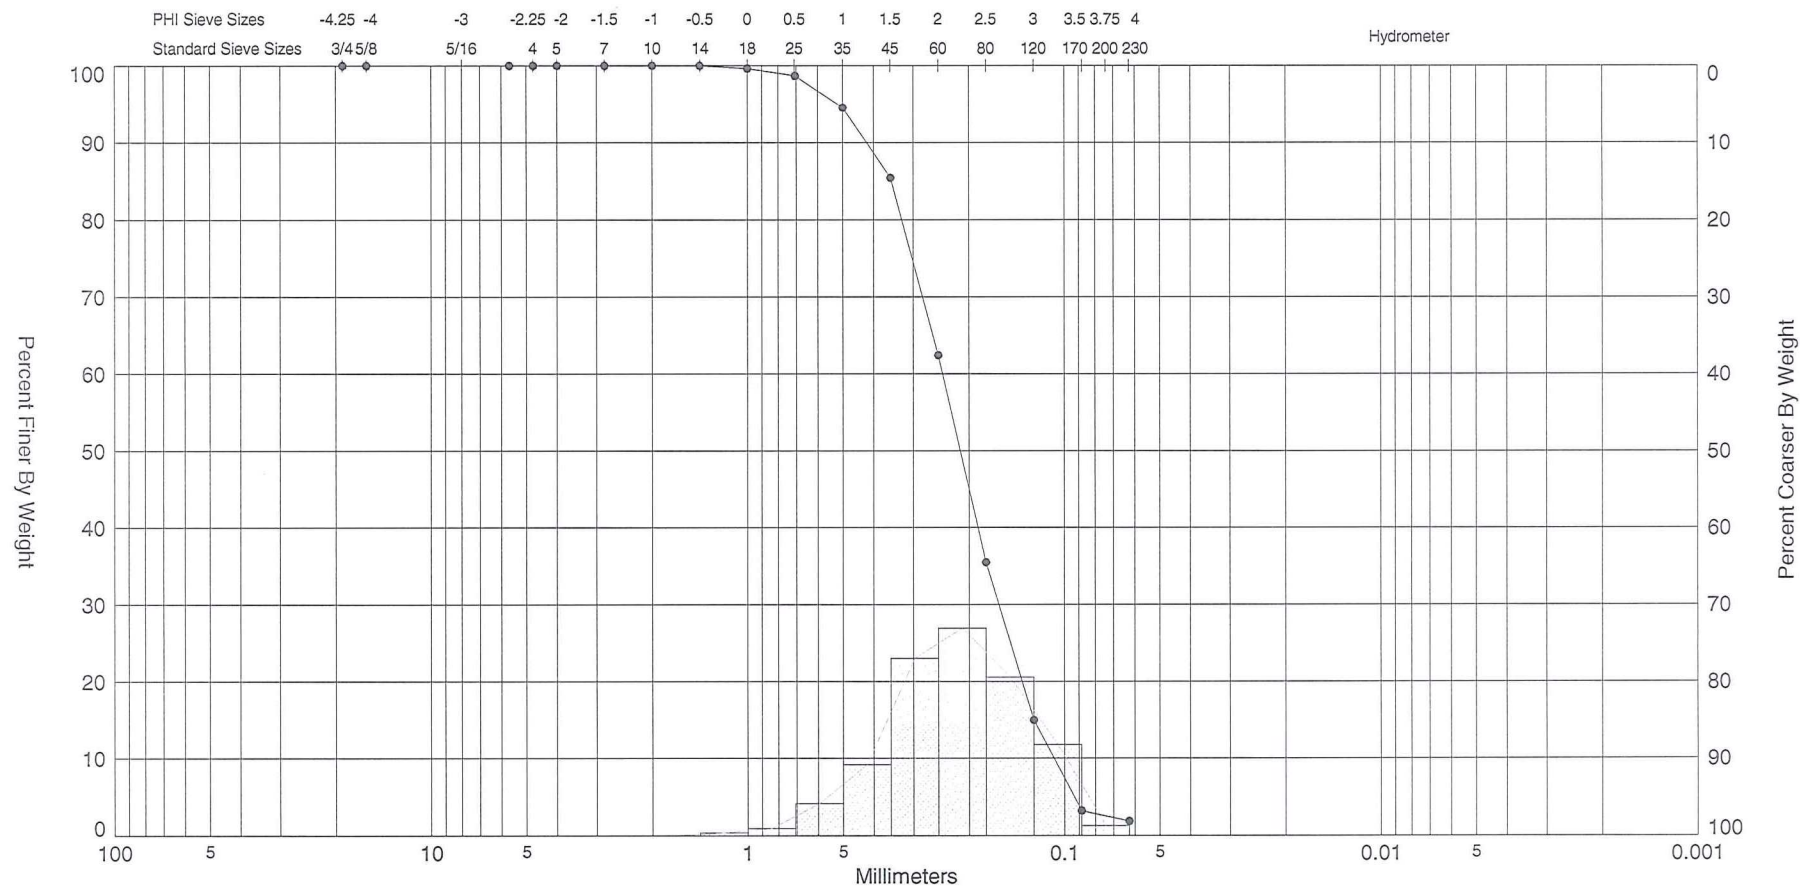
Sample	Symbol	Elev. (ft)	USCS	% Fines	% Organics	% Carbonates	Median	Mean	Skew	Kurt	Sort	Sample Information	
VC-12-4 PCC #S-1 (8.5')	—●—	-77.9	SP	#230 - 1.87			2.23	2.19	-0.34	3.05	0.71	Project Name:	Singer Island 2012
Comments:												Analysis Date:	04-05-12
Depths and elevations based on measured values												Analyzed By:	ER

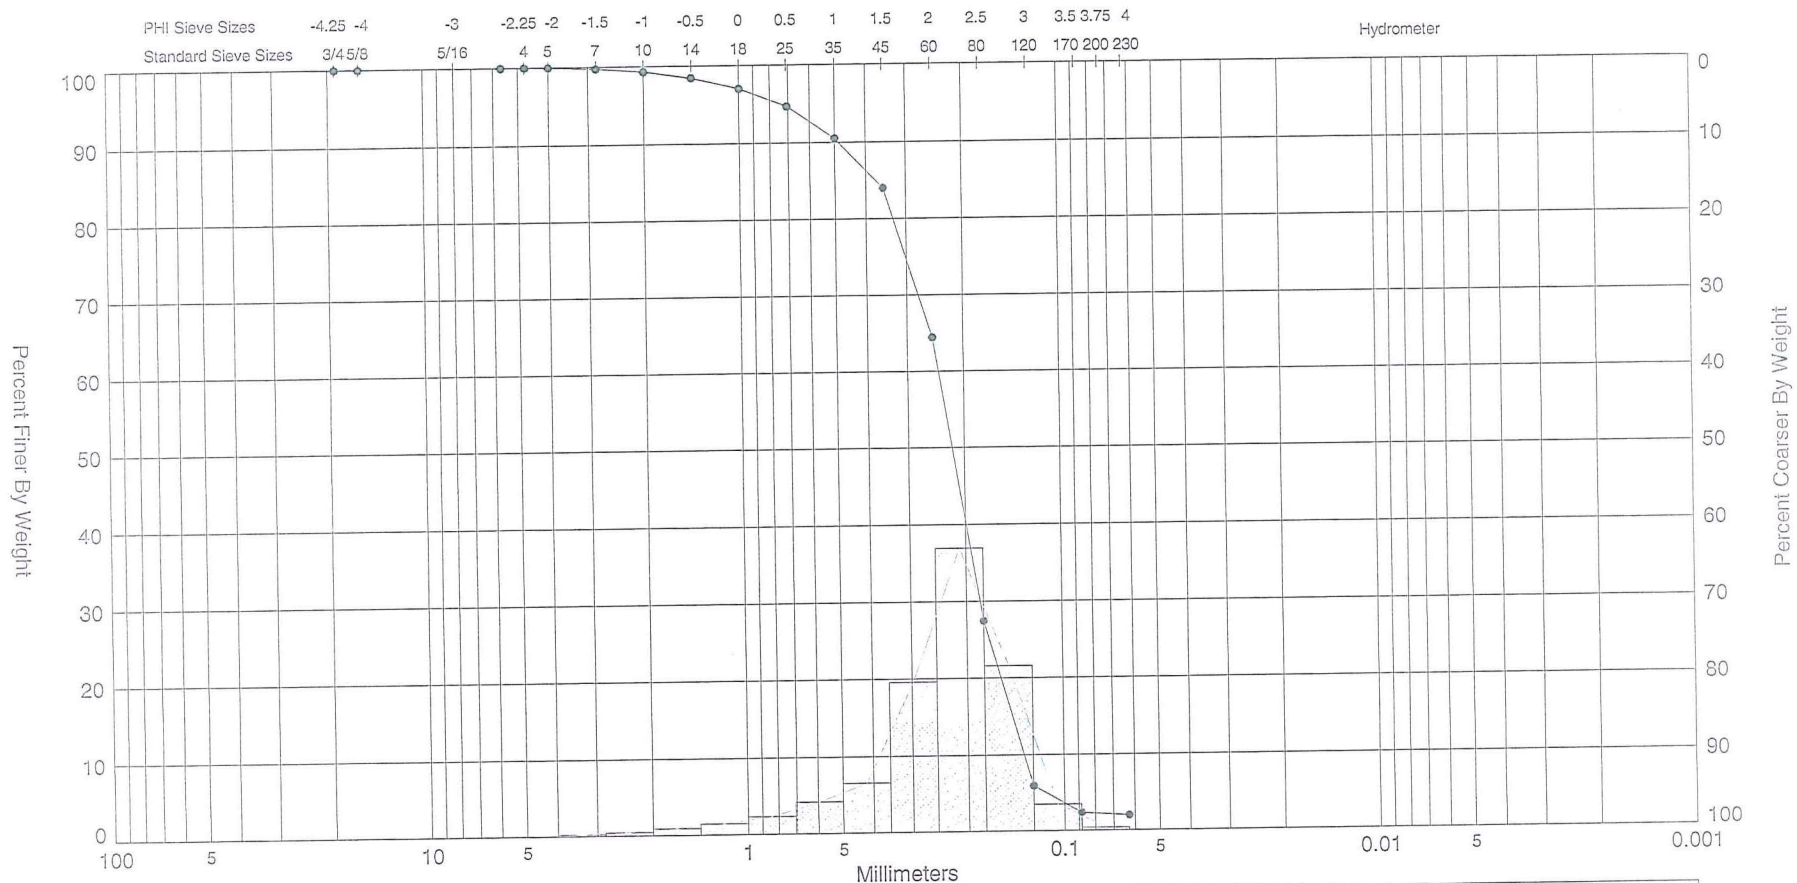
Sample	Symbol	Elev. (ft)	USCS	% Fines	% Organics	% Carbonates	Median	Mean	Skew	Kurt	Sort	Sample Information	
SIVC-12-4 #S-2 (8.5')	—●—	-77.9	SP	#230 - 2.00		86.80	2.2	2.04	-1.52	6.43	0.79	Project Name:	Singer Island 2012
Comments:												Analysis Date:	03-29-12
Depths and elevations based on measured values												Analyzed By:	ER
