SIEVE ANALYSIS: SINGER ISLAND.GPJ FL DEP ROSS.GDT 9/23/05

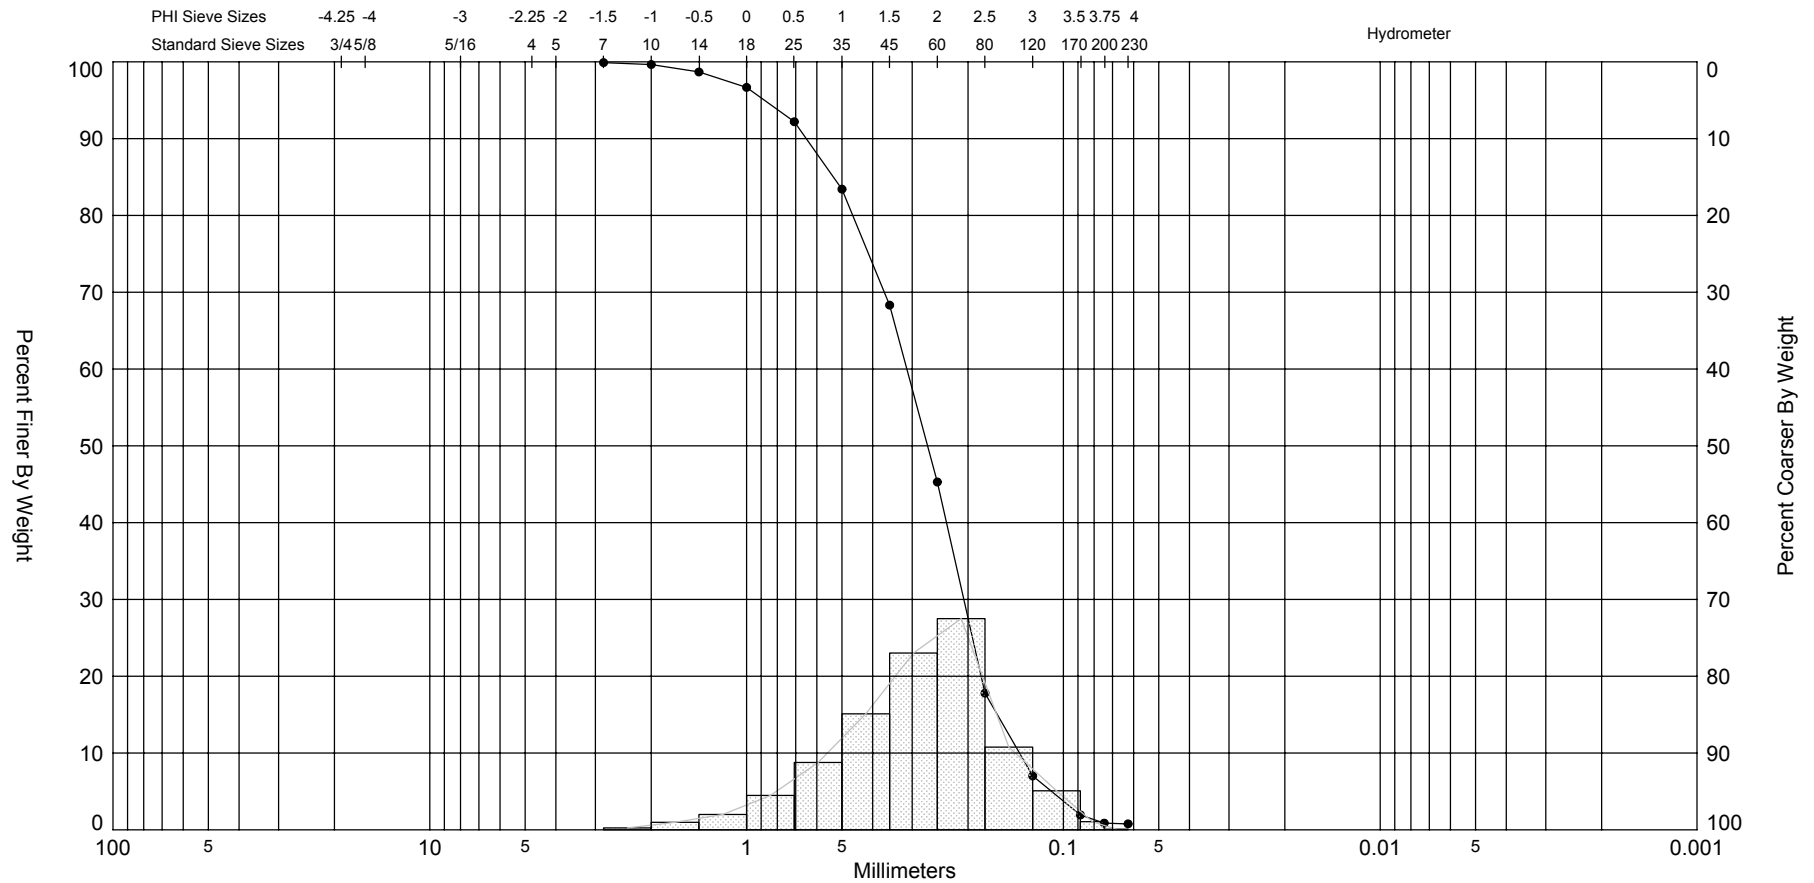
Sample	Symbol	Elev. (ft)	USCS	% Fines	% Organics	% Carbonates	Median	Mean	Skew	Kurt	Sort	Sample Information	
SI-05-58 #1.0	—●—	-68.0	SP	#200 - 0.87 #230 - 0.78		51.52	1.9	1.79	-0.53	3.44	0.85	Project Name:	Singer Island 2005
Comments:												Analysis Date:	08-23-05
Depths and elevations based on measured values												Analyzed By:	SEA Inc.
						Scientific Environmental Applications 5575 Willoughby Drive Melbourne, FL 32934 ph 321 254-2708 fax 321 254-2708						Easting (X, ft):	974,424
												Northing (Y, ft):	909,266
												Horizontal System:	NAD 1983
												Vertical System:	NGVD 29

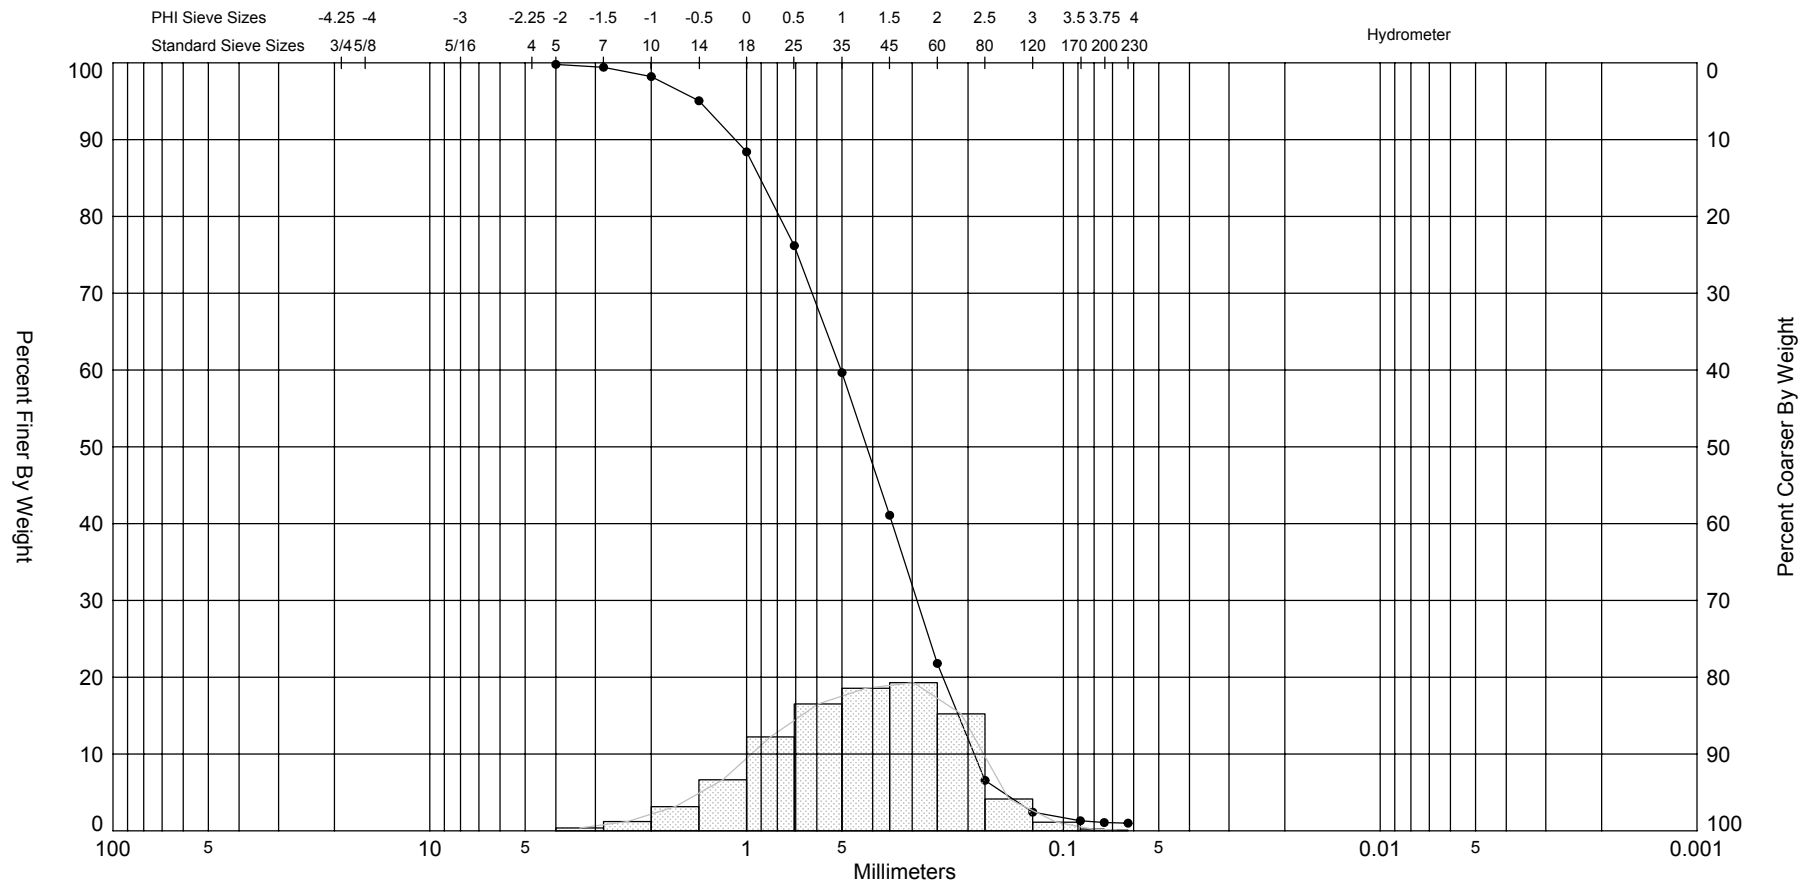
Gravel		Sand			Silt and Clay	
Coarse	Fine	Coarse	Medium	Fine

Sample	Symbol	Elev. (ft)	USCS	% Fines	% Organics	% Carbonates	Median	Mean	Skew	Kurt	Sort	Sample Information	
SI-05-58 #3.0	—●—	-70.0	SW	#200 - 1.08 #230 - 1.00		75.23	1.26	1.17	-0.29	2.82	0.95	Project Name:	Singer Island 2005
Comments:												Analysis Date:	08-23-05
Depths and elevations based on measured values												Analyzed By:	SEA Inc.
						Scientific Environmental Applications 5575 Willoughby Drive Melbourne, FL 32934 ph 321 254-2708 fax 321 254-2708						Easting (X, ft):	974,424
												Northing (Y, ft):	909,266
												Horizontal System:	NAD 1983
												Vertical System:	NGVD 29

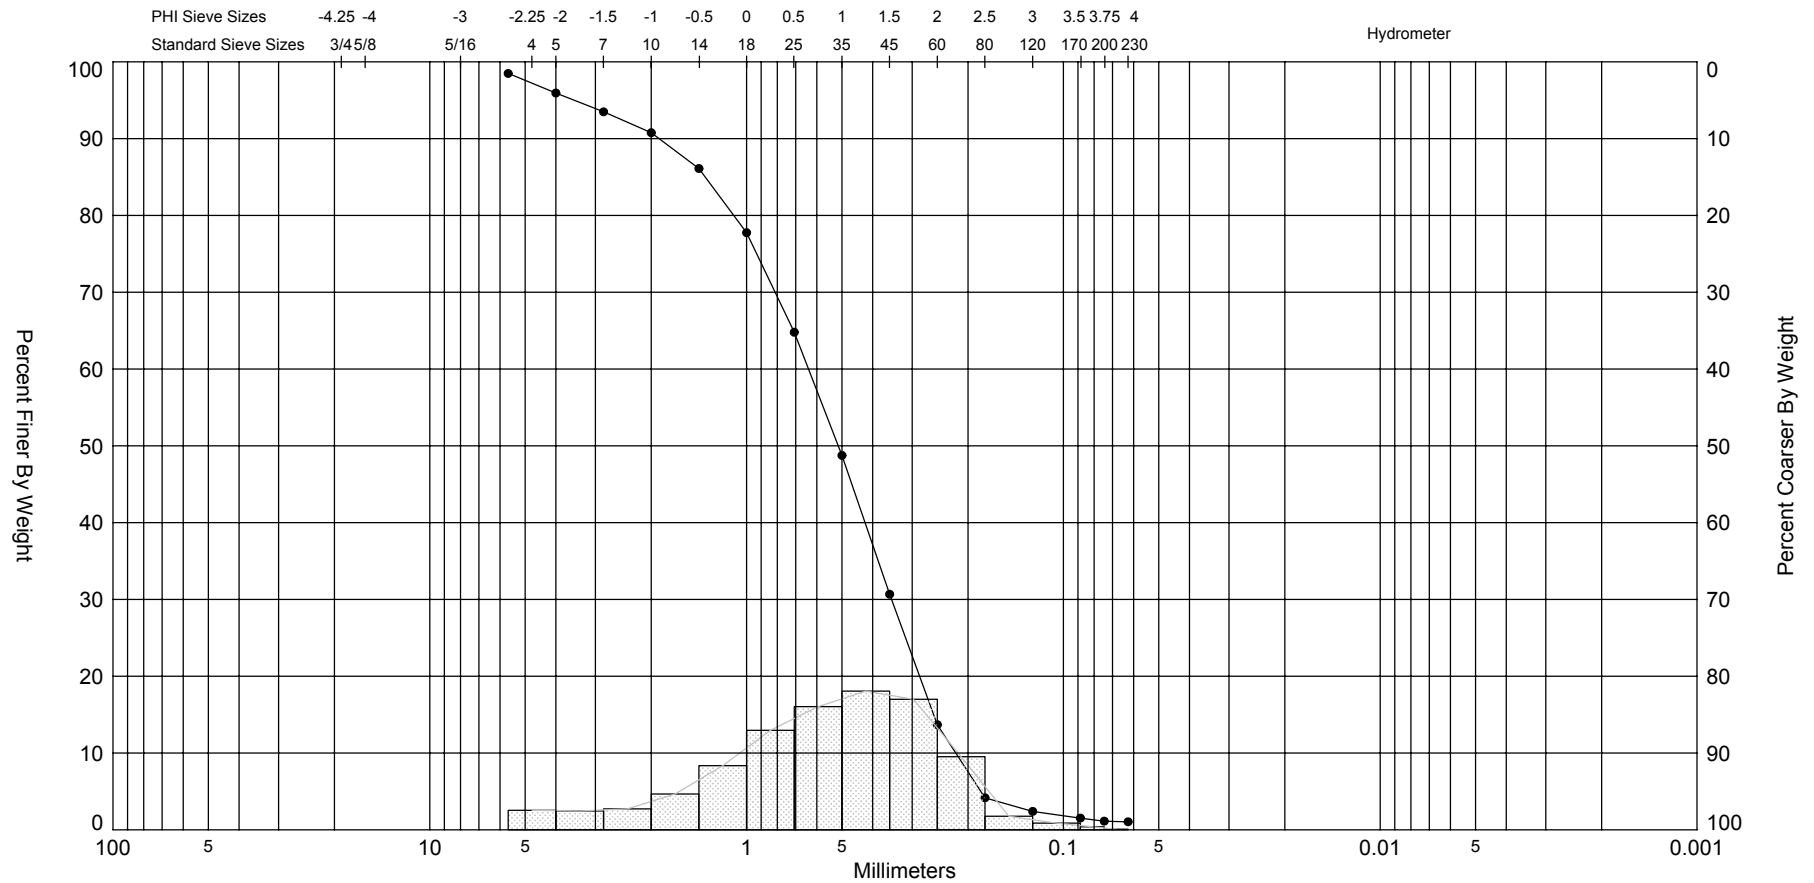
Gravel		Sand			Silt and Clay
Coarse	Fine	Coarse	Medium	Fine

Sample	Symbol	Elev. (ft)	USCS	% Fines	% Organics	% Carbonates	Median	Mean	Skew	Kurt	Sort	Sample Information	
SI-05-58 #6.0	—●—	-73.0	SW	#200 - 1.13 #230 - 1.05		82.00	0.96	0.76	-0.45	3.16	1.15	Project Name:	Singer Island 2005
Comments:												Analysis Date:	08-23-05
Depths and elevations based on measured values												Analyzed By:	SEA Inc.
						Scientific Environmental Applications						Easting (X, ft):	974,424
						5575 Willoughby Drive						Northing (Y, ft):	909,266
						Melbourne, FL 32934						Horizontal System:	NAD 1983
						ph 321 254-2708 fax 321 254-2708						Vertical System:	NGVD 29

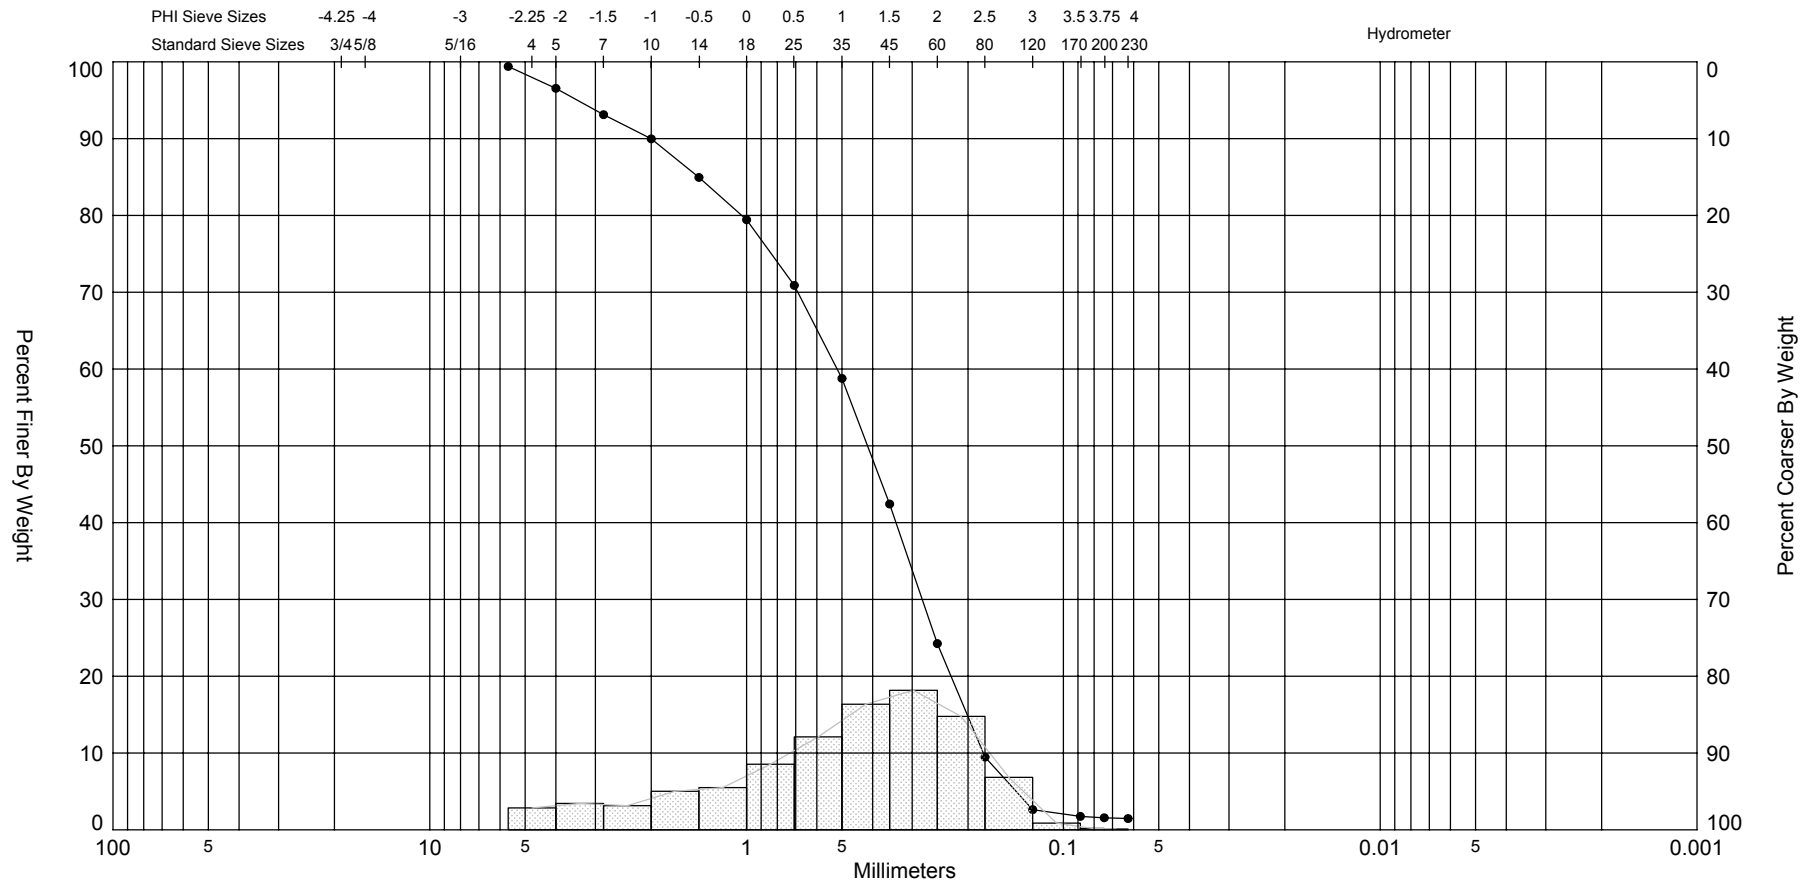
Sample	Symbol	Elev. (ft)	USCS	% Fines	% Organics	% Carbonates	Median	Mean	Skew	Kurt	Sort	Sample Information	
SI-05-58 #9.0	—●—	-76.0	SW	#200 - 1.57 #230 - 1.47		86.66	1.27	0.98	-0.7	2.91	1.29	Project Name:	Singer Island 2005
Comments:												Analysis Date:	08-23-05
Depths and elevations based on measured values												Analyzed By:	SEA Inc.
						Scientific Environmental Applications 5575 Willoughby Drive Melbourne, FL 32934 ph 321 254-2708 fax 321 254-2708						Easting (X, ft):	974,424
												Northing (Y, ft):	909,266
												Horizontal System:	NAD 1983
												Vertical System:	NGVD 29
