| Sample | Symbol | Elev. (ft) | USCS | % Fines | % Organics | % Carbonates | Median | Mean | Skew | Kurt | Sort | Sample Information | |
|---|---|---|---|---|---|---|---|---|---|---|---|---|---|
| JIVC-10-17 #S-1 (2') | —●— | -58.3 | SP | #230 - 0.86 | | | 1.58 | 1.55 | -0.25 | 4.28 | 0.66 | Project Name: | Jupiter Island 10 Detail Phase |

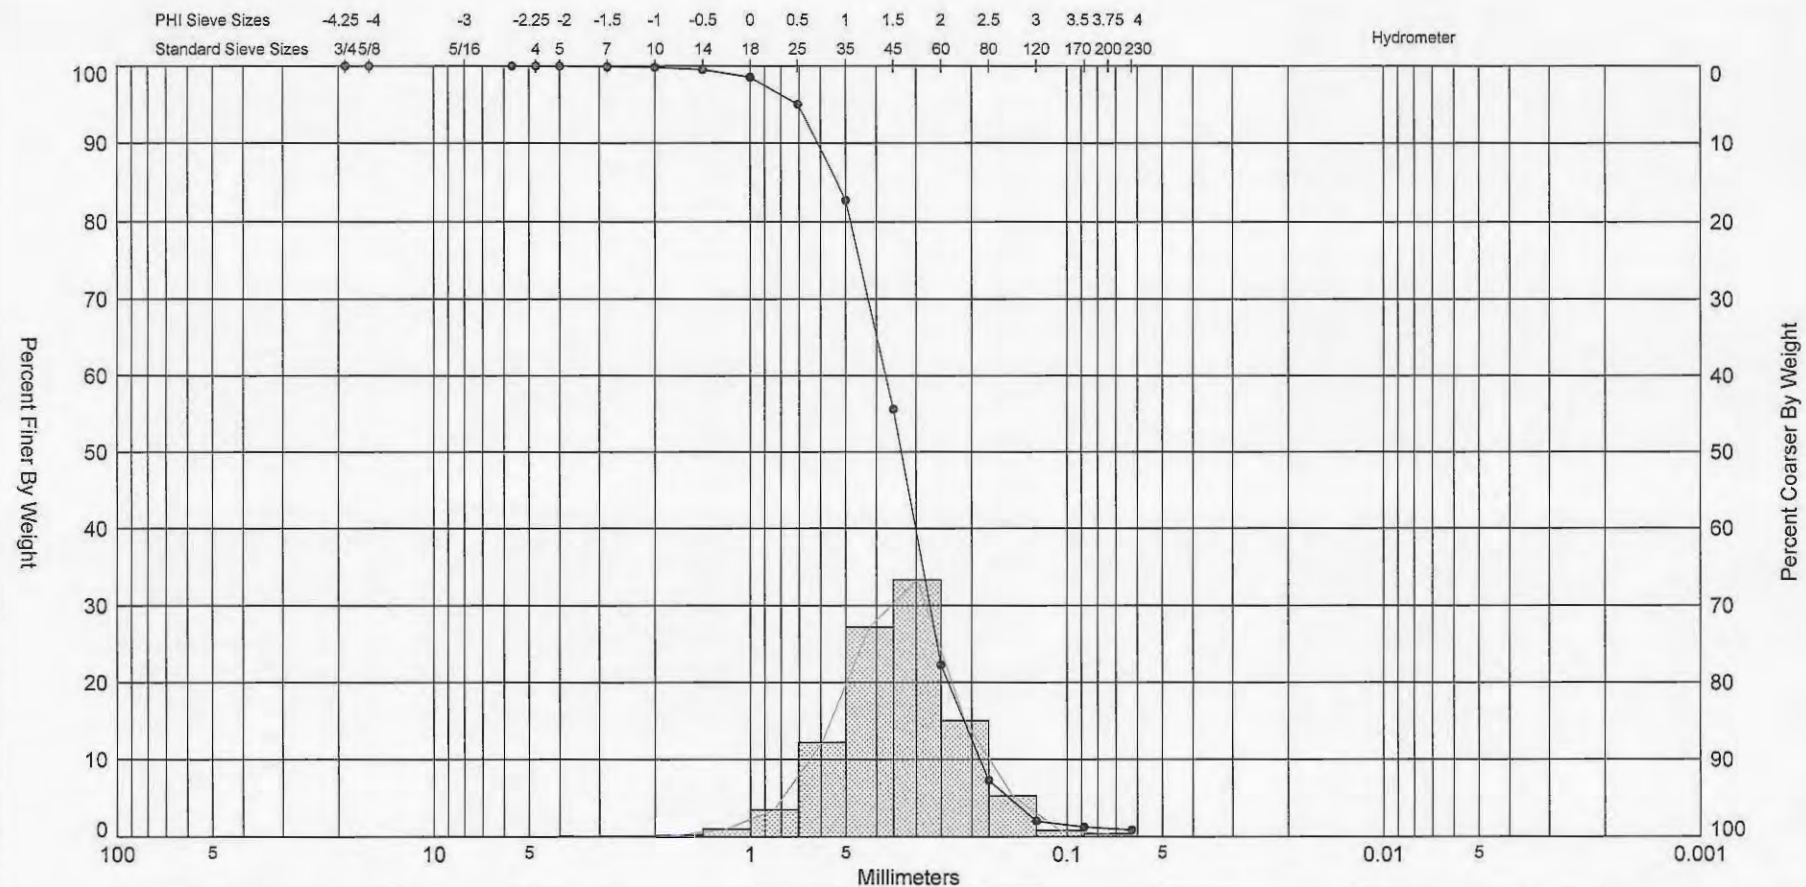
| Sample | Symbol | Elev. (ft) | USCS | % Fines | % Organics | % Carbonates | Median | Mean | Skew | Kurt | Sort | Sample Information | |
|---|---|---|---|---|---|---|---|---|---|---|---|---|---|
| Comments: Visual Shell Content = 0% | | | | | | | | | | | | Analysis Date: | 11-16-10 |
| Depths and elevations based on measured values | | | | | | | | | | | | Analyzed By: | JR |

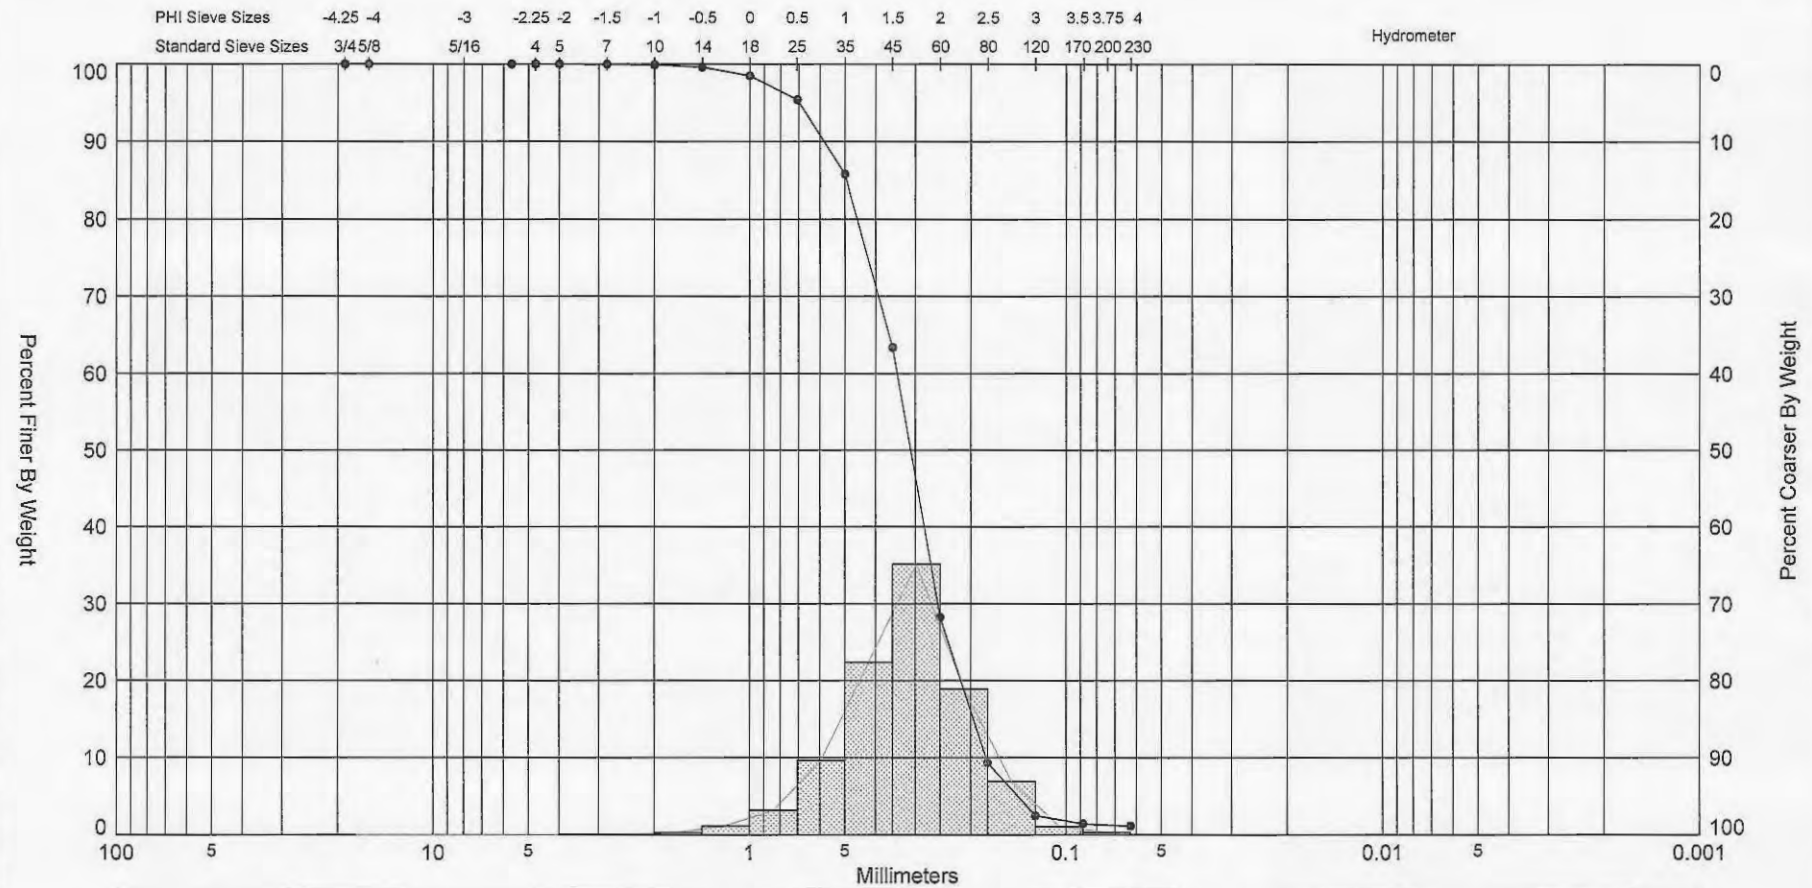
| Sample | Symbol | Elev. (ft) | USCS | % Fines | % Organics | % Carbonates | Median | Mean | Skew | Kurt | Sort | Sample Information | |
|---|---|---|---|---|---|---|---|---|---|---|---|---|---|
| JIVC-10-17 #S-2 (5') | —●— | -61.3 | SP | #230 - 1.10 | | 66.70 | 1.69 | 1.65 | -0.37 | 3.99 | 0.66 | Project Name: | Jupiter Island 10 Detail Phase |
| Comments: Visual Shell Content = 0% | | | | | | | | | | | | Analysis Date: | 11-08-10 |
| Depths and elevations based on measured values | | | | | | | | | | | | Analyzed By: | JR |

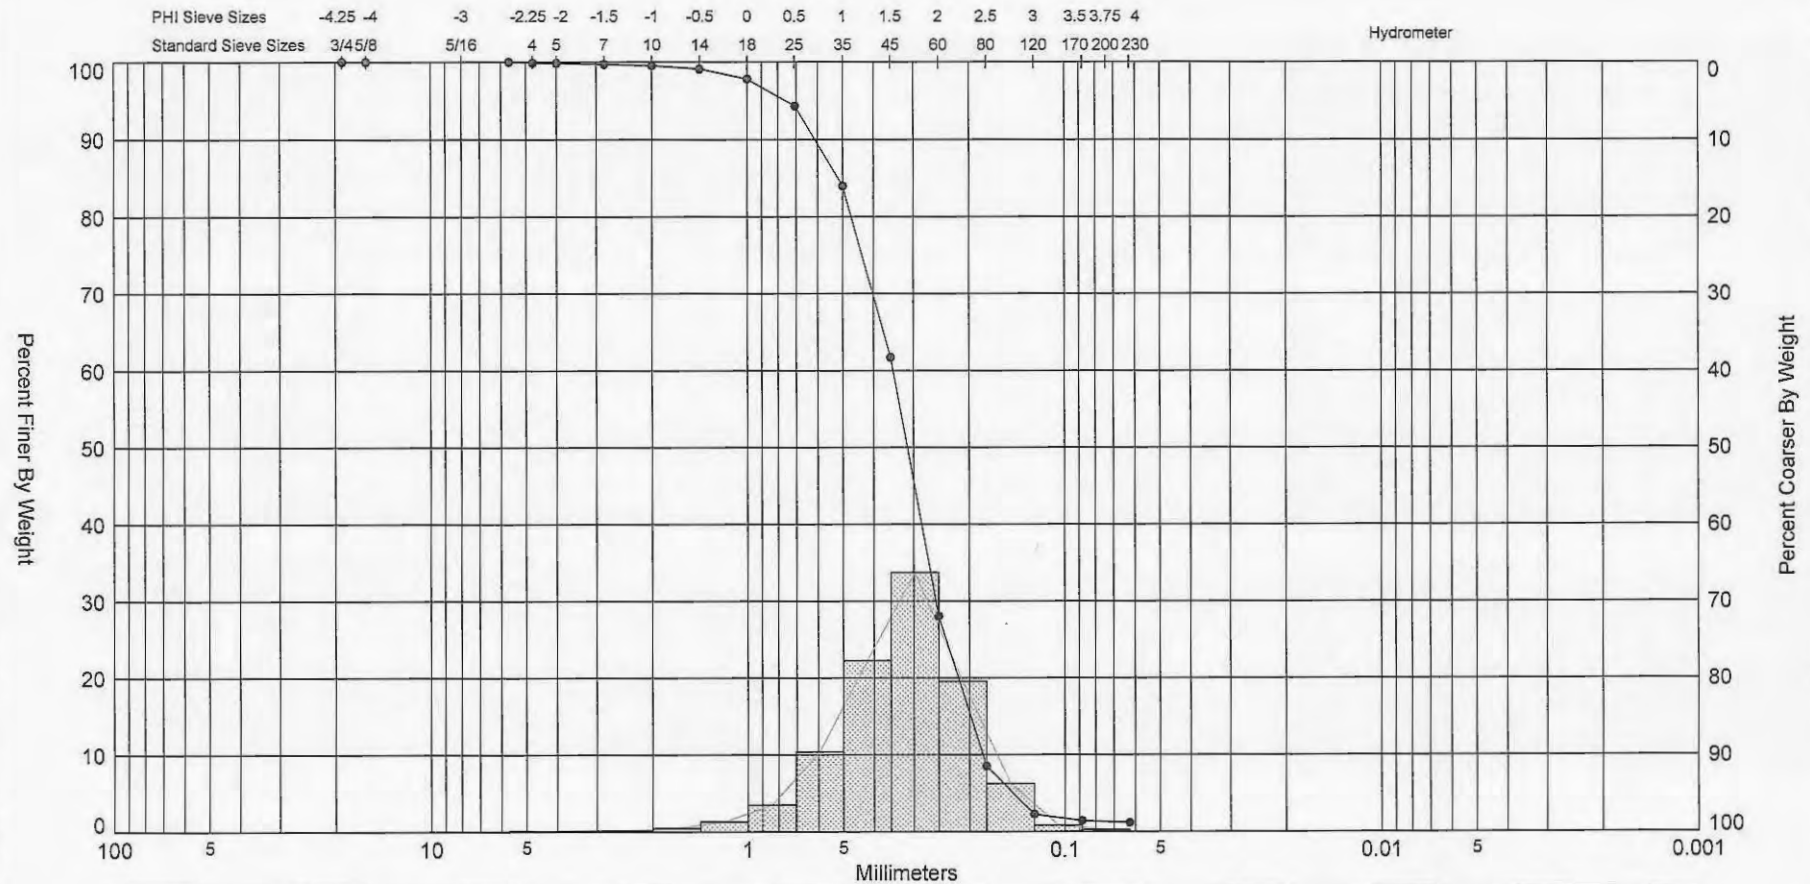
| Sample | Symbol | Elev. (ft) | USCS | % Fines | % Organics | % Carbonates | Median | Mean | Skew | Kurt | Sort | Sample Information | |
|--|---|---|---|---|---|---|---|---|---|---|---|---|---|
| JIVC-10-17 #S-3 (8') | —●— | -64.3 | SP | #230 - 1.15 | | | 1.67 | 1.61 | -0.78 | 5.54 | 0.71 | Project Name: | Jupiter Island 10 Detail Phase |
| Comments: Visual Shell Content = >1% | | | | | | | | | | | | Analysis Date: | 11-16-10 |
| Depths and elevations based on measured values | | | | | | | | | | | | Analyzed By: | JR |
