| Sample | Symbol | Elev. | Comments | USCS | % Fines | Median | Mean | Skew | Kurt | Sort | Sample Information | |
|---|---|---|---|---|---|---|---|---|---|---|---|---|
| HB04-40 R1R2 #4.0 | —●— | -70.9 | | SP | #200 - 1.12 #230 - 1.02 | 2.61 | 2.4 | -2.28 | 9.67 | 0.87 | Project Name: | Palm Beach County Vibracore 2004 |

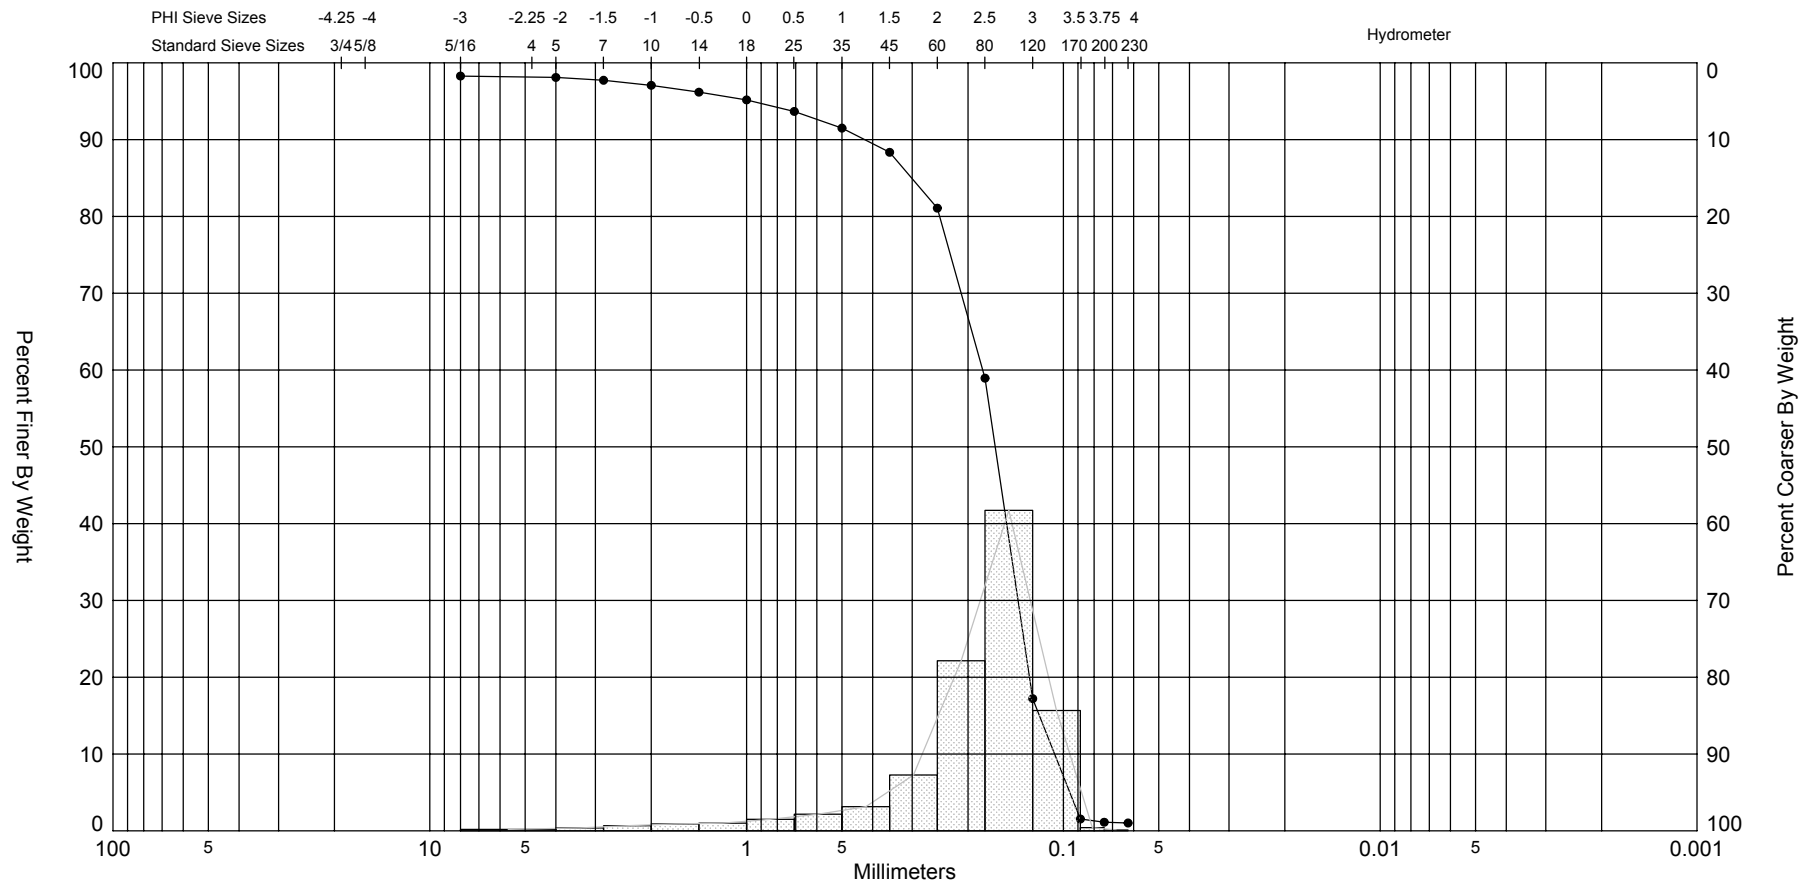
| Sample | Symbol | Elev. | Comments | USCS | % Fines | Median | Mean | Skew | Kurt | Sort | Sample Information | |
|---|---|---|---|---|---|---|---|---|---|---|---|---|
| HB04-40 R1R2 #8.0 | | -74.9 | | SP | #200 - 2.93 #230 - 2.63 | 2.6 | 2.24 | -1.74 | 5.82 | 1.09 | Project Name: | Palm Beach County Vibracore 2004 |
