| Sample No. | C3-1.8 | Elev / Depth | -24.8 / 1.8 | Classification | SAND, poorly graded, med to fine quartz & shell, VIS: 50% shell (Sp) | Nat w % | LL | PL | PI | Project | Ft. Pierce, FL, Shore Protection Project |

| GRADATION CURVES | | | | | | | | | |
| Project: Ft. Pierce, FL, Shore Protection Project | | | | | | | | | |

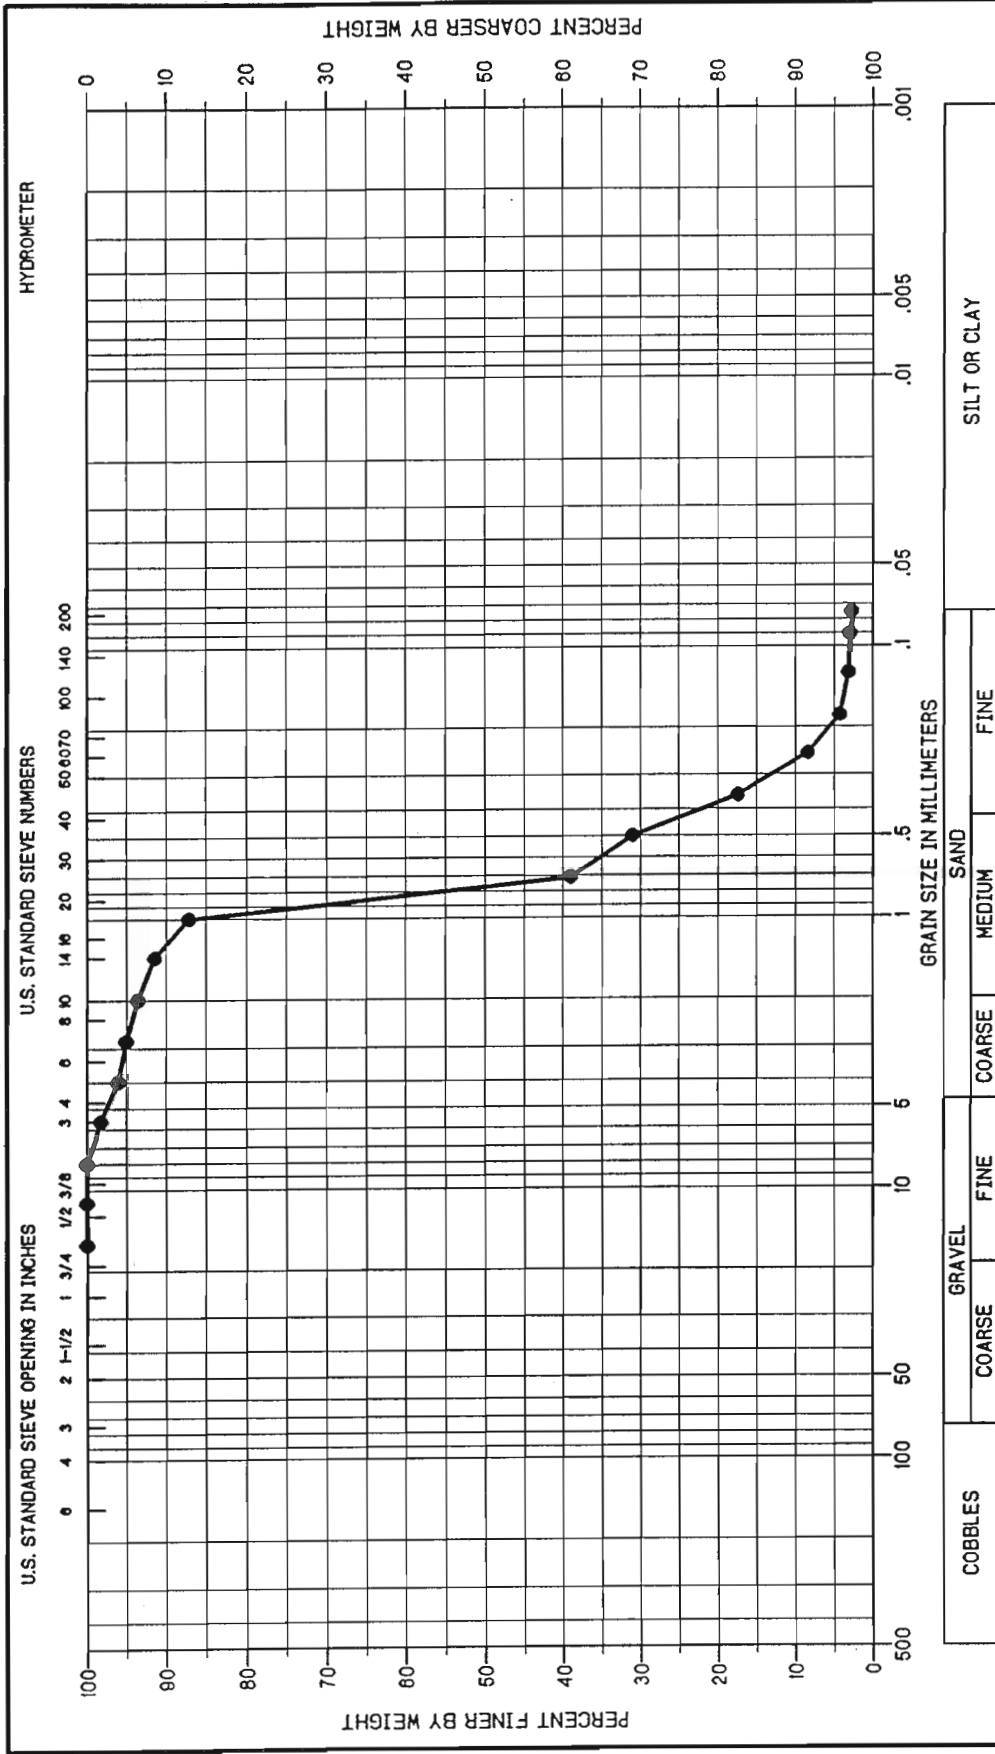
| Sample No. | C3-8.2 | Elev / Depth | -29.2 / 8.2 | Classification | SAND, poorly graded, med quartz & shell, VIS: 50% shell (SP) | Net wt | LL | PL | PI |

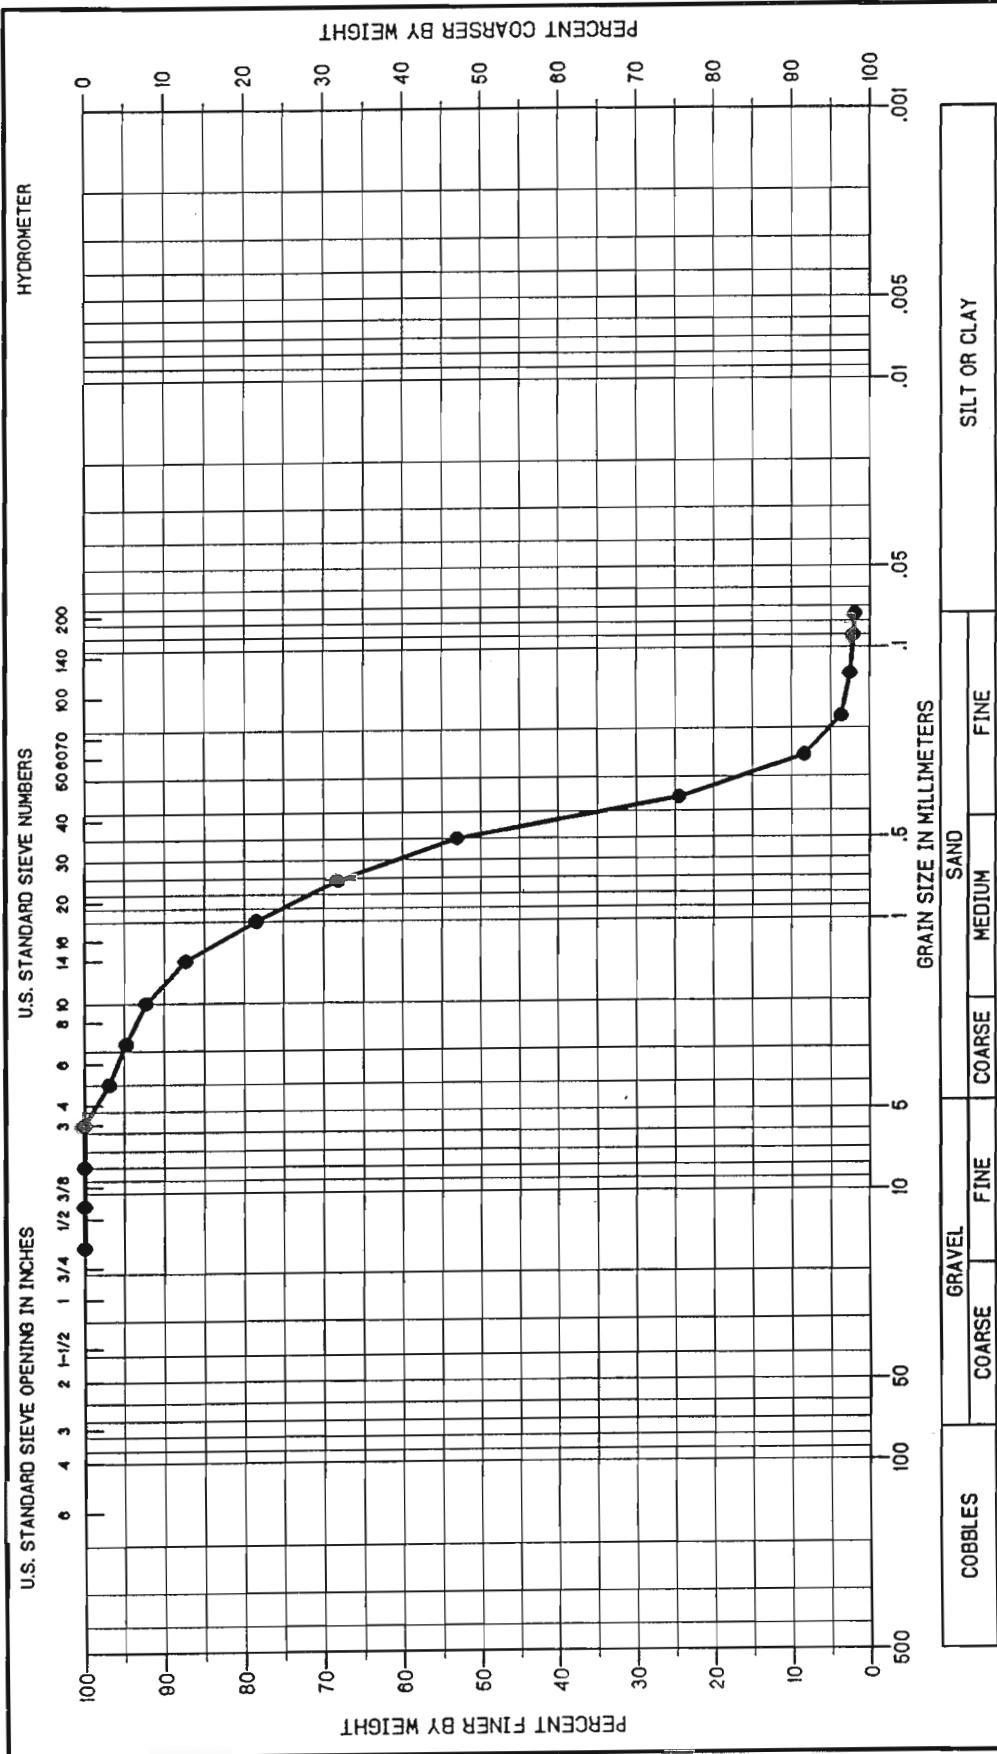
GRADATION CURVES

| Sample No. | C3-8.2 | Elev / Depth | -31.2 / 8.2 | Classification | SAND, poorly graded, med quartz & shell, VIS: 50% shell (SP) | Nat w % | LL | PL | PI |
