SIEVE ANALYSIS SINGER ISLAND 2012.G

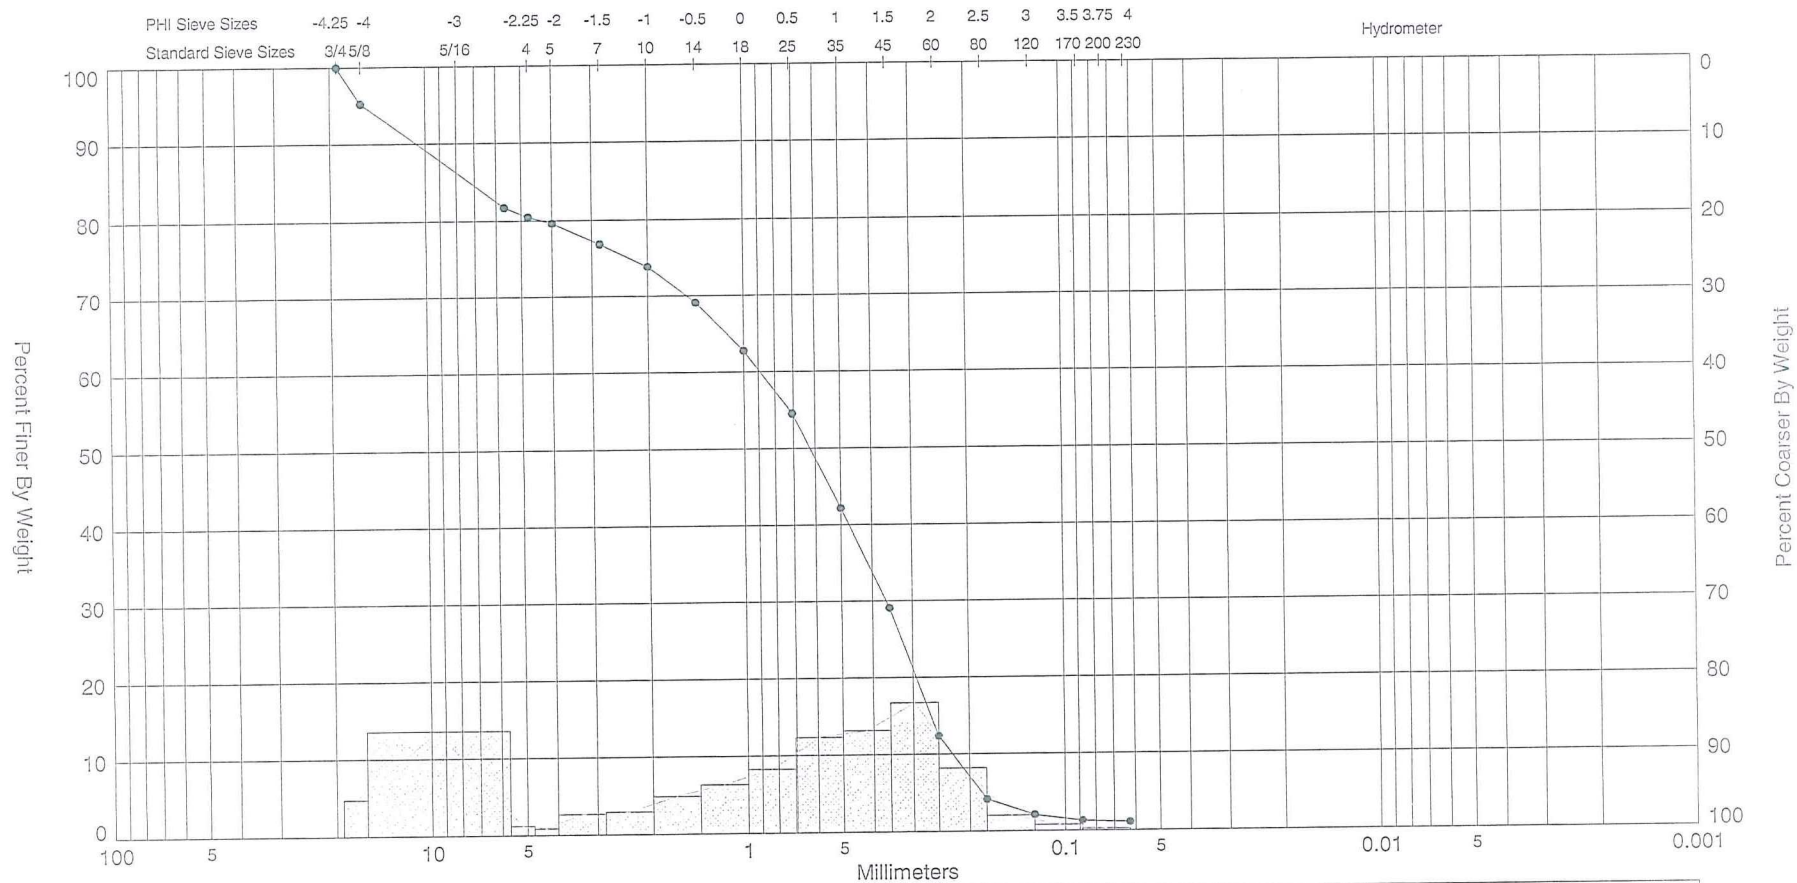
Sample	Symbol	Elev. (ft)	USCS	% Fines	% Organics	% Carbonates	Median	Mean	Skew	Kurt	Sort	Sample Information	
SIVC-12-5 #S-1 (1.7')	—○—	-73.4	SW	#230 - 1.08		83.60	0.68	0.03	-0.72	2.3	2.01	Project Name:	Singer Island 2012
Comments:												Analysis Date:	03-29-12
Depths and elevations based on measured values												Analyzed By:	ER

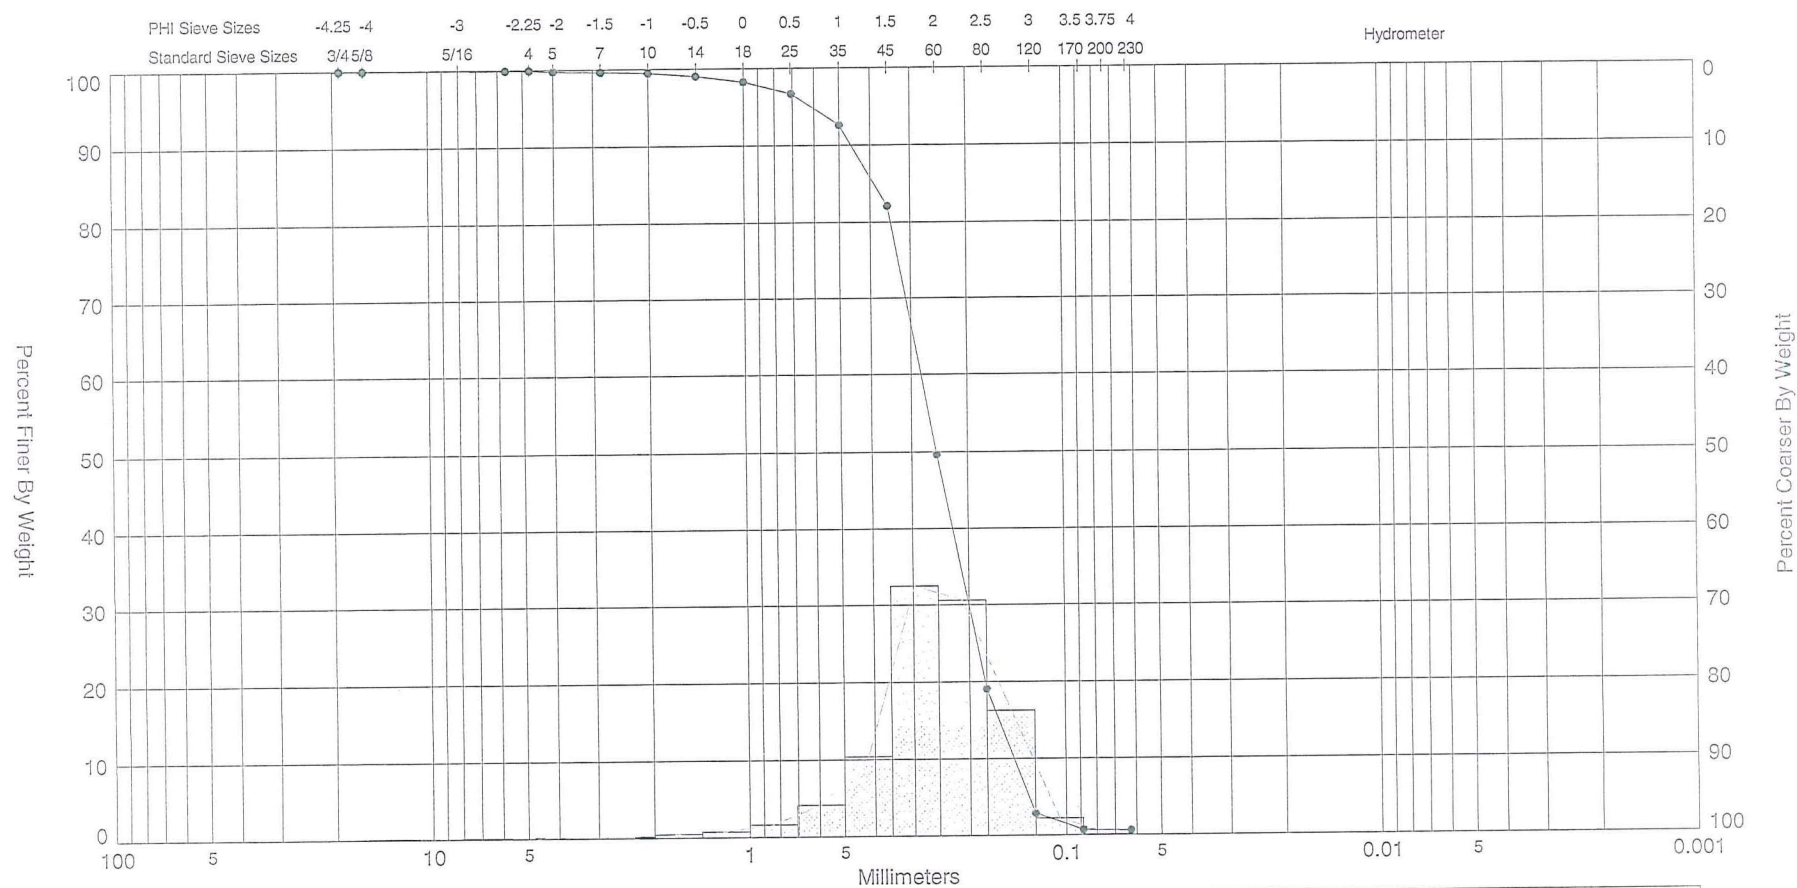
Sample	Symbol	Elev. (ft)	USCS	% Fines	% Organics	% Carbonates	Median	Mean	Skew	Kurt	Sort	Sample Information	
SIVC-12-5 #S-2 (8')	—●—	-79.7	SP	#230 - 0.58		83.40	1.99	1.94	-1.51	8.82	0.7	Project Name:	Singer Island 2012
Comments:												Analysis Date:	03-30-12
Depths and elevations based on measured values												Analyzed By:	ER

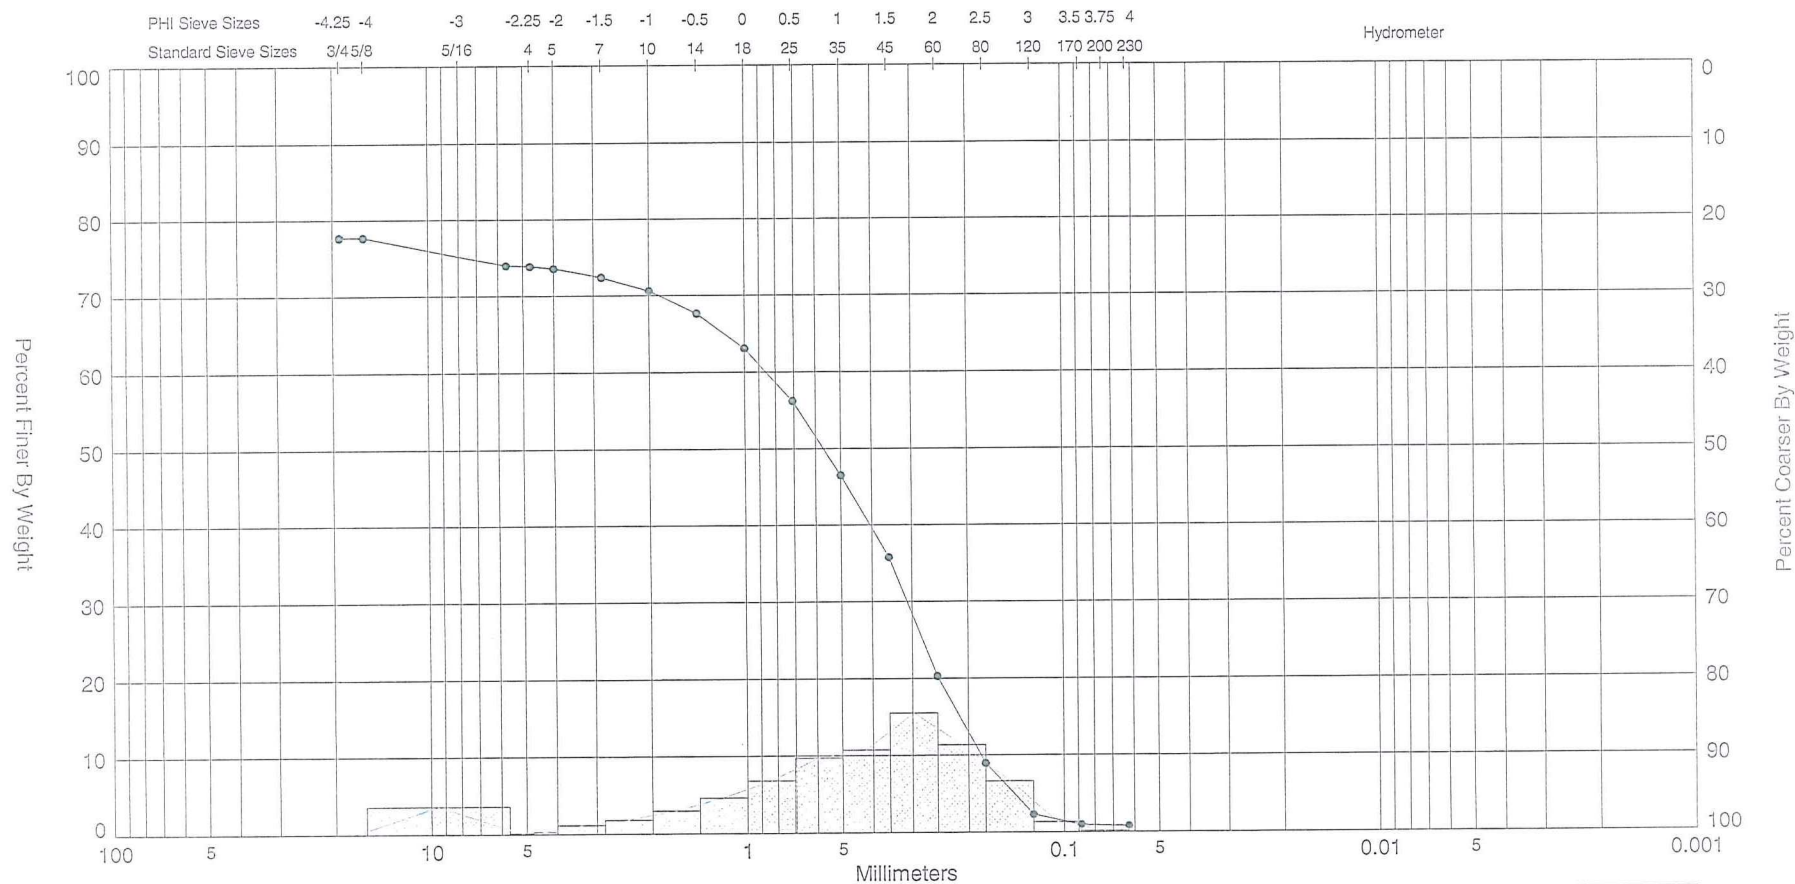
Sample	Symbol	Elev. (ft)	USCS	% Fines	% Organics	% Carbonates	Median	Mean	Skew	Kurt	Sort	Sample Information	
SIVC-12-5 #S-3 (13.5')

-85.2	SW	#230 - 0.79			0.82	-0.2	0.96	2.26	1.67	Project Name:	Singer Island 2012
Comments:												Analysis Date:	03-30-12
Depths and elevations based on measured values												Analyzed By:	ER
