SIEVE ANALYSIS FL_BOEM_2015_VC_GRP_JPBRAZIL.GDT 9/12/16

Sample	Symbol	Elev. (ft)	USCS	% Fines	% Organics	% Carbonates	Median	Mean	Skew	Kurt	Sort	Sample Information	
FL-BOEM-2015-VC08 #1	—●—	-63.0	SP	#200 - 1.39 #230 - 1.29		8	2.24	2.12	-3.43	20.53	0.71	Project Name:	Inventory of Potential Beach Nourishment and Coastal
Comments:												Analysis Date:	Restoration Sand Sources on the Atlantic OCS
Depths and elevations based on measured values												Analyzed By:	10-27-15 SMT

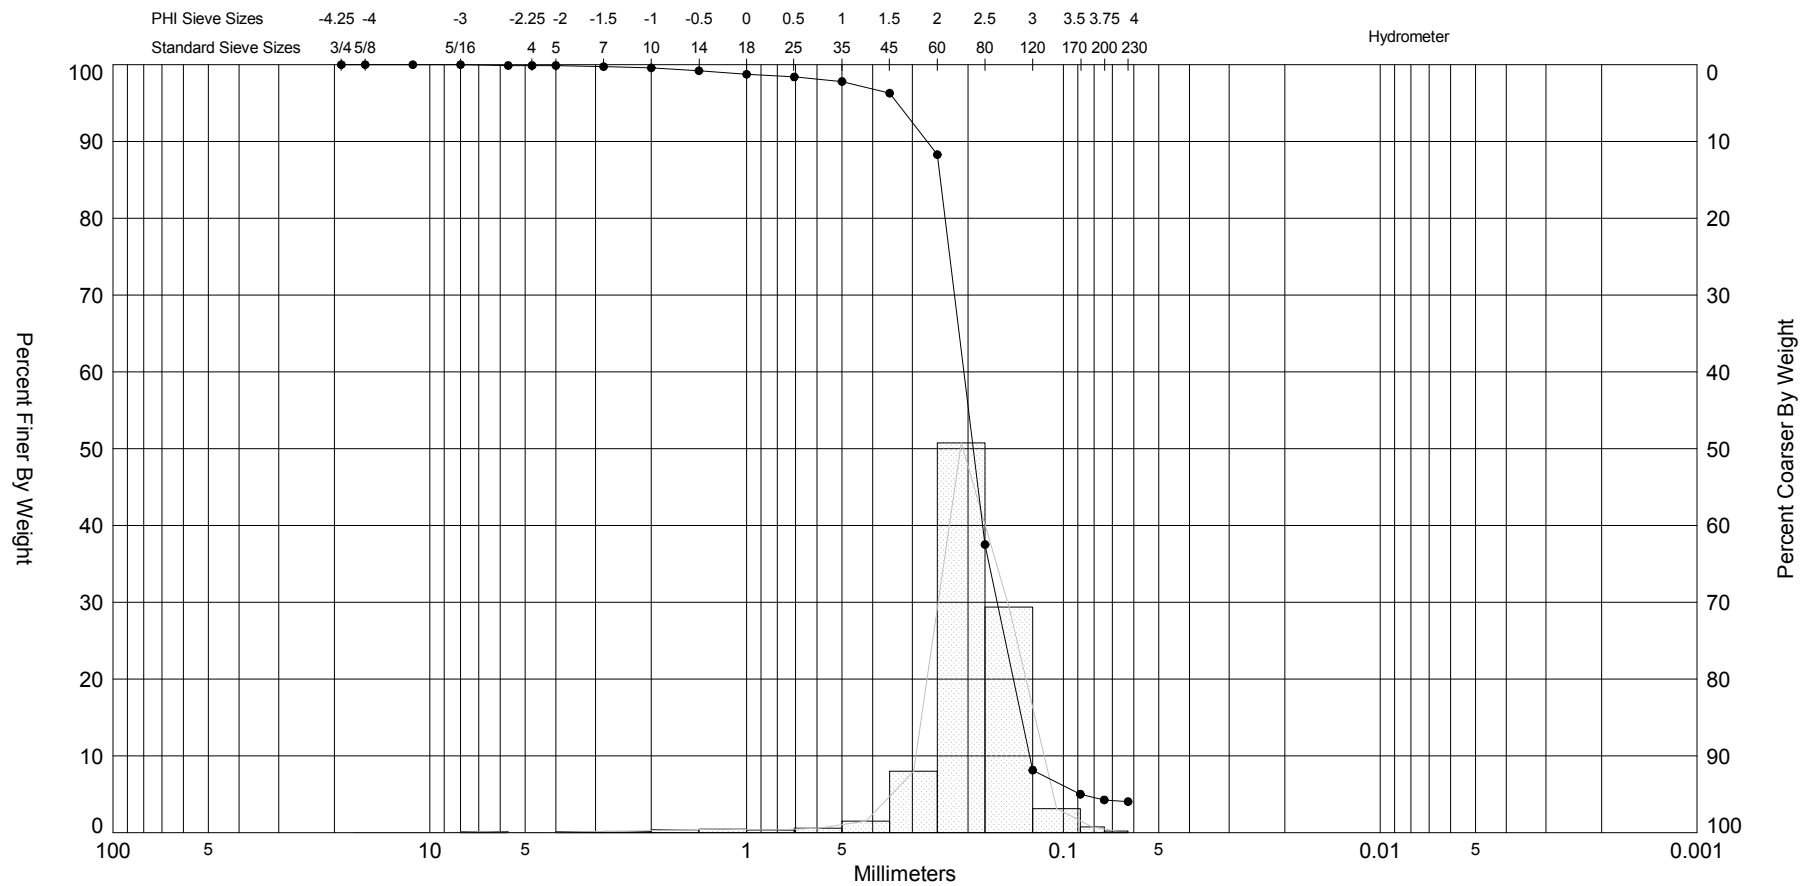
SIEVE ANALYSIS FL_BOEM_2015_VC.GPJ_JPBRAZIL.GDT 9/12/16

Sample	Symbol	Elev. (ft)	USCS	% Fines	% Organics	% Carbonates	Median	Mean	Skew	Kurt	Sort	Sample Information	
FL-BOEM-2015-VC08 #2	—●—	-67.0	SP	#200 - 4.27 #230 - 4.05		7	2.38	2.33	-2.96	21.01	0.57	Project Name:	Inventory of Potential Beach Nourishment and Coastal
Comments:												Analysis Date:	Restoration Sand Sources on the Atlantic OCS
Depths and elevations based on measured values												Analyzed By:	10-28-15

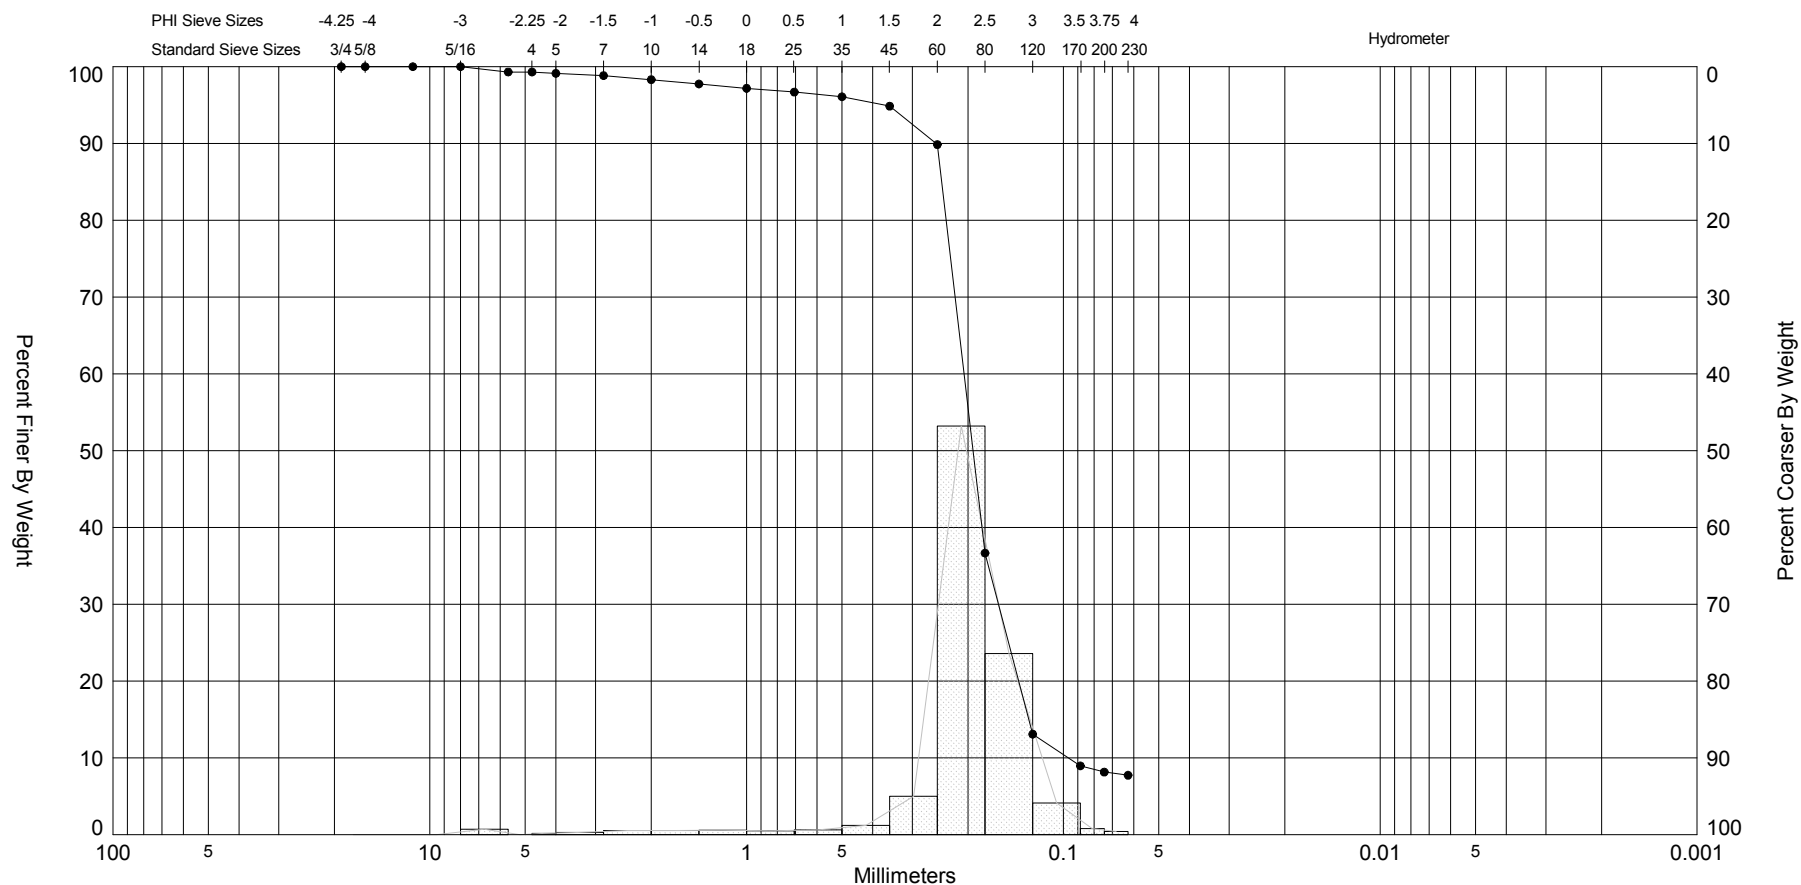
Sample	Symbol	Elev. (ft)	USCS	% Fines	% Organics	% Carbonates	Median	Mean	Skew	Kurt	Sort	Sample Information	
FL-BOEM-2015-VC08 #3

-69.4	SP-SM	#200 - 8.15 #230 - 7.74		10	2.37	2.27	-3.55	20.12	0.8	Project Name:	Inventory of Potential Beach Nourishment and Coastal
Comments:												Analysis Date:	Restoration Sand Sources on the Atlantic OCS
Depths and elevations based on measured values												Analyzed By:	10-28-15

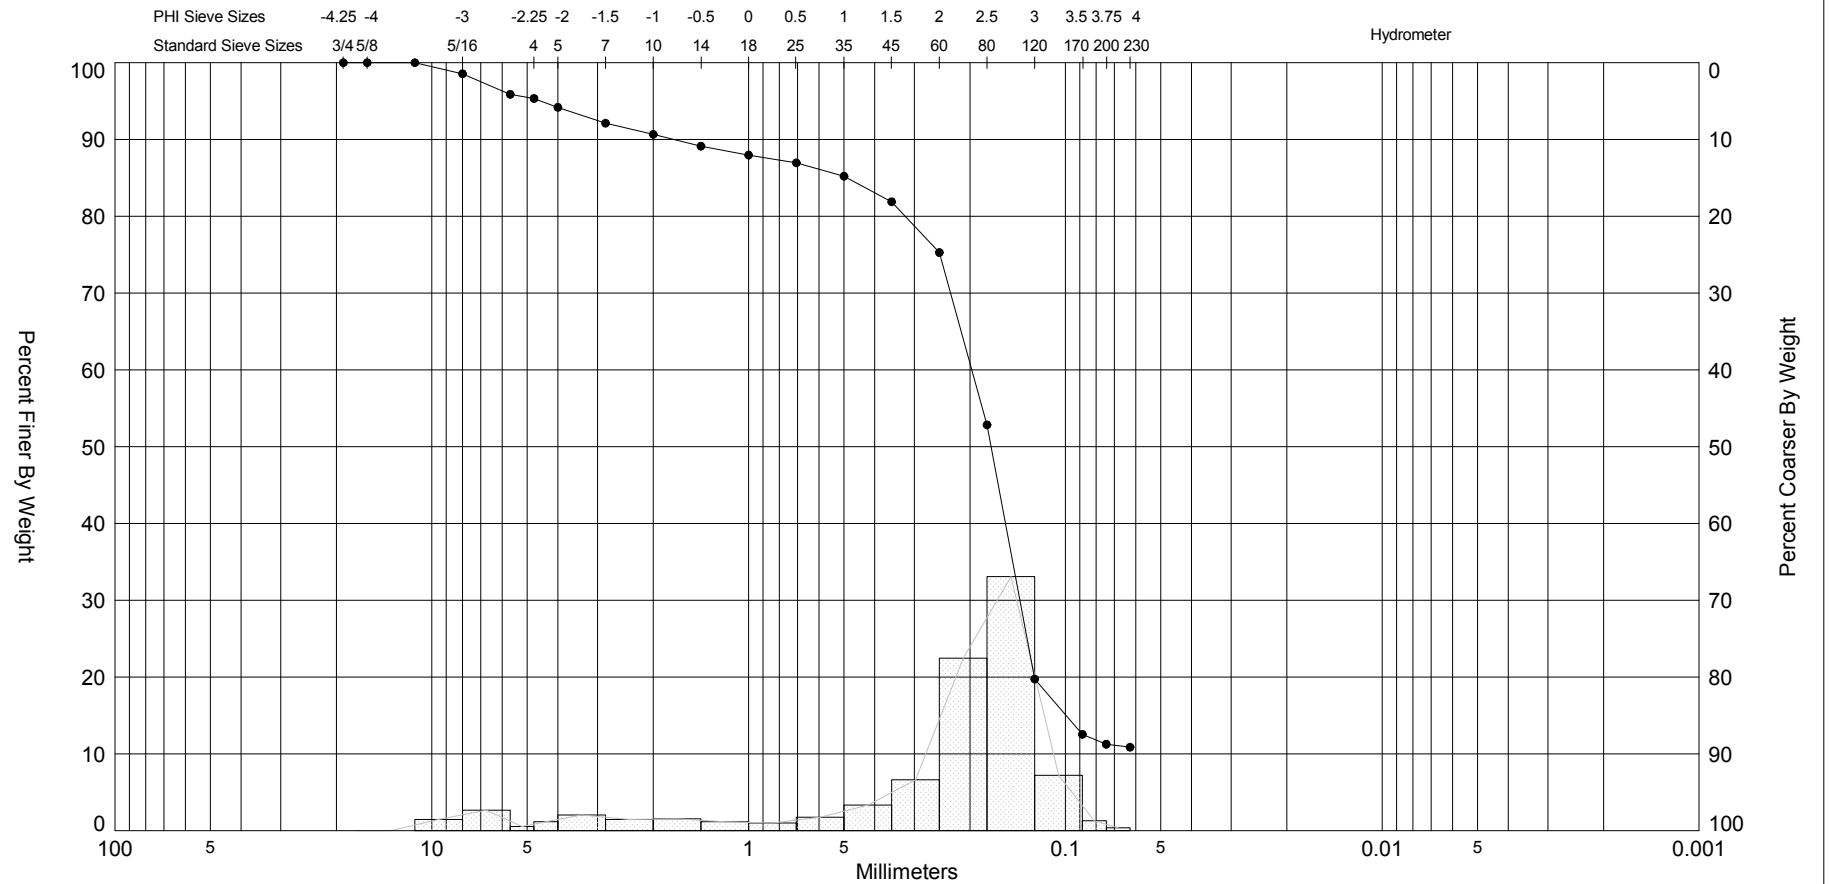
Sample	Symbol	Elev. (ft)	USCS	% Fines	% Organics	% Carbonates	Median	Mean	Skew	Kurt	Sort	Sample Information	
FL-BOEM-2015-VC08 #4

-72.4	SW-SM	#200 - 11.26 #230 - 10.87		22	2.54	1.86	-1.84	5.37	1.62	Project Name:	Inventory of Potential Beach Nourishment and Coastal
Comments:												Analysis Date:	Restoration Sand Sources on the Atlantic OCS
Depths and elevations based on measured values												Analyzed By:	10-28-15
