SIEVE ANALYSIS JUNO HISTORIC_JUNE3.GPJ FL DEP ROSS.GDT 6/5/16

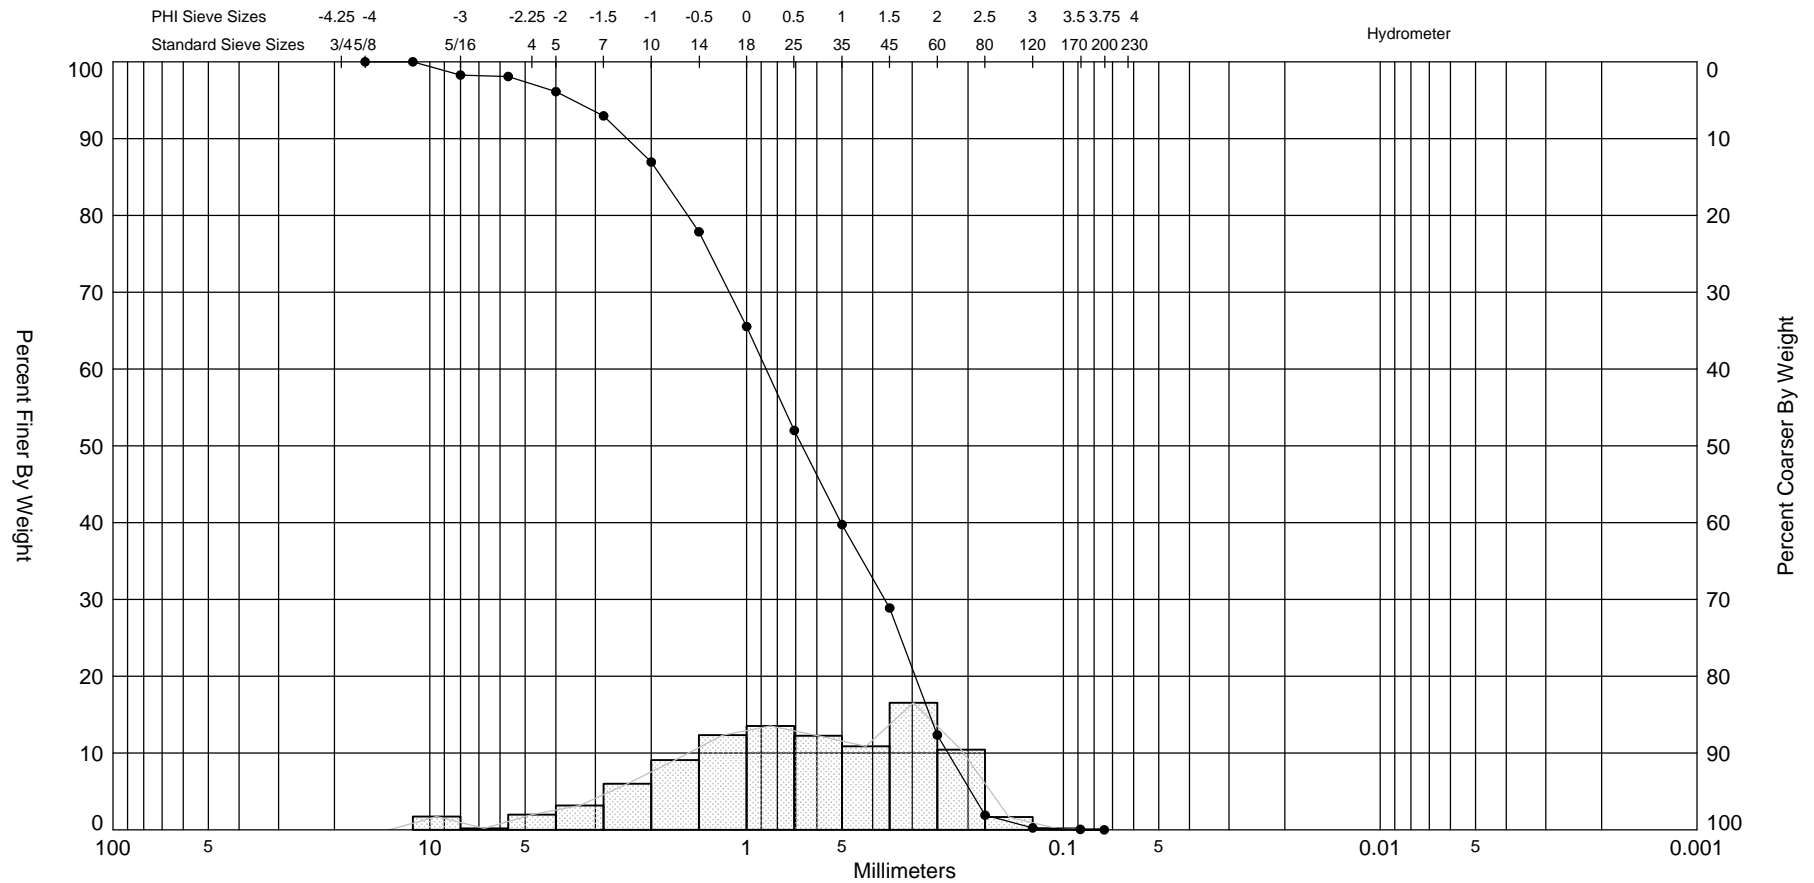
Sample	Symbol	Elev. (ft)	USCS	% Fines	% Organics	% Carbonates	Median	Mean	Skew	Kurt	Sort	Sample Information	
PB-96-C57 #0.5	—●—	-66.0	SW	#200 - 0.00		91.30	0.58	0.5	-0.5	2.82	1.31	Project Name:	Juno Historic
Comments:												Analysis Date:	08-01-96
Depths and elevations based on measured values												Analyzed By:	
						Scientific Environmental Applications 5575 Willoughby Drive Melbourne, FL 32934 seappinc.com seapp1@aol.com (321) 254-2708						Easting (X, ft):	966,634
												Northing (Y, ft):	958,065
												Horizontal System:	NAD 1983
												Vertical System:	NAVD 88

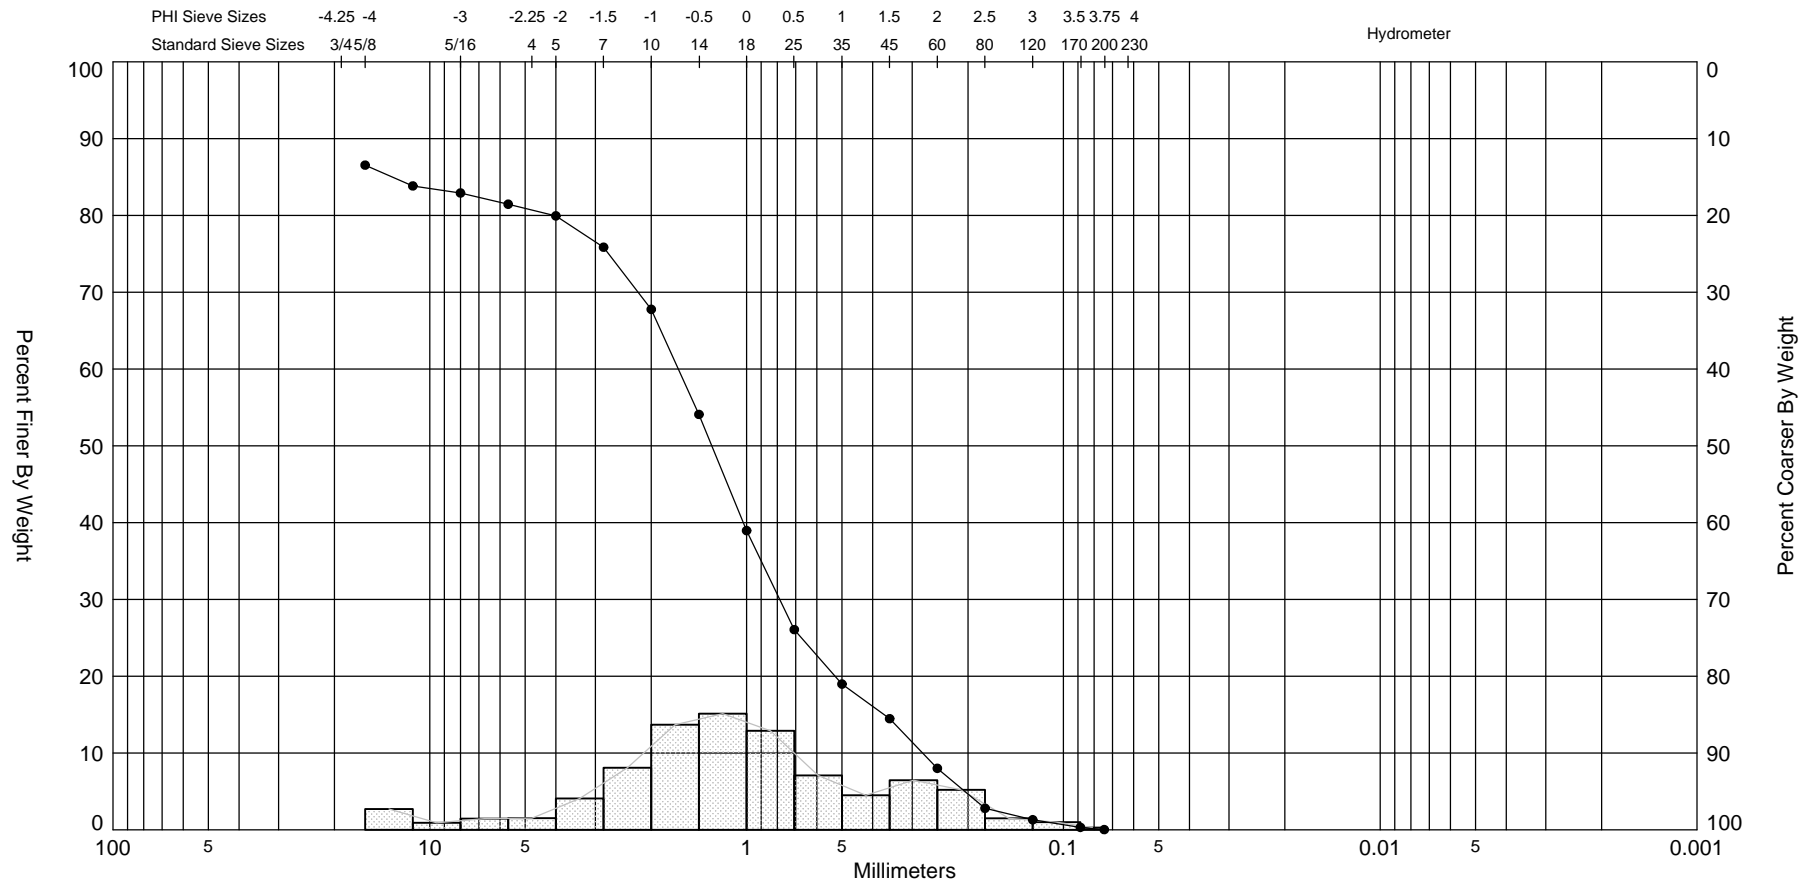
Sample	Symbol	Elev. (ft)	USCS	% Fines	% Organics	% Carbonates	Median	Mean	Skew	Kurt	Sort	Sample Information	
PB-96-C57 #3.0	—●—	-68.5		#200 - 0.03		92.70		-0.64	0.93	3.43	1.45	Project Name:	Juno Historic
Comments:												Analysis Date:	08-01-96
Depths and elevations based on measured values												Analyzed By:	
						Scientific Environmental Applications 5575 Willoughby Drive Melbourne, FL 32934 seappinc.com seapp1@aol.com (321) 254-2708						Easting (X, ft):	966,634
												Northing (Y, ft):	958,065
												Horizontal System:	NAD 1983
												Vertical System:	NAVD 88

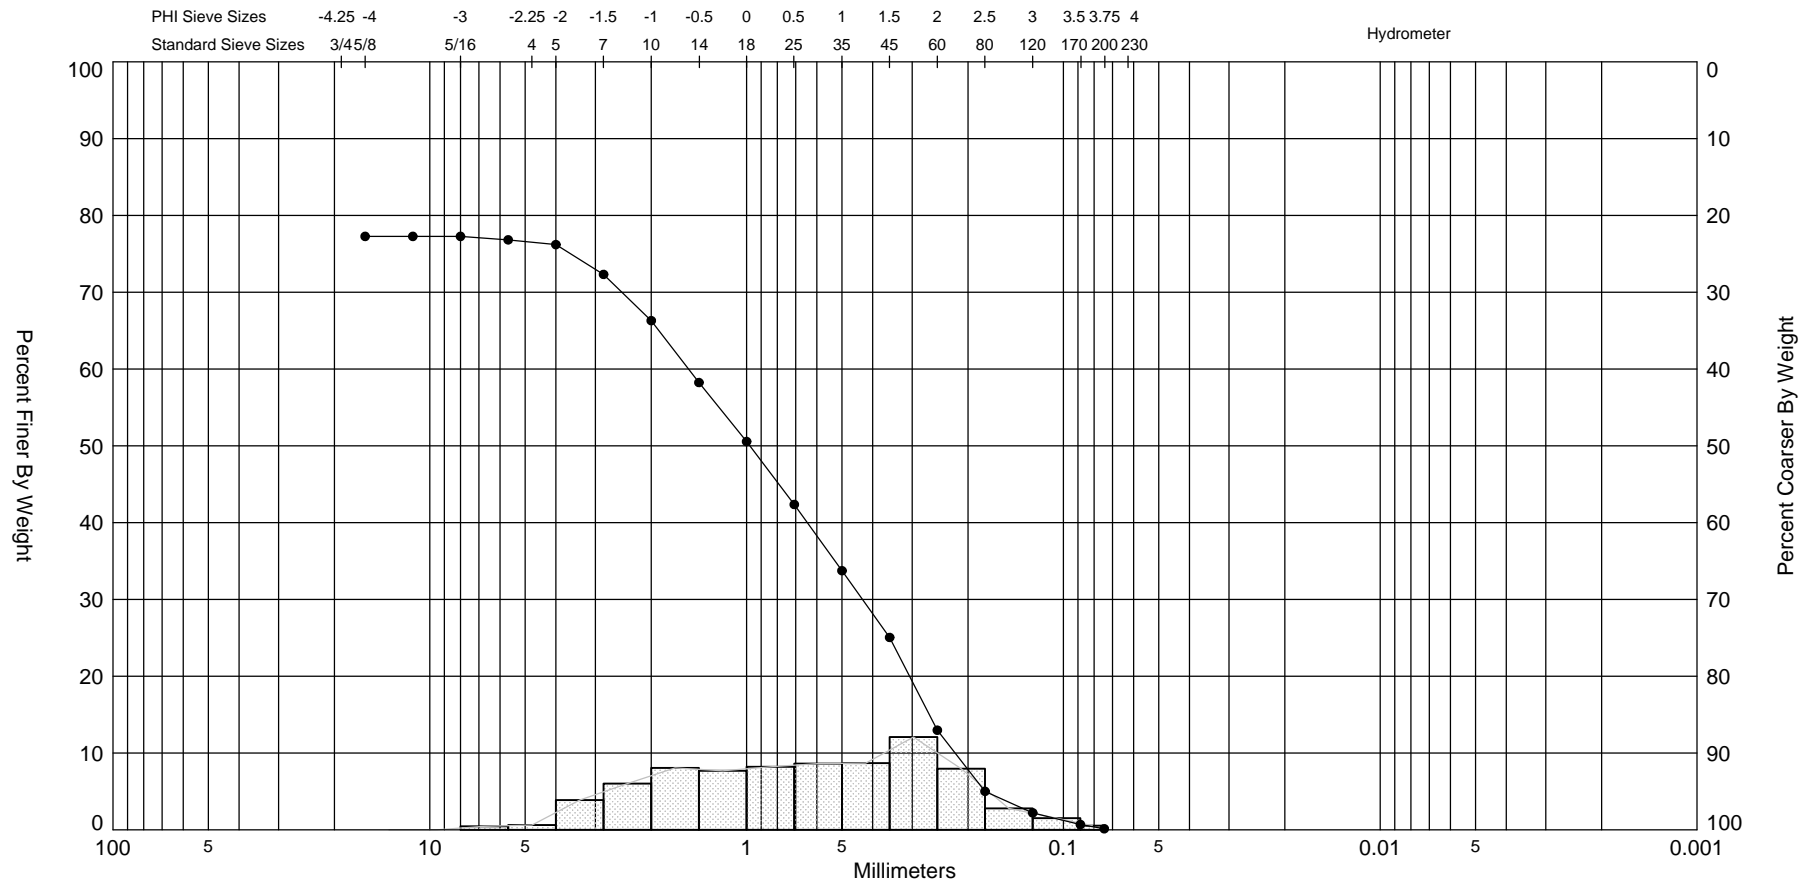
Sample	Symbol	Elev. (ft)	USCS	% Fines	% Organics	% Carbonates	Median	Mean	Skew	Kurt	Sort	Sample Information	
PB-96-C57 #6.0	—●—	-71.5		#200 - 0.14		95.50	0.03	-0.49	1.51	2.88	1.55	Project Name:	Juno Historic
Comments:												Analysis Date:	08-01-96
Depths and elevations based on measured values												Analyzed By:	
						Scientific Environmental Applications 5575 Willoughby Drive Melbourne, FL 32934 seappinc.com seapp1@aol.com (321) 254-2708						Easting (X, ft):	966,634
												Northing (Y, ft):	958,065
												Horizontal System:	NAD 1983
												Vertical System:	NAVD 88

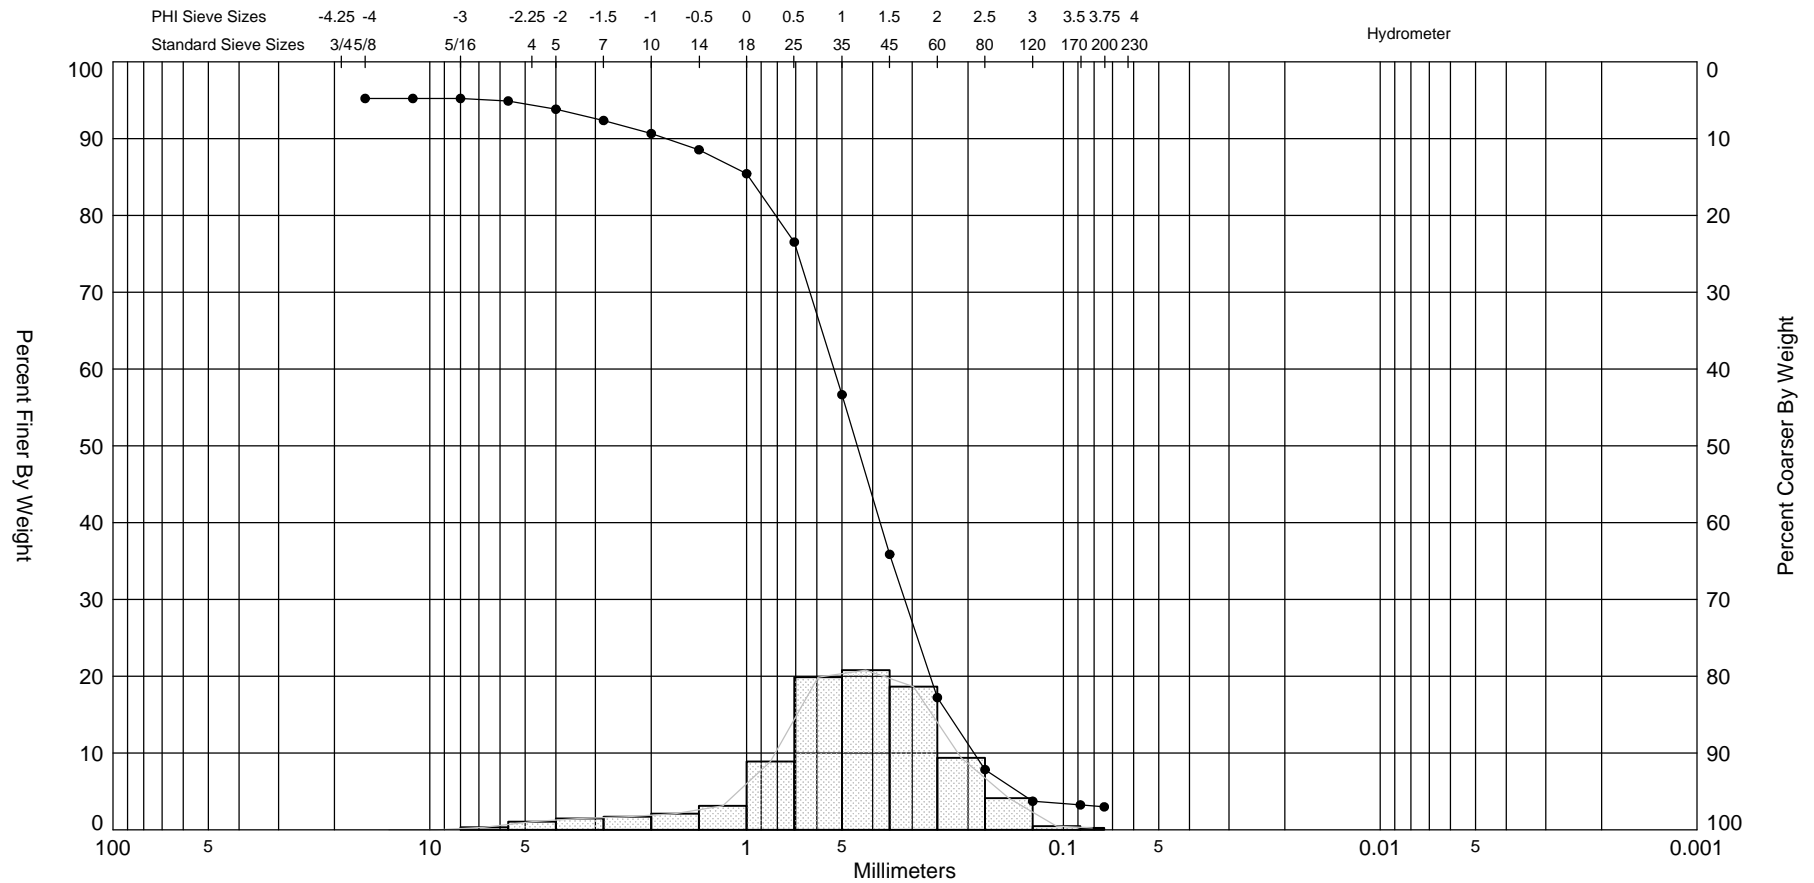
Sample	Symbol	Elev. (ft)	USCS	% Fines	% Organics	% Carbonates	Median	Mean	Skew	Kurt	Sort	Sample Information	
PB-96-C57 #9.0

-74.5		#200 - 2.99		82.20	1.16	0.82	-0.14	3.77	1.03	Project Name:	Juno Historic
Comments:												Analysis Date:	08-01-96
Depths and elevations based on measured values												Analyzed By:	
						Scientific Environmental Applications 5575 Willoughby Drive Melbourne, FL 32934 seappinc.com seapp1@aol.com (321) 254-2708						Easting (X, ft):	966,634
												Northing (Y, ft):	958,065
												Horizontal System:	NAD 1983
												Vertical System:	NAVD 88

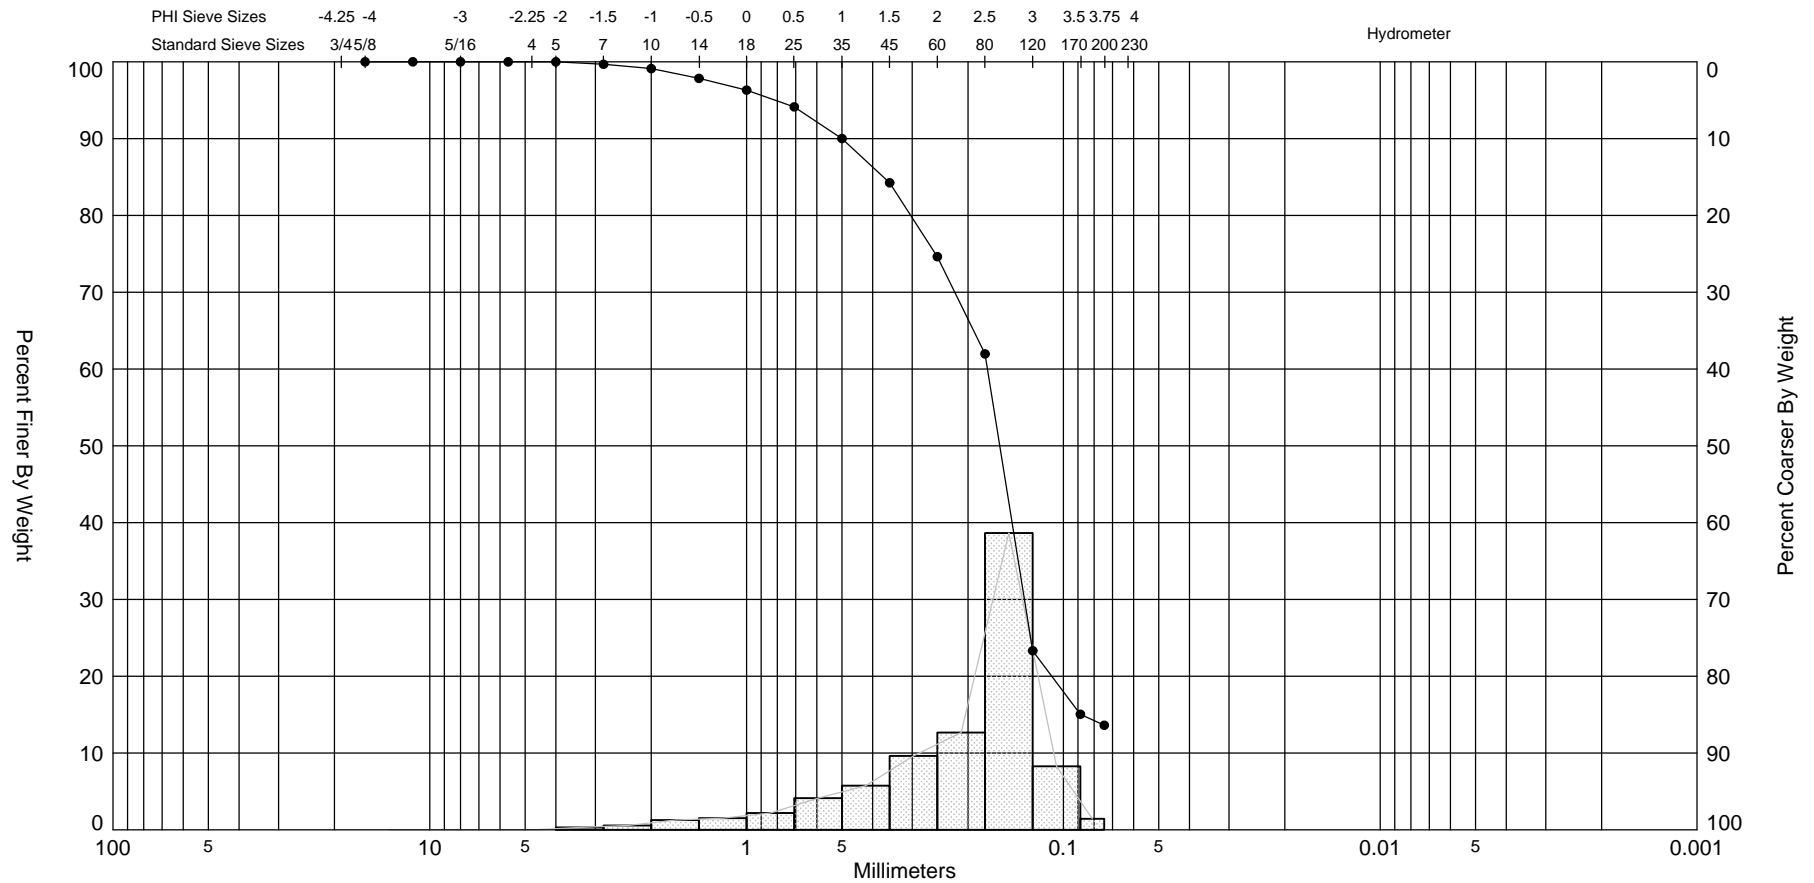
Sample	Symbol	Elev. (ft)	USCS	% Fines	% Organics	% Carbonates	Median	Mean	Skew	Kurt	Sort	Sample Information	
PB-96-C57 #15.0

-80.5		#200 - 13.62		75.10	2.65	2.22	-1.53	5.33	0.96	Project Name:	Juno Historic
Comments:												Analysis Date:	08-01-96
Depths and elevations based on measured values												Analyzed By:	
						Scientific Environmental Applications 5575 Willoughby Drive Melbourne, FL 32934 seappinc.com seapp1@aol.com (321) 254-2708						Easting (X, ft):	966,634
												Northing (Y, ft):	958,065
												Horizontal System:	NAD 1983
												Vertical System:	NAVD 88

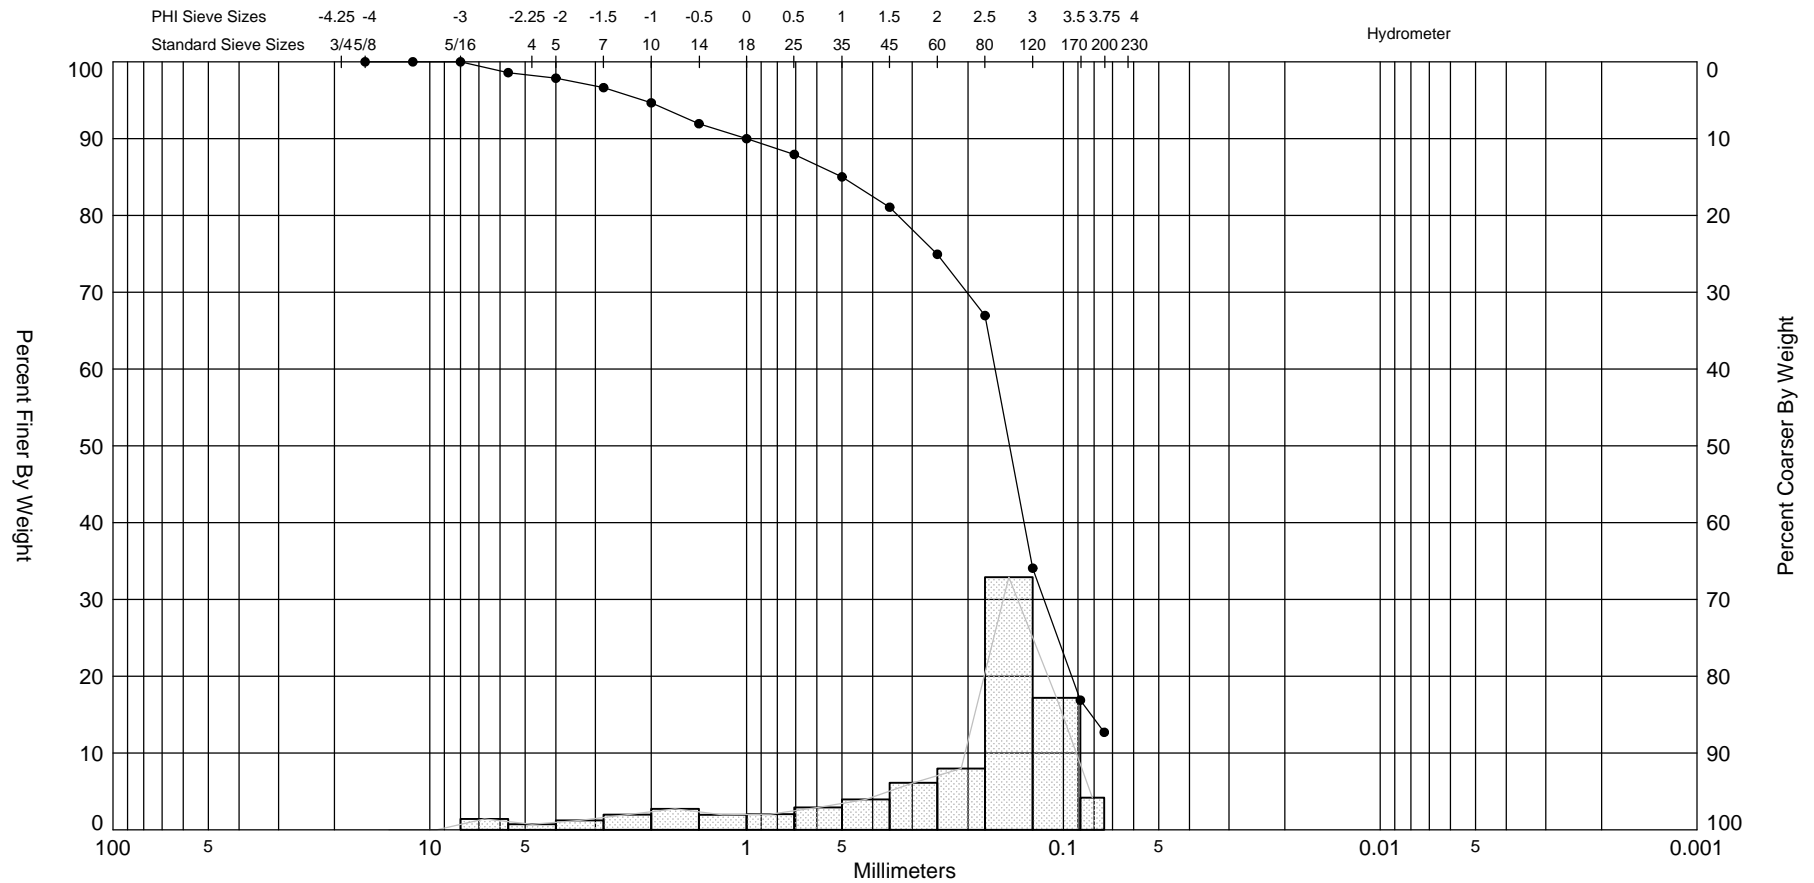
Sample	Symbol	Elev. (ft)	USCS	% Fines	% Organics	% Carbonates	Median	Mean	Skew	Kurt	Sort	Sample Information	
PB-96-C57 #18.0

-83.5		#200 - 12.70		73.50	2.76	2.12	-1.66	5.05	1.45	Project Name:	Juno Historic
Comments:												Analysis Date:	08-01-96
Depths and elevations based on measured values												Analyzed By:	
						Scientific Environmental Applications 5575 Willoughby Drive Melbourne, FL 32934 seappinc.com seapp1@aol.com (321) 254-2708						Easting (X, ft):	966,634
												Northing (Y, ft):	958,065
												Horizontal System:	NAD 1983
												Vertical System:	NAVD 88
