Sample	Symbol	Elev. (ft)	USCS	% Fines	% Organics	% Carbonates	Median	Mean	Skew	Kurt	Sort	Sample Information	
Juno16-14 #0.5

SIEVE ANALYSIS JUNO16.GPJ FL DEP ROSS.GDT 6/16/16

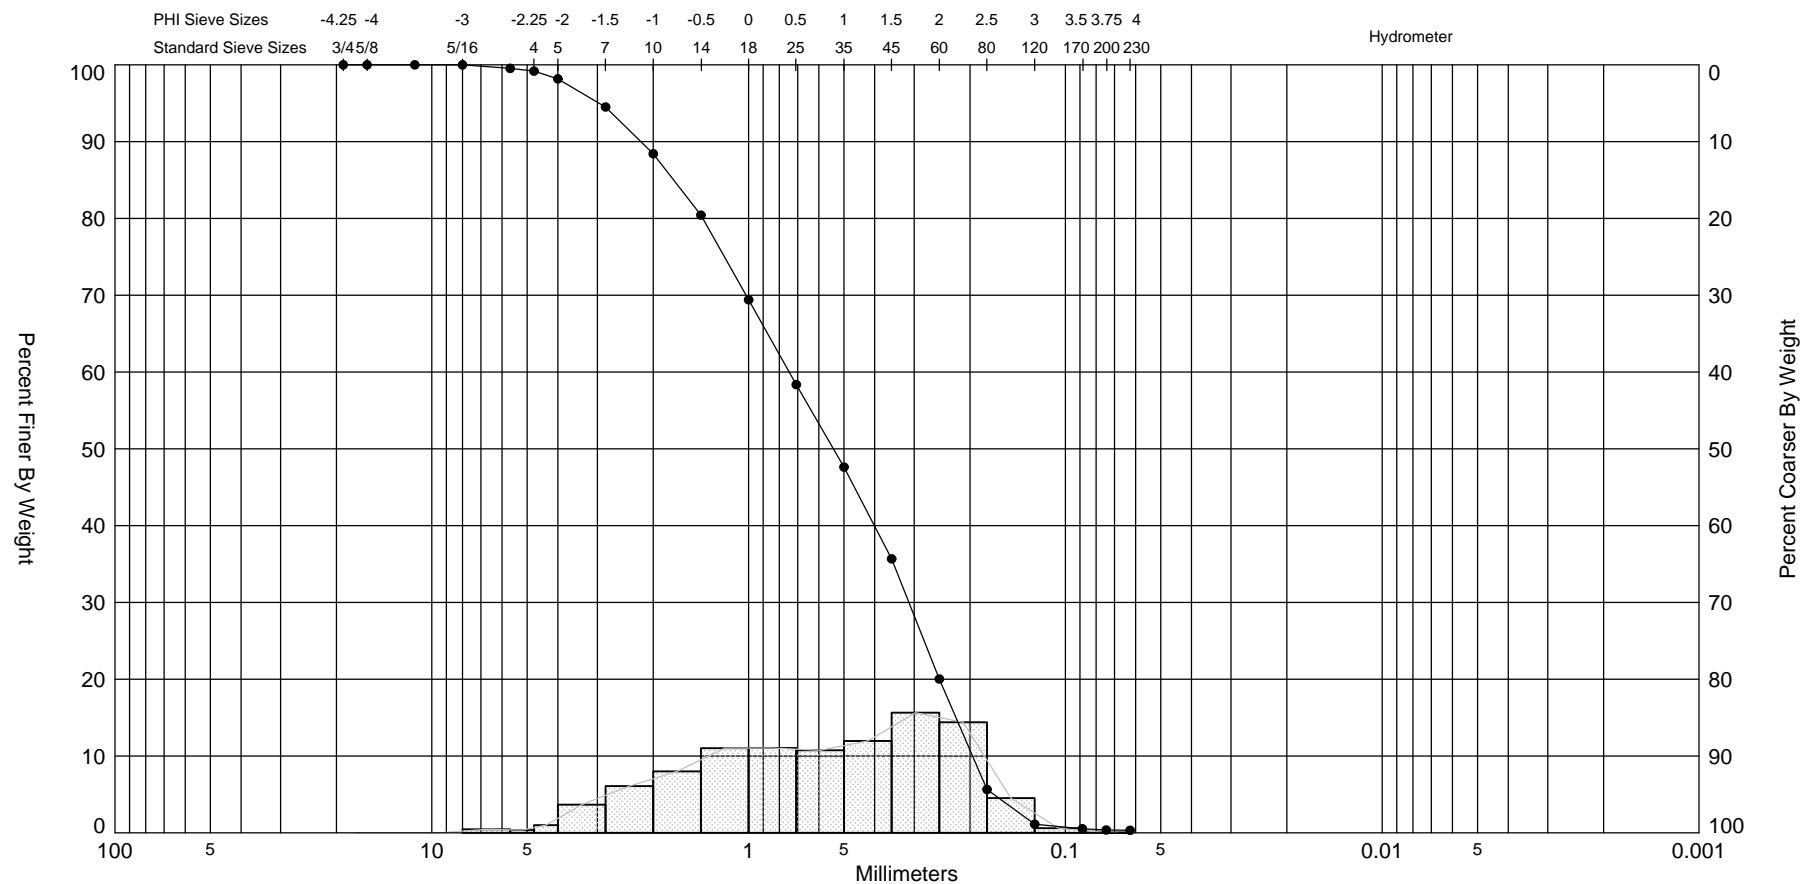
-62.7	SW	#200 - 0.37 #230 - 0.33		81.87	0.89	0.74	-0.35	2.25	1.31	Project Name:	Juno 2016
Comments:												Analysis Date:	05-05-16
Depths and elevations based on measured values												Analyzed By:	
						Scientific Environmental Applications 5575 Willoughby Drive Melbourne, FL 32934 seappinc.com seapp1@aol.com (321) 254-2708						Easting (X, ft):	966,872
												Northing (Y, ft):	962,943
												Horizontal System:	NAD 1983
												Vertical System:	NAVD 88
