Sample	Symbol	Elev. (ft)	USCS	% Fines	% Organics	% Carbonates	Median	Mean	Skew	Kurt	Sort	Sample Information	
Jl-14 #S-1 (1')	—●—	-45.7	SW	#230 - 0.80		75.50	0.97	0.83	-0.89	5.17	0.95	Project Name:	Jupiter Island 10
Comments: 10 YR 4/1 Munsell @ 10% Moisture												Analysis Date:	04-16-10
Depths and elevations based on measured values												Analyzed By:	JR

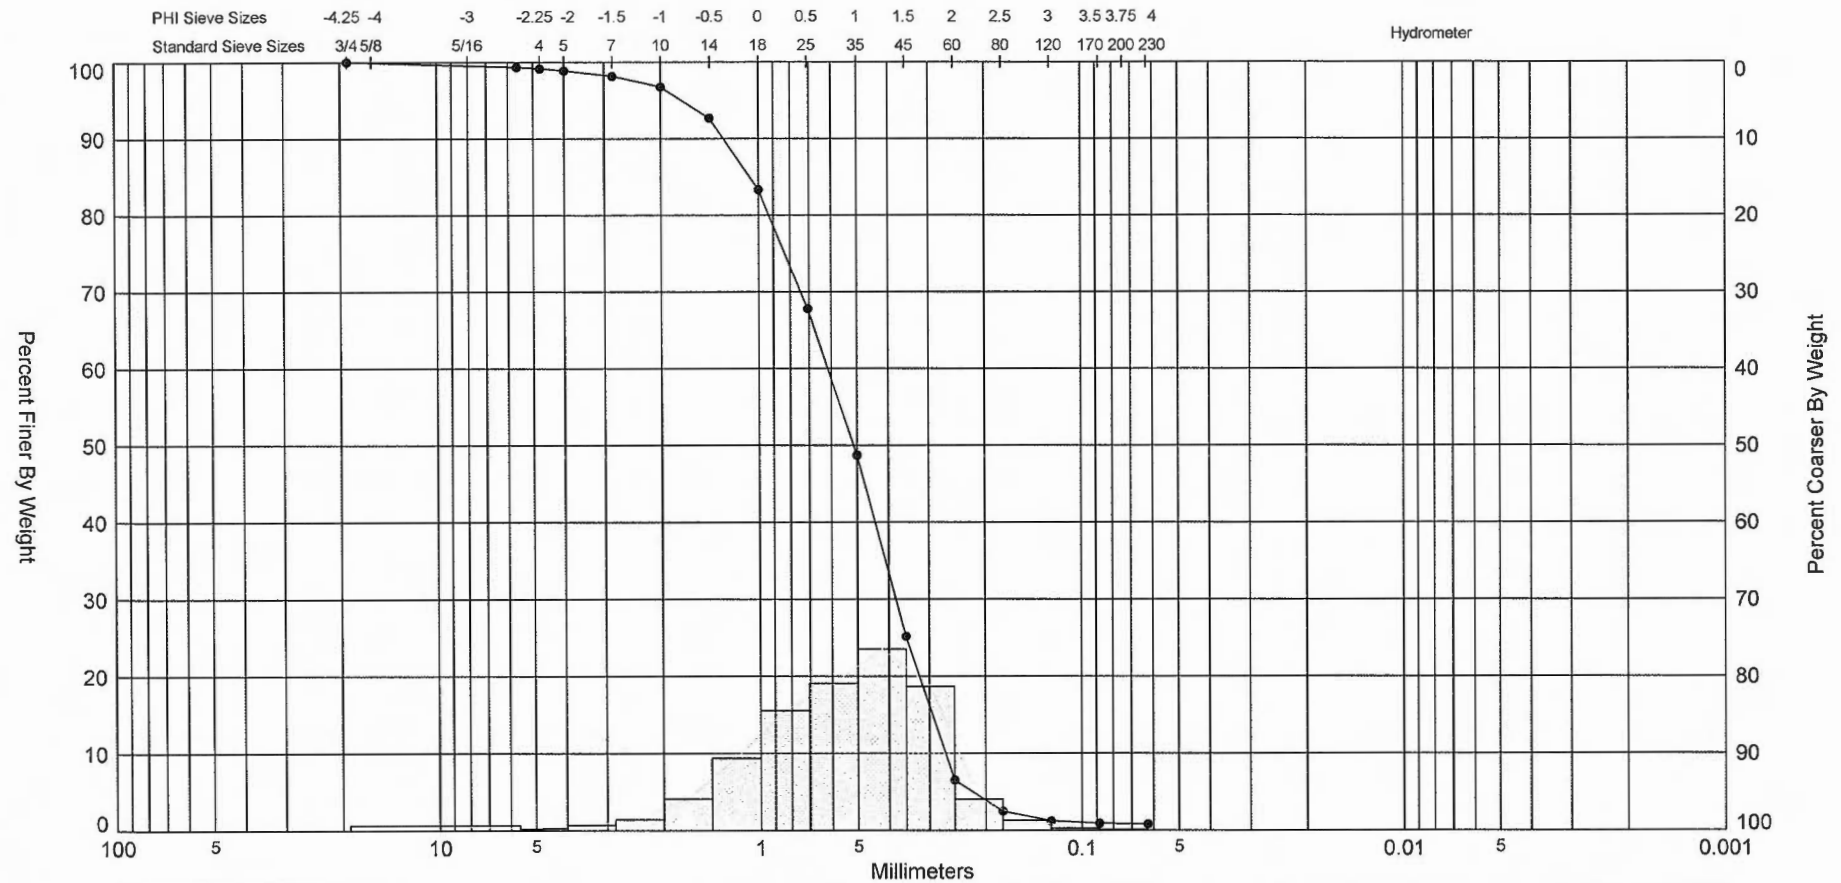
Gravel		Sand			Silt and Clay
Coarse	Fine	Coarse	Medium	Fine
