Sample	Symbol	Elev. (ft)	USCS	% Fines	% Organics	% Carbonates	Median	Mean	Skew	Kurt	Sort	Sample Information	
JL-12 #S-1 (1')	—●—	-44.5	SP	#230 - 1.62			1.44	1.23	-0.87	4.13	0.85	Project Name:	Jupiter Island 10
Comments: 10 YR 4/1 Munsell @ 10% Moisture												Analysis Date:	04-01-10
Depths and elevations based on measured values												Analyzed By:	JR

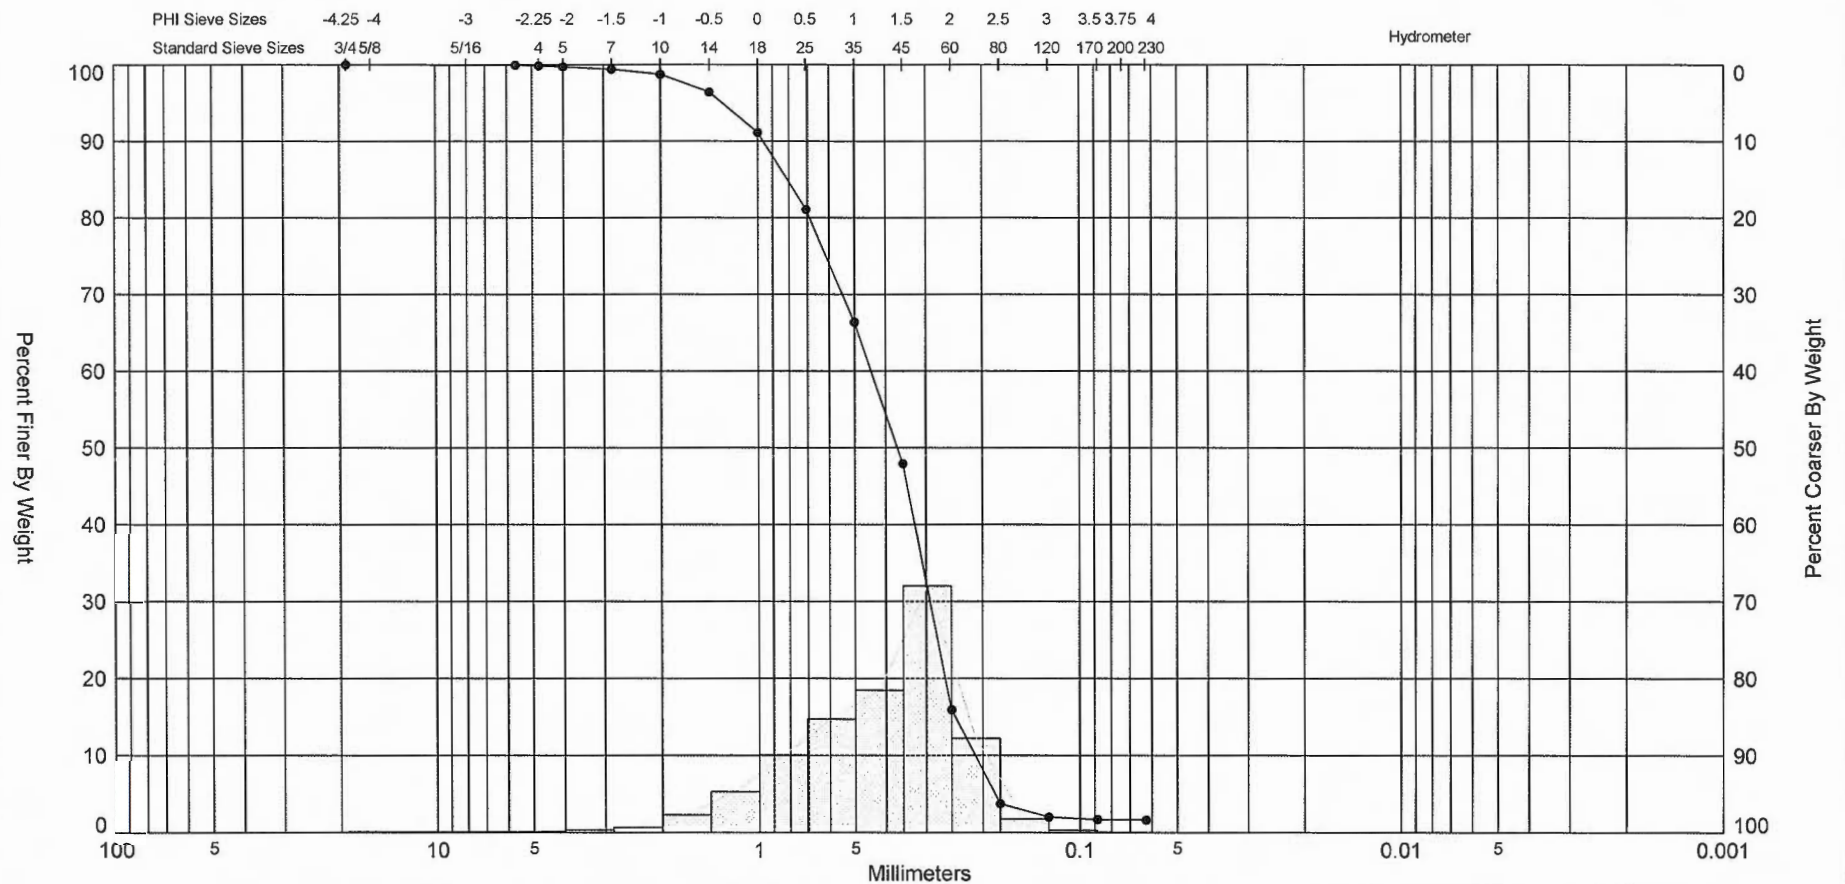
Gravel		Sand			Silt and Clay
Coarse	Fine	Coarse	Medium	Fine
