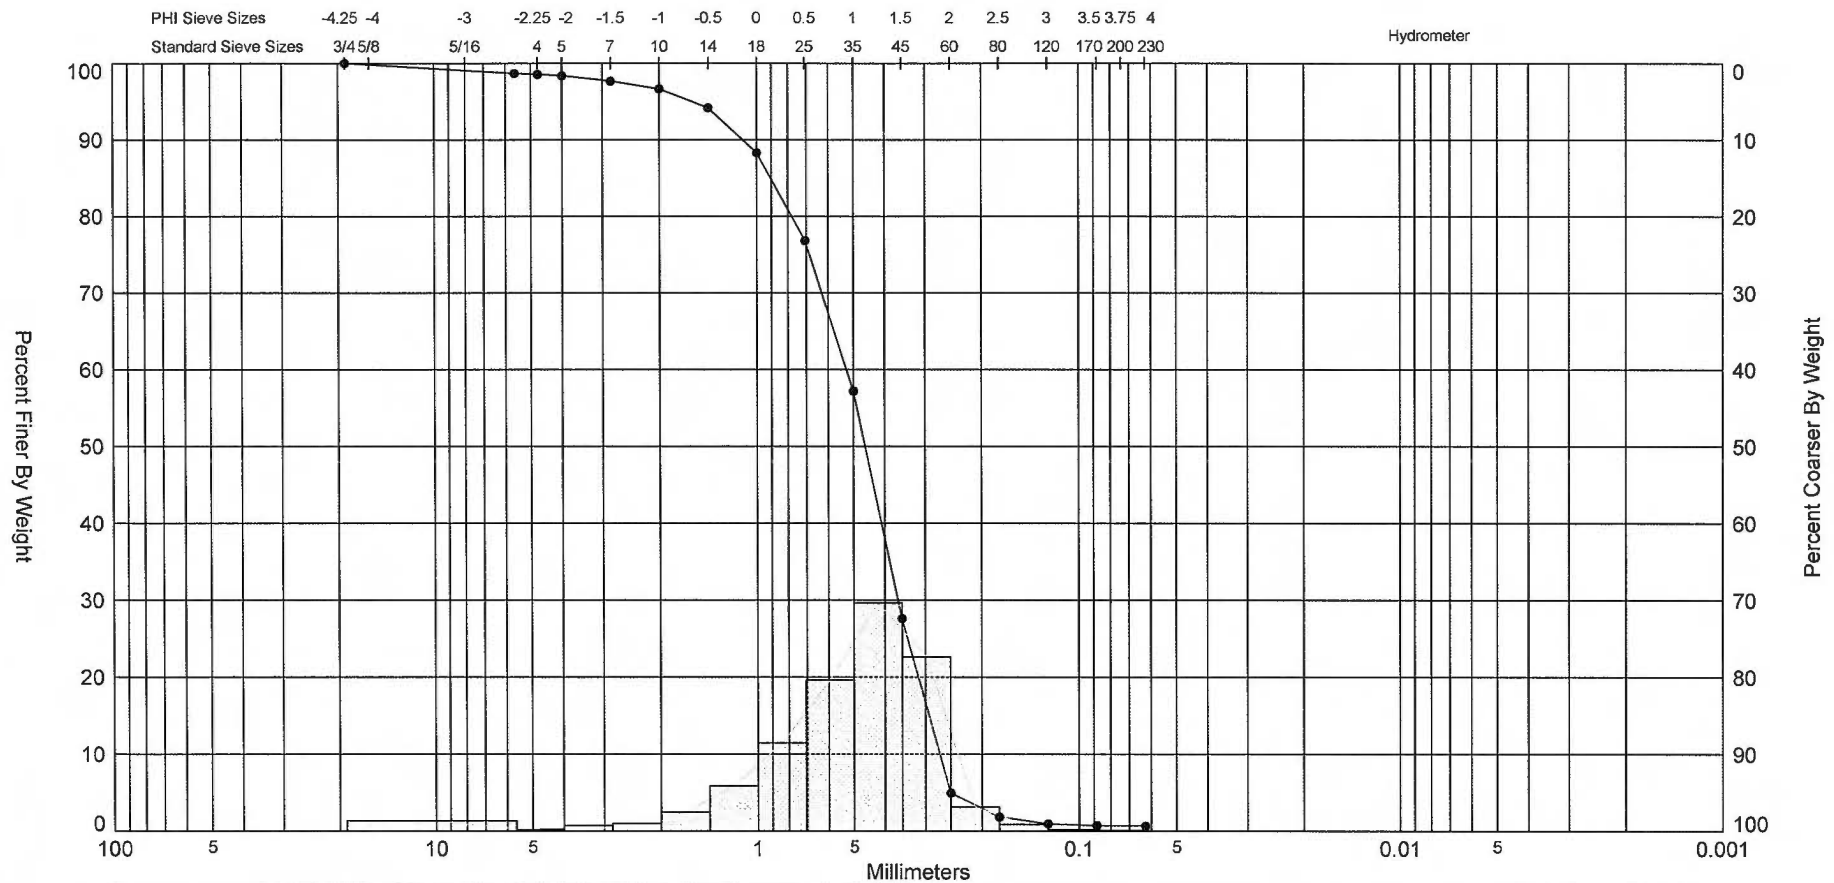
Gravel		Sand			Silt and Clay
Coarse	Fine	Coarse	Medium	Fine

Sample	Symbol	Elev. (ft)	USCS	% Fines	% Organics	% Carbonates	Median	Mean	Skew	Kurt	Sort	Sample Information	
JI-9 #S-2 (3.6')	—●—	-51.7	SW	#230 - 2.41			0.72	0.39	-1.12	4.21	1.28	Project Name:	Jupiter Island 10
Comments: 10YR 6/1 Munsell @ 10% Moisture												Analysis Date:	03-29-10
Depths and elevations based on measured values												Analyzed By:	JR

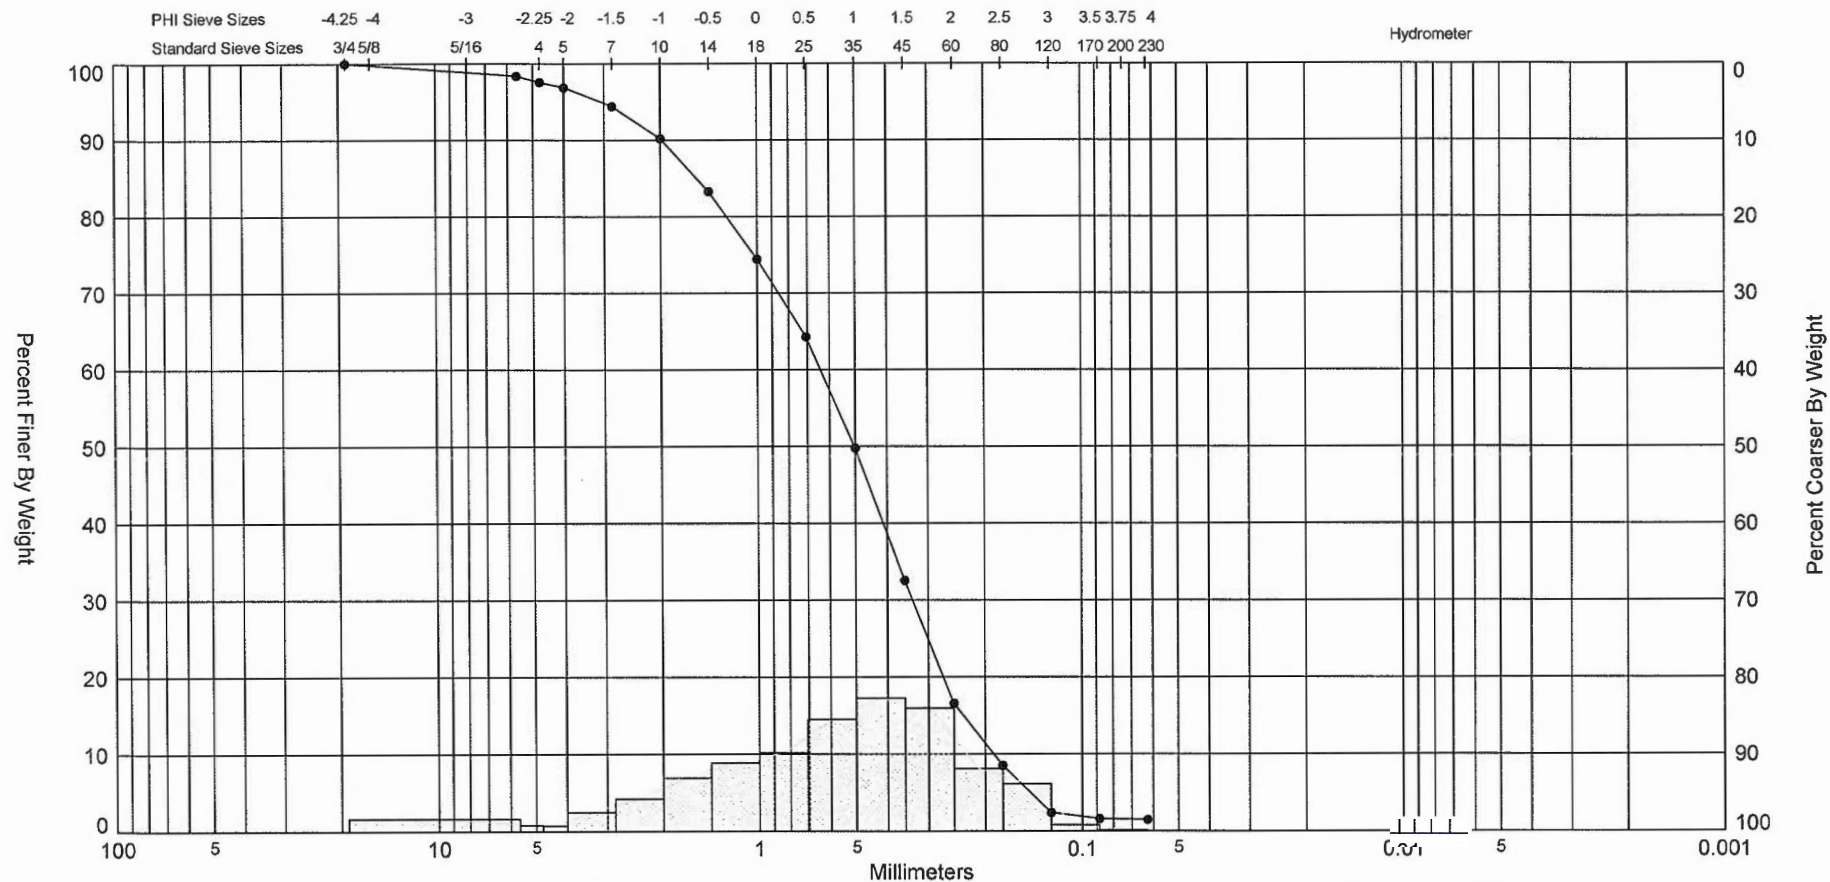
Sample	Symbol	Elev. (ft)	USCS	% Fines	% Organics	% Carbonates	Median	Mean	Skew	Kurt	Sort	Sample Information	
JI-9 #S-3 (5.6')	—●—	-53.7	SW	#230 - 1.46		79.00	0.99	0.76	-0.71	3.45	1.31	Project Name:	Jupiter Island 10
Comments: 10 YR 4/1 Munsell @ 10% Moisture												Analysis Date:	04-23-10
Depths and elevations based on measured values												Analyzed By:	JR
<div style="display: flex; justify-content: space-between; align-items: center;"> <div style="text-align: center;">

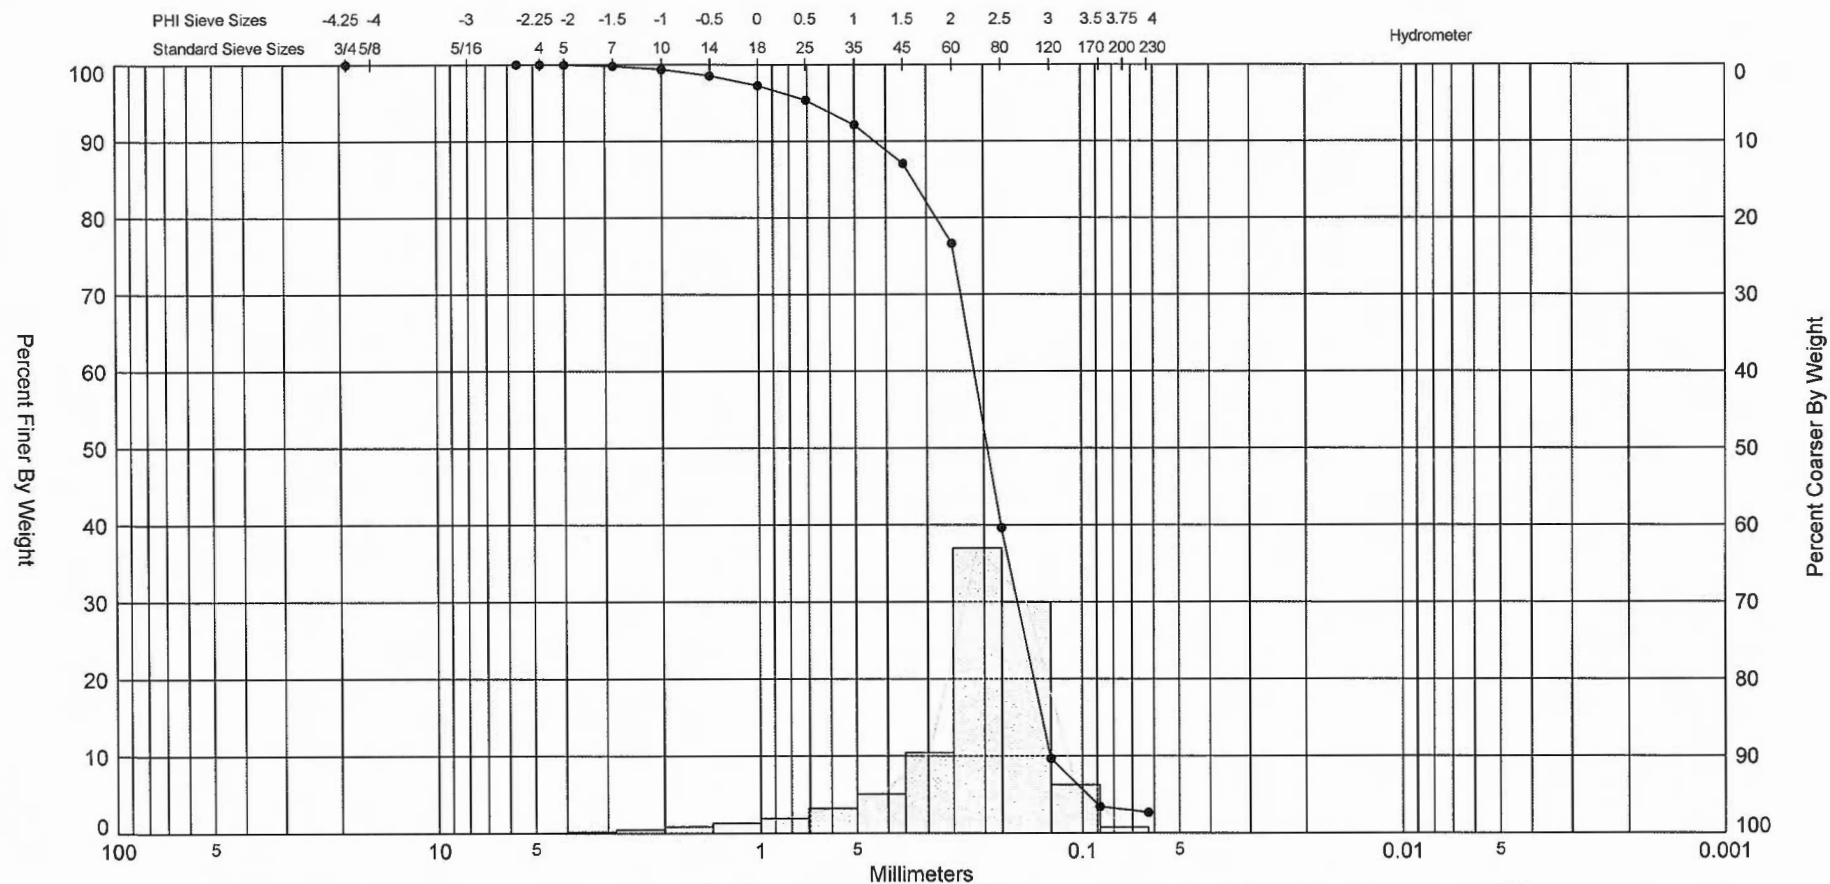
Sample	Symbol	Elev. (ft)	USCS	% Fines	% Organics	% Carbonates	Median	Mean	Skew	Kurt	Sort	Sample Information	
JI-9 #S-4 (11')	—●—	-59.1	SP	#230 - 2.66			2.36	2.2	-1.73	7.23	0.8	Project Name:	Jupiter Island 10
Comments: 10YR 4/1 Munsell @ 10% Moisture												Analysis Date:	03-29-10
Depths and elevations based on measured values												Analyzed By:	JR
<div style="display: flex; justify-content: space-between; align-items: center;"> <div style="text-align: center;">

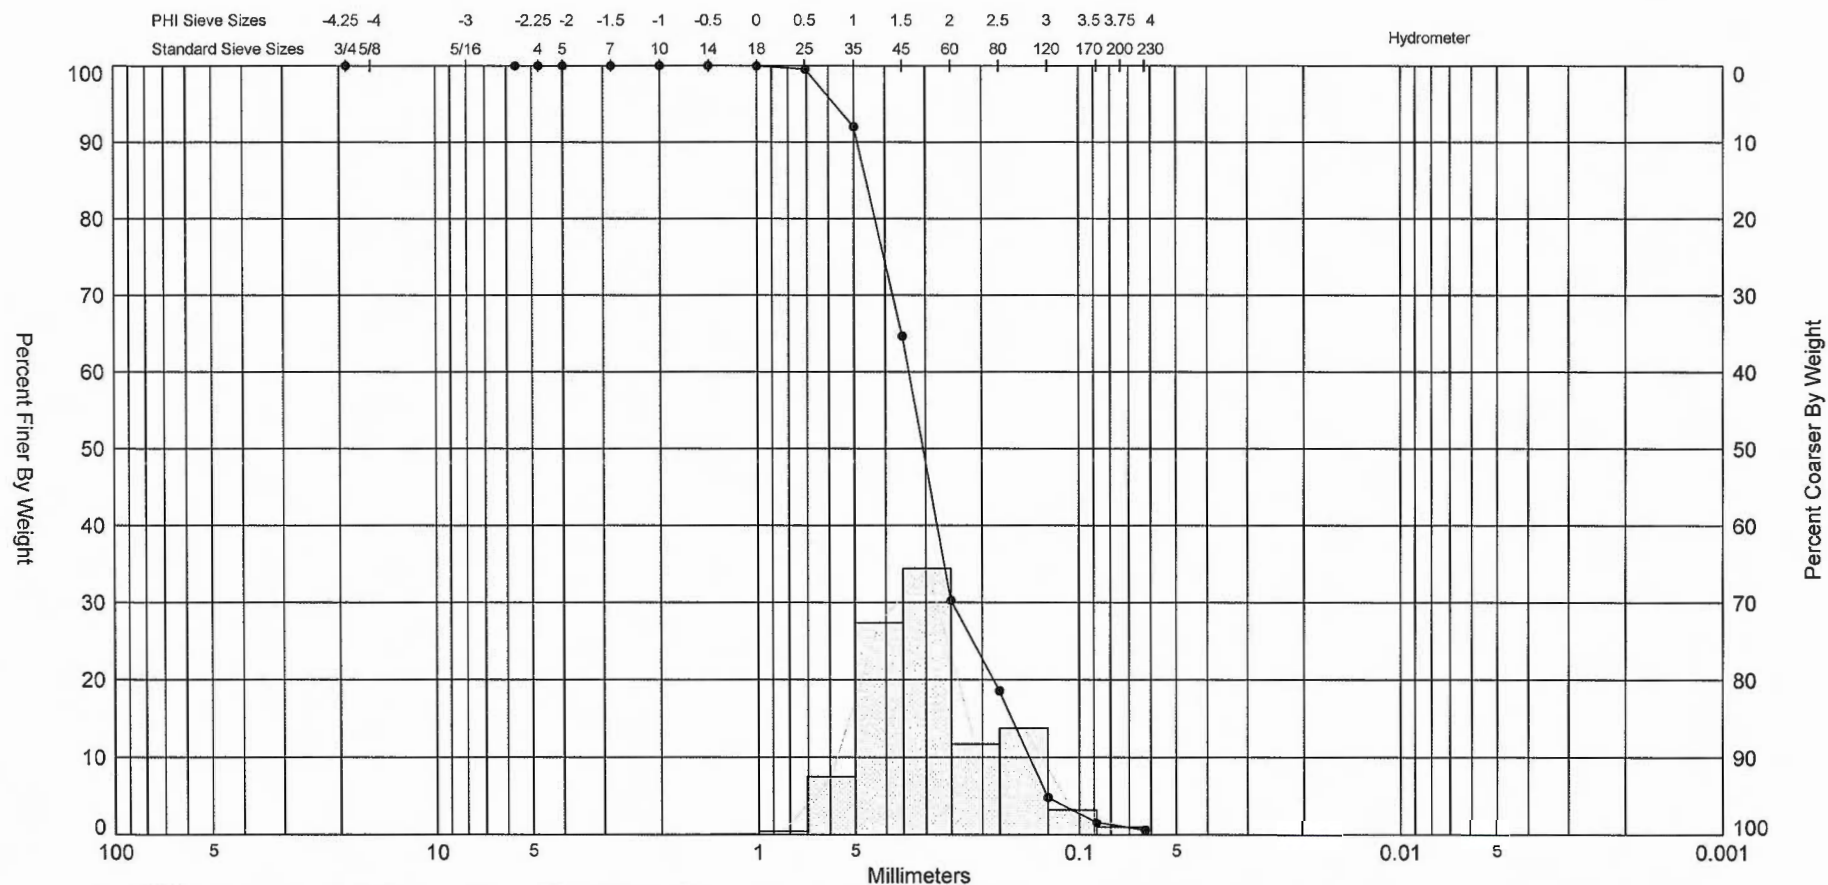
Sample	Symbol	Elev. (ft)	USCS	% Fines	% Organics	% Carbonates	Median	Mean	Skew	Kurt	Sort	Sample Information	
JI-9 PCC #S-1 (5.6")

-53.7	SP	#230 - 0.60			1.71	1.8	0.54	2.96	0.66	Project Name:	Jupiter Island 10
Comments: 10 YR 4/1 Munsell @ 10% Moisture. Sample after calcium carbonate.												Analysis Date:	02-23-10
Depths and elevations based on measured values												Analyzed By:	ML
