Sample	Symbol	Elev. (ft)	USCS	% Fines	% Organics	% Carbonates	Median	Mean	Skew	Kurt	Sort	Sample Information	
JIVC-10-3 #S-1 (2')	—●—	-47.3	SP	#230 - 0.77			1.69	1.52	-1.78	8.21	0.77	Project Name:	Jupiter Island 10 Detail Phase
Comments: Visual Shell Content = 0 %												Analysis Date:	11-11-10
Depths and elevations based on measured values												Analyzed By:	JR

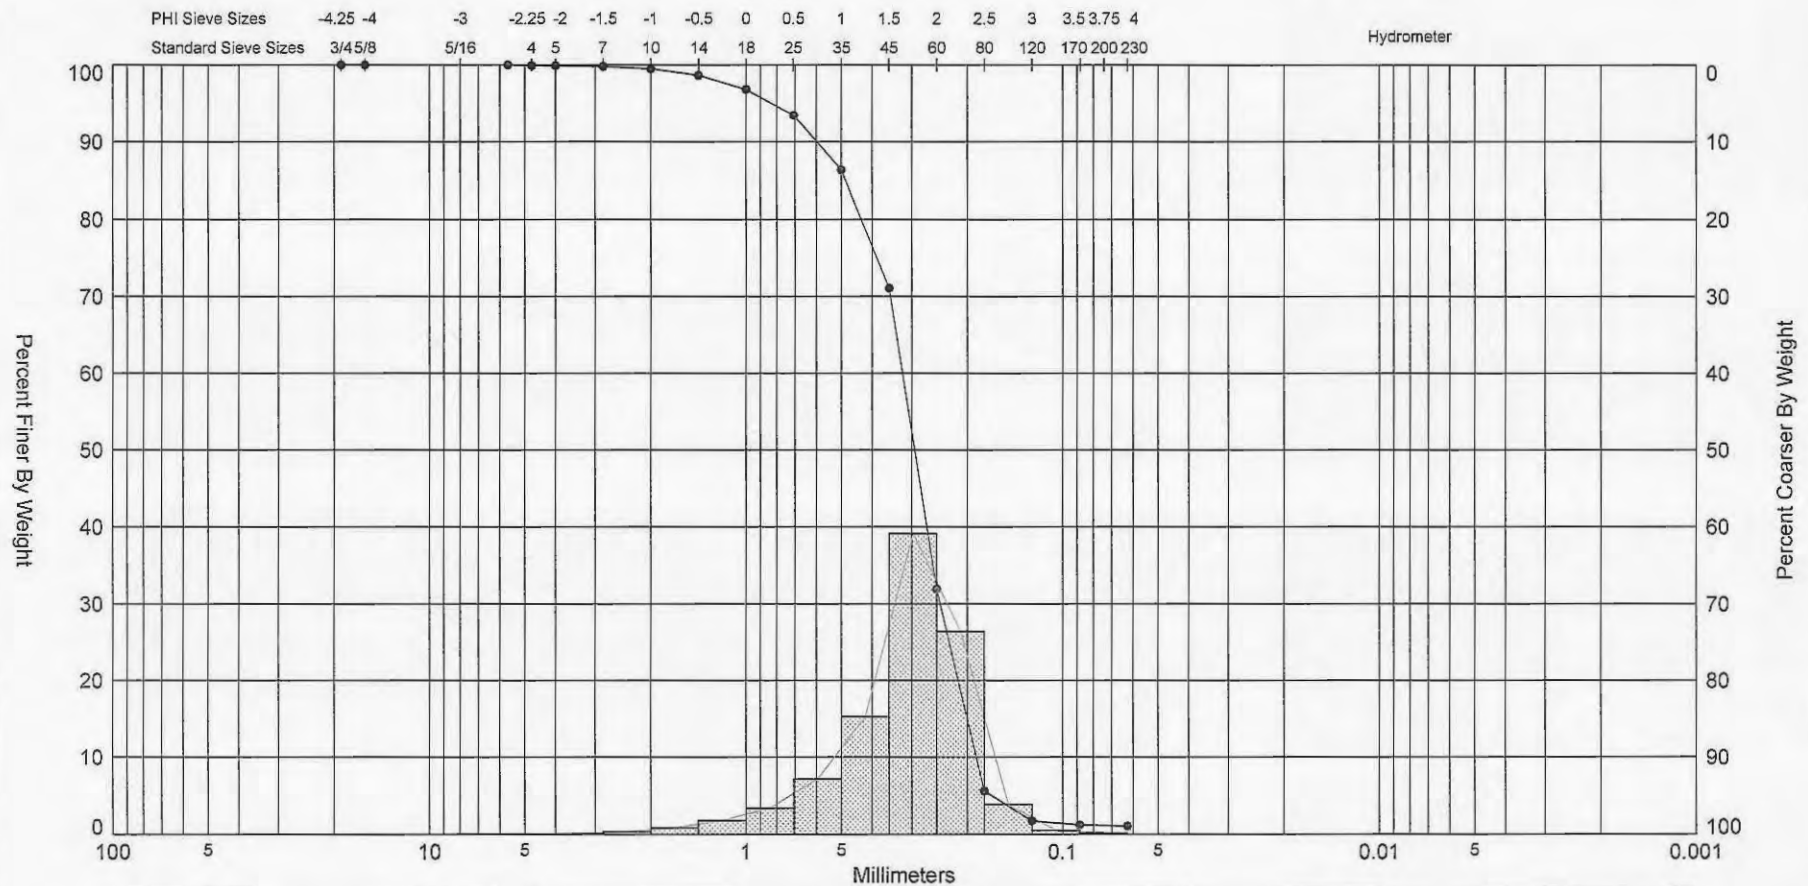
Sample	Symbol	Elev. (ft)	USCS	% Fines	% Organics	% Carbonates	Median	Mean	Skew	Kurt	Sort	Sample Information	
JIVC-10-3 #S-2 (6')	—●—	-51.3	SP	#230 - 1.04		66.00	1.77	1.66	-1.31	6.28	0.7	Project Name:	Jupiter Island 10 Detail Phase
Comments: Visual Shell Content = 0 %												Analysis Date:	11-05-10
Depths and elevations based on measured values												Analyzed By:	JR

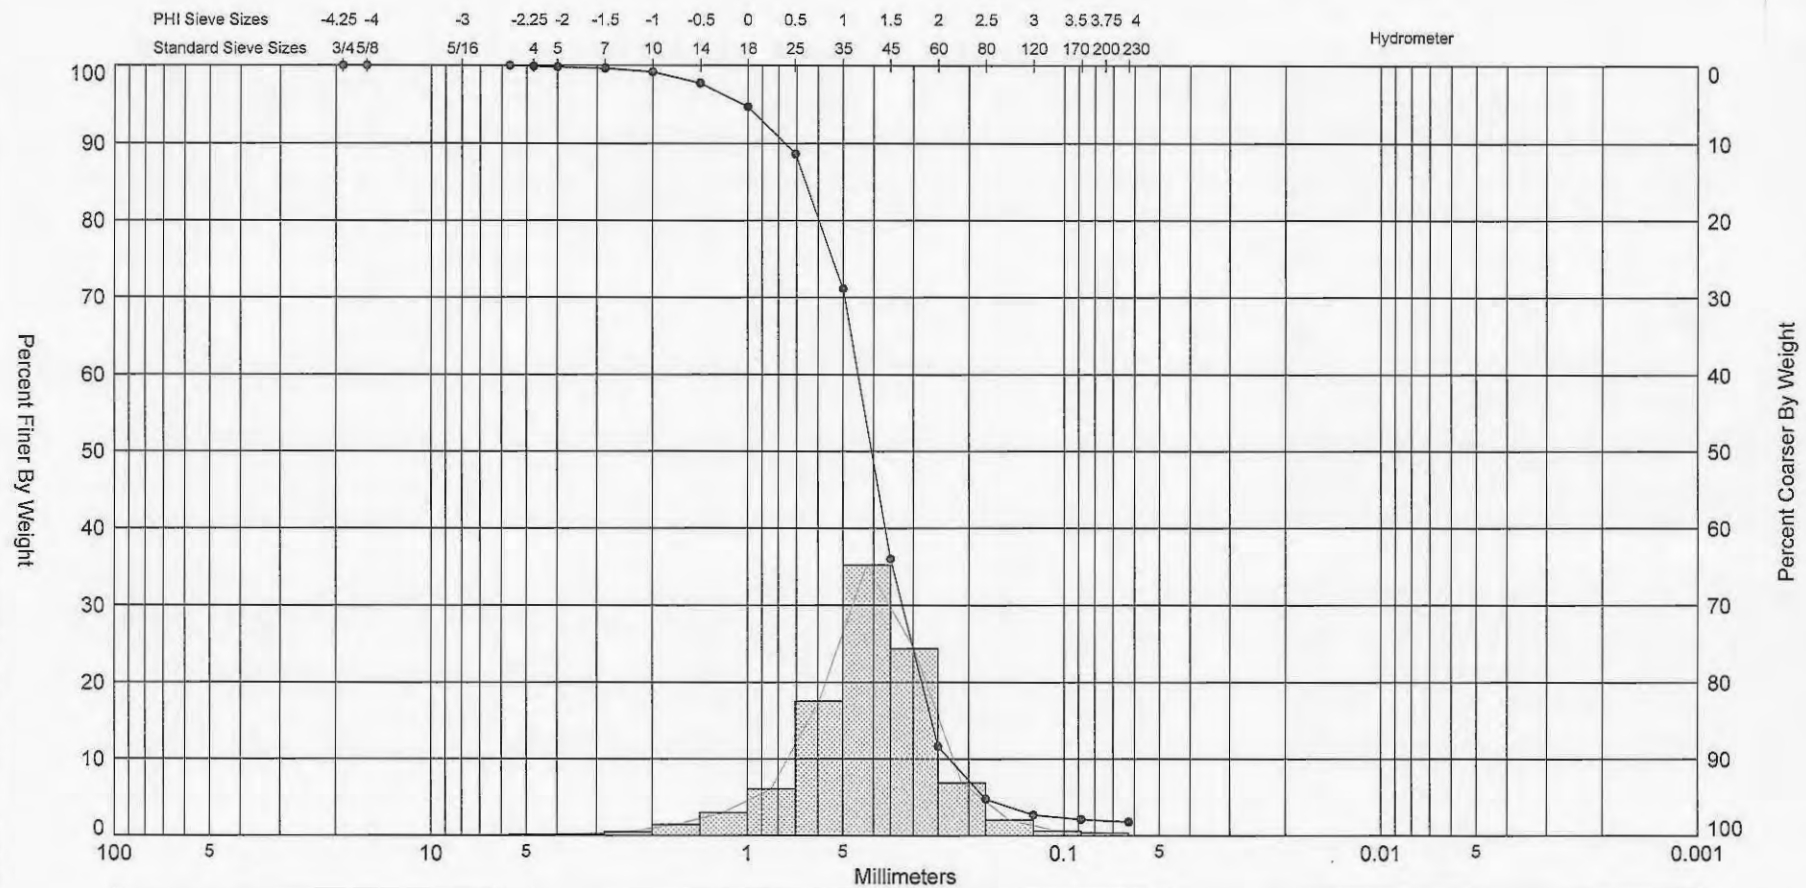
Sample	Symbol	Elev. (ft)	USCS	% Fines	% Organics	% Carbonates	Median	Mean	Skew	Kurt	Sort	Sample Information	
JIVC-10-3 #S-4 (10')	—●—	-55.3	SP	#230 - 1.81			1.3	1.25	-0.6	5.4	0.72	Project Name:	Jupiter Island 10 Detail Phase
Comments: Visual Shell Content = >1 %												Analysis Date:	11-11-10
Depths and elevations based on measured values												Analyzed By:	JR
