Sample	Symbol	Elev. (ft)	USCS	% Fines	% Organics	% Carbonates	Median	Mean	Skew	Kurt	Sort	Sample Information	
JIVC-10-22 #S-1 (1')	—●—	-52.9	SP	#230 - 1.05			1.34	1.16	-0.44	2.82	0.84	Project Name:	Jupiter Island 10 Detail Phase
Comments: Visual Shell Content = 0%												Analysis Date:	11-16-10
Depths and elevations based on measured values												Analyzed By:	CA

SIEVE ANALYSIS JUPITER ISLAND 10 DETAIL PHASE.GPJ FL DEP ROSS.GDT 4/29/11

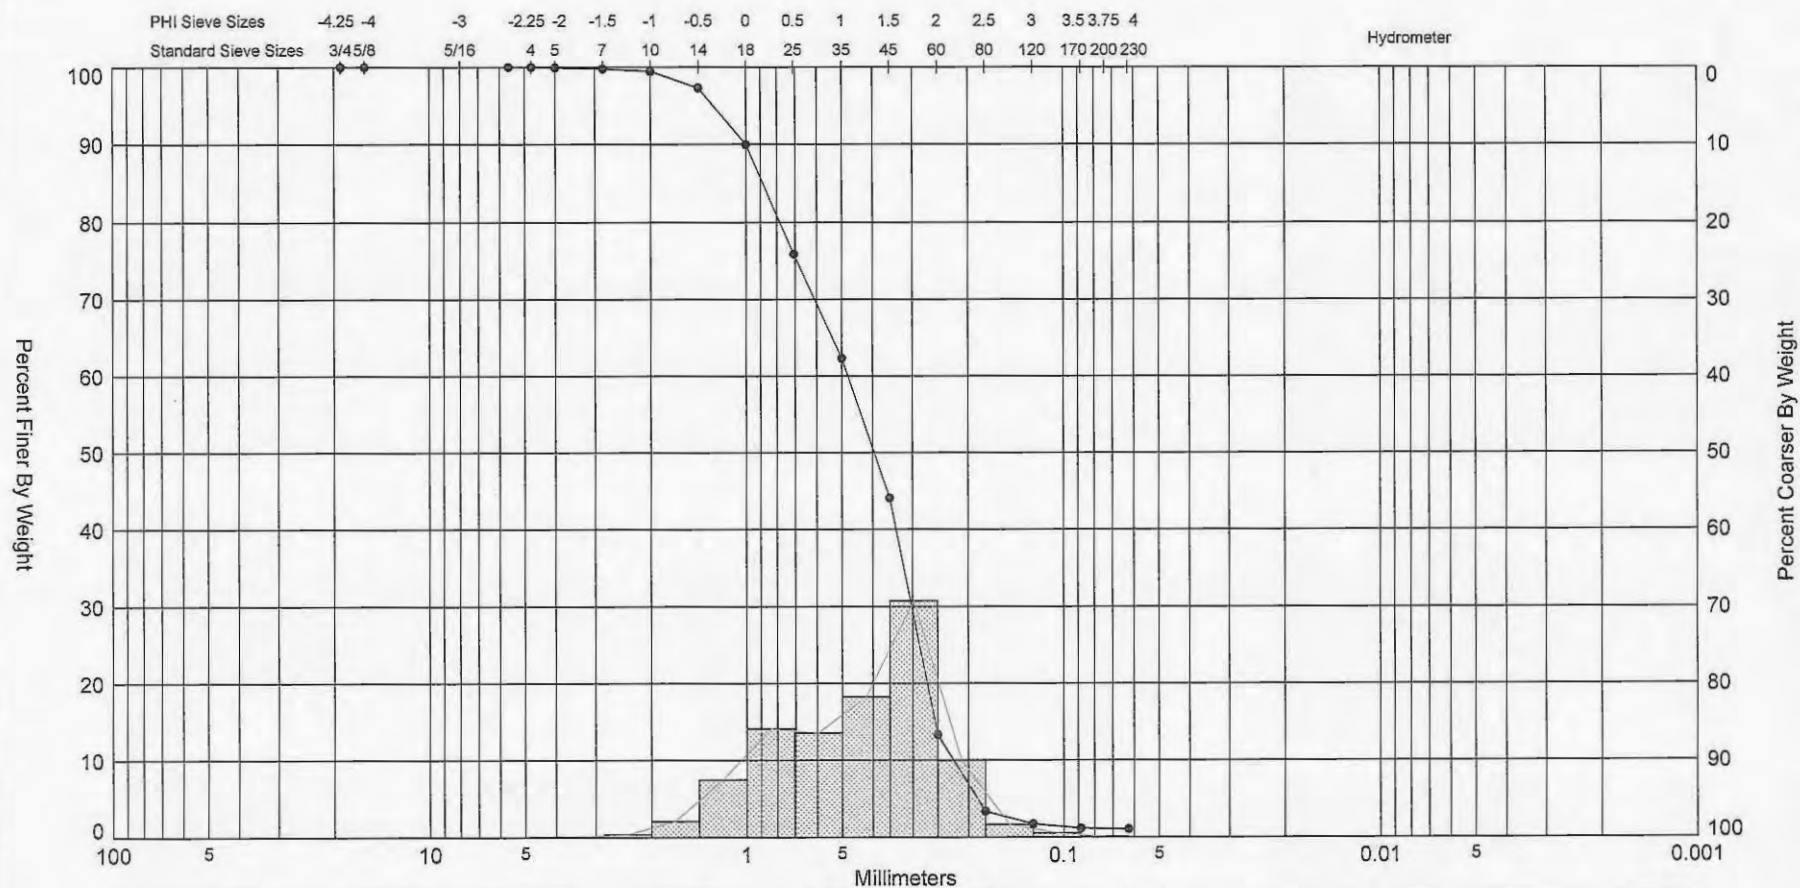
Gravel		Sand			Silt and Clay
Coarse	Fine	Coarse	Medium	Fine

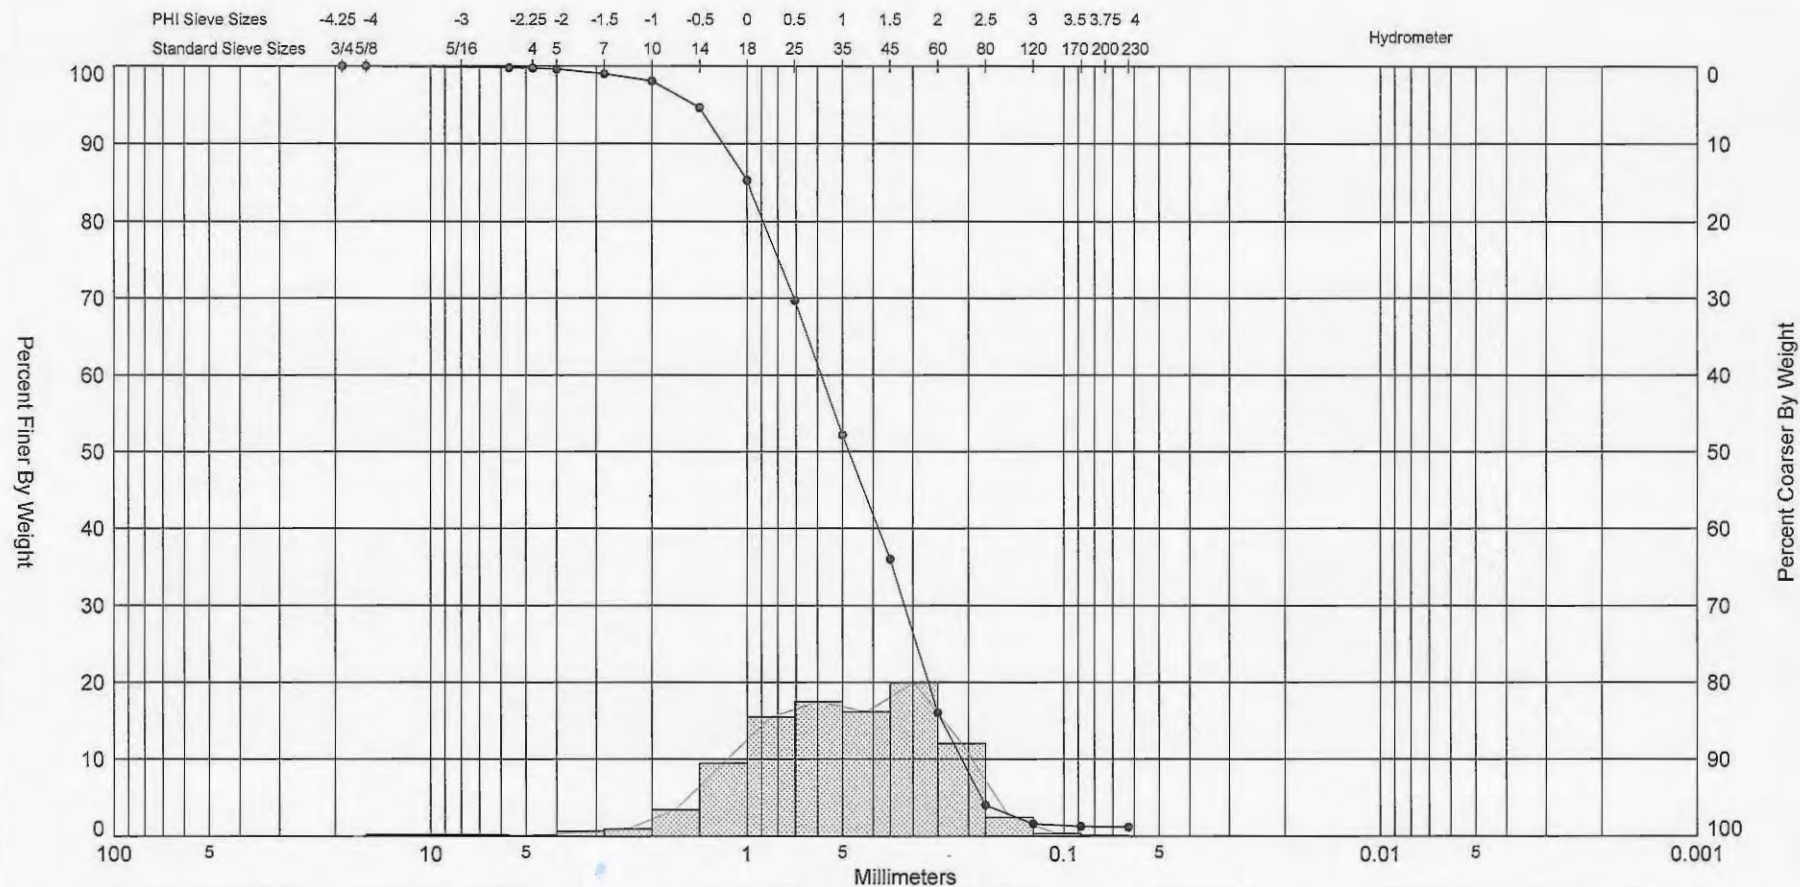
Gravel		Sand			Silt and Clay
Coarse	Fine	Coarse	Medium	Fine

Sample	Symbol	Elev. (ft)	USCS	% Fines	% Organics	% Carbonates	Median	Mean	Skew	Kurt	Sort	Sample Information	
JIVC-10-22 #S-2 (4')	—●—	-55.9	SW	#230 - 1.15		79.00	1.07	1	-0.45	3.35	0.96	Project Name:	Jupiter Island 10 Detail Phase
Comments: Visual Shell Content = >1%												Analysis Date:	11-30-10
Depths and elevations based on measured values												Analyzed By:	ML
<div style="display: flex; align-items: center;"> <div> <p>American Vibracore Services, Inc.</p> <p>1215 Wallace Drive</p> <p>Delray Beach, FL 33444</p> </div> </div>												Easting (X, ft):	967715.
												Northing (Y, ft):	972800.
												Horizontal System:	NAD 1983
												Vertical System:	NAVD 88

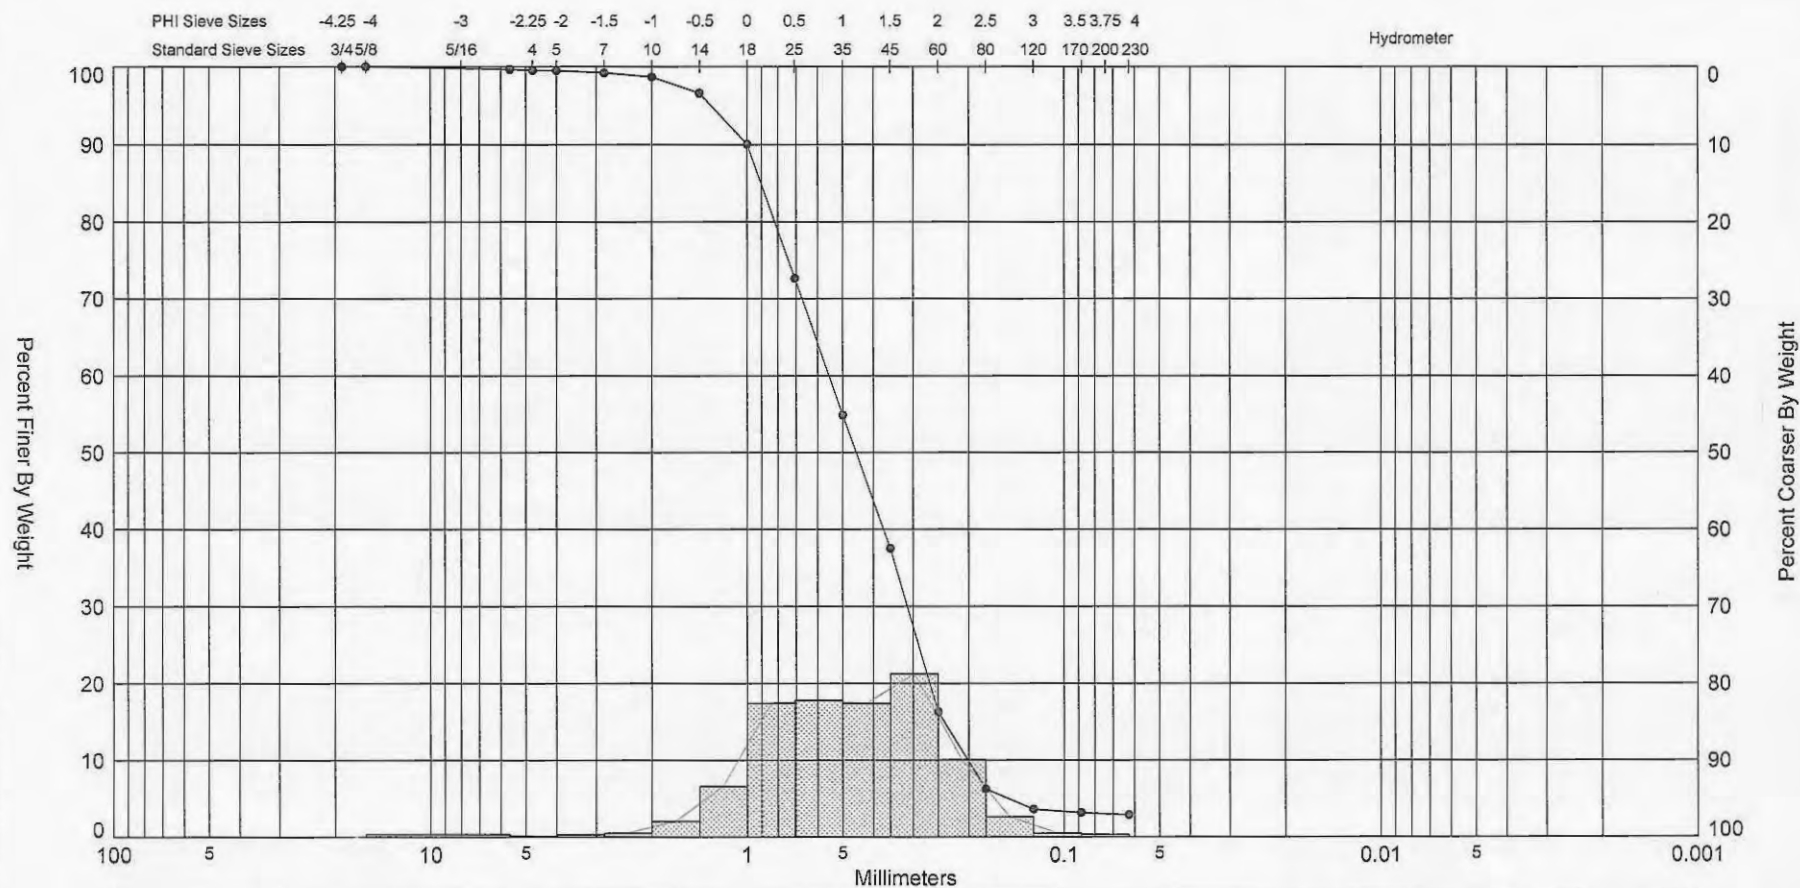
Gravel		Sand			Silt and Clay
Coarse	Fine	Coarse	Medium	Fine

Sample	Symbol	Elev. (ft)	USCS	% Fines	% Organics	% Carbonates	Median	Mean	Skew	Kurt	Sort	Sample Information	
JIVC-10-22 #S-3 (7')	—●—	-58.9	SW	#230 - 2.89			1.14	1.06	-0.5	4.35	0.91	Project Name:	Jupiter Island 10 Detail Phase
Comments: Visual Shell Content = >1%												Analysis Date:	11-17-10
Depths and elevations based on measured values												Analyzed By:	CA

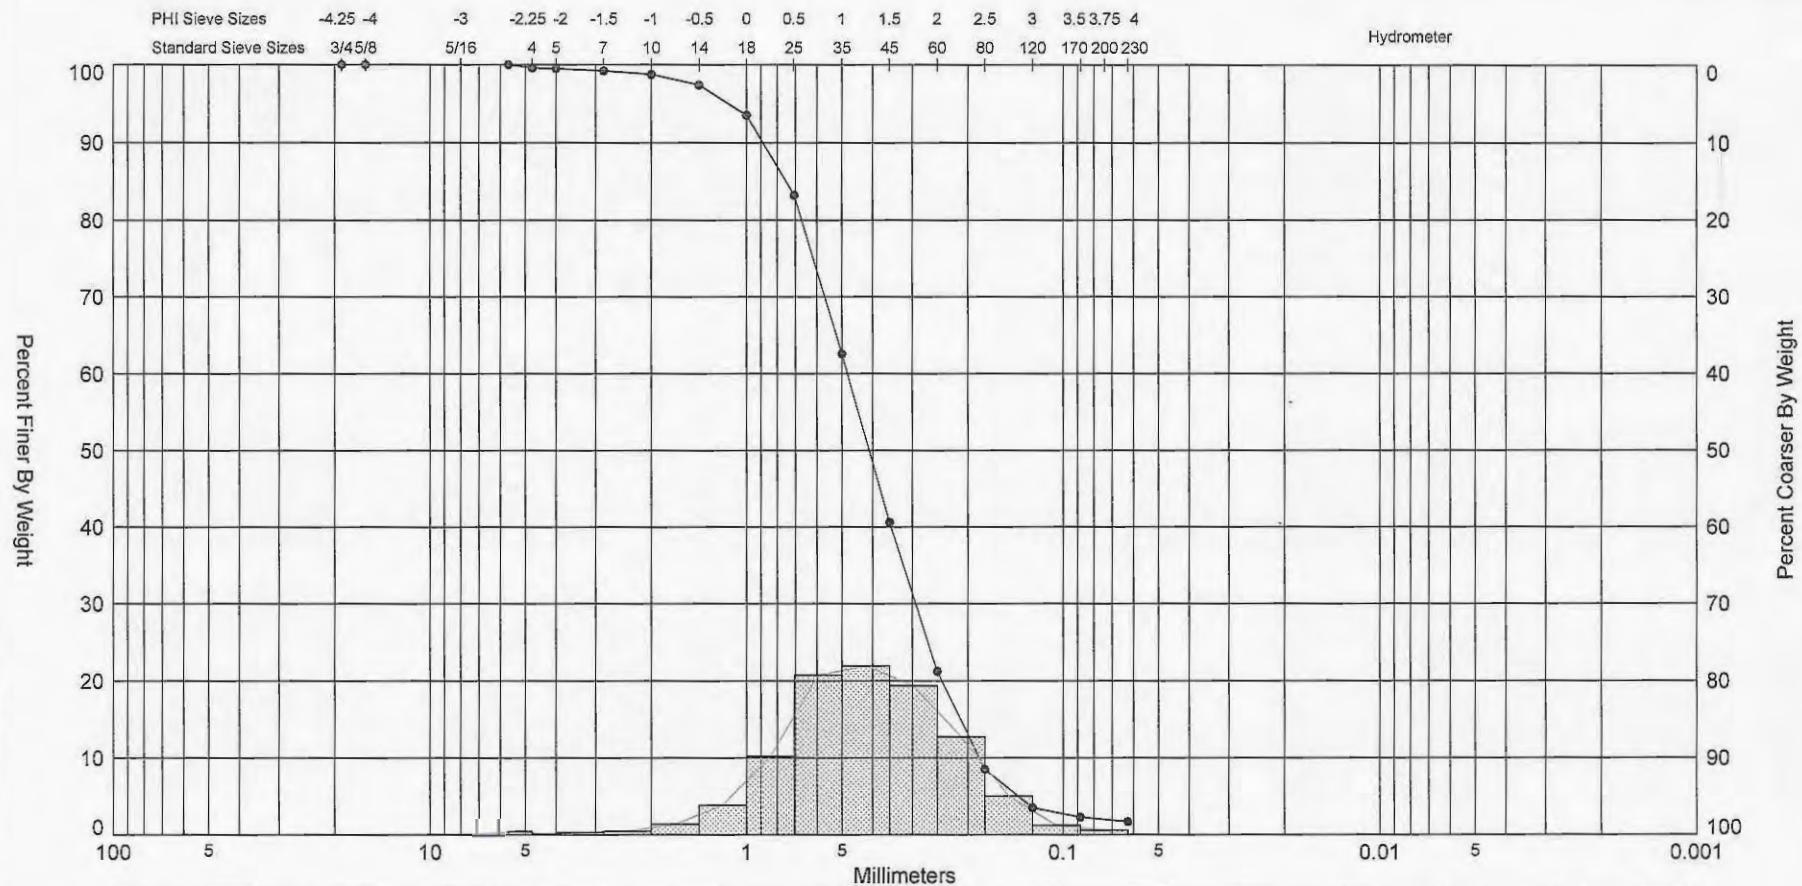
Gravel		Sand			Silt and Clay
Coarse	Fine	Coarse	Medium	Fine

Sample	Symbol	Elev. (ft)	USCS	% Fines	% Organics	% Carbonates	Median	Mean	Skew	Kurt	Sort	Sample Information	
JIVC-10-22 #S-4 (10')	—●—	-61.9	SW	#230 - 1.70		75.00	1.29	1.26	-0.38	4.12	0.9	Project Name:	Jupiter Island 10 Detail Phase
Comments: Visual Shell Content = >1%												Analysis Date:	11-08-10
Depths and elevations based on measured values												Analyzed By:	JR
