Sample	Symbol	Elev. (ft)	USCS	% Fines	% Organics	% Carbonates	Median	Mean	Skew	Kurt	Sort	Sample Information	
JIVC-10-2 #S-1 (0.5')	—●—	-48.4	SP	#230 - 1.03			1.32	1.16	-1.08	5.29	0.79	Project Name:	Jupiter Island 10 Detail Phase
Comments: Visual Shell Content = >1%												Analysis Date:	11-11-10
Depths and elevations based on measured values												Analyzed By:	JR

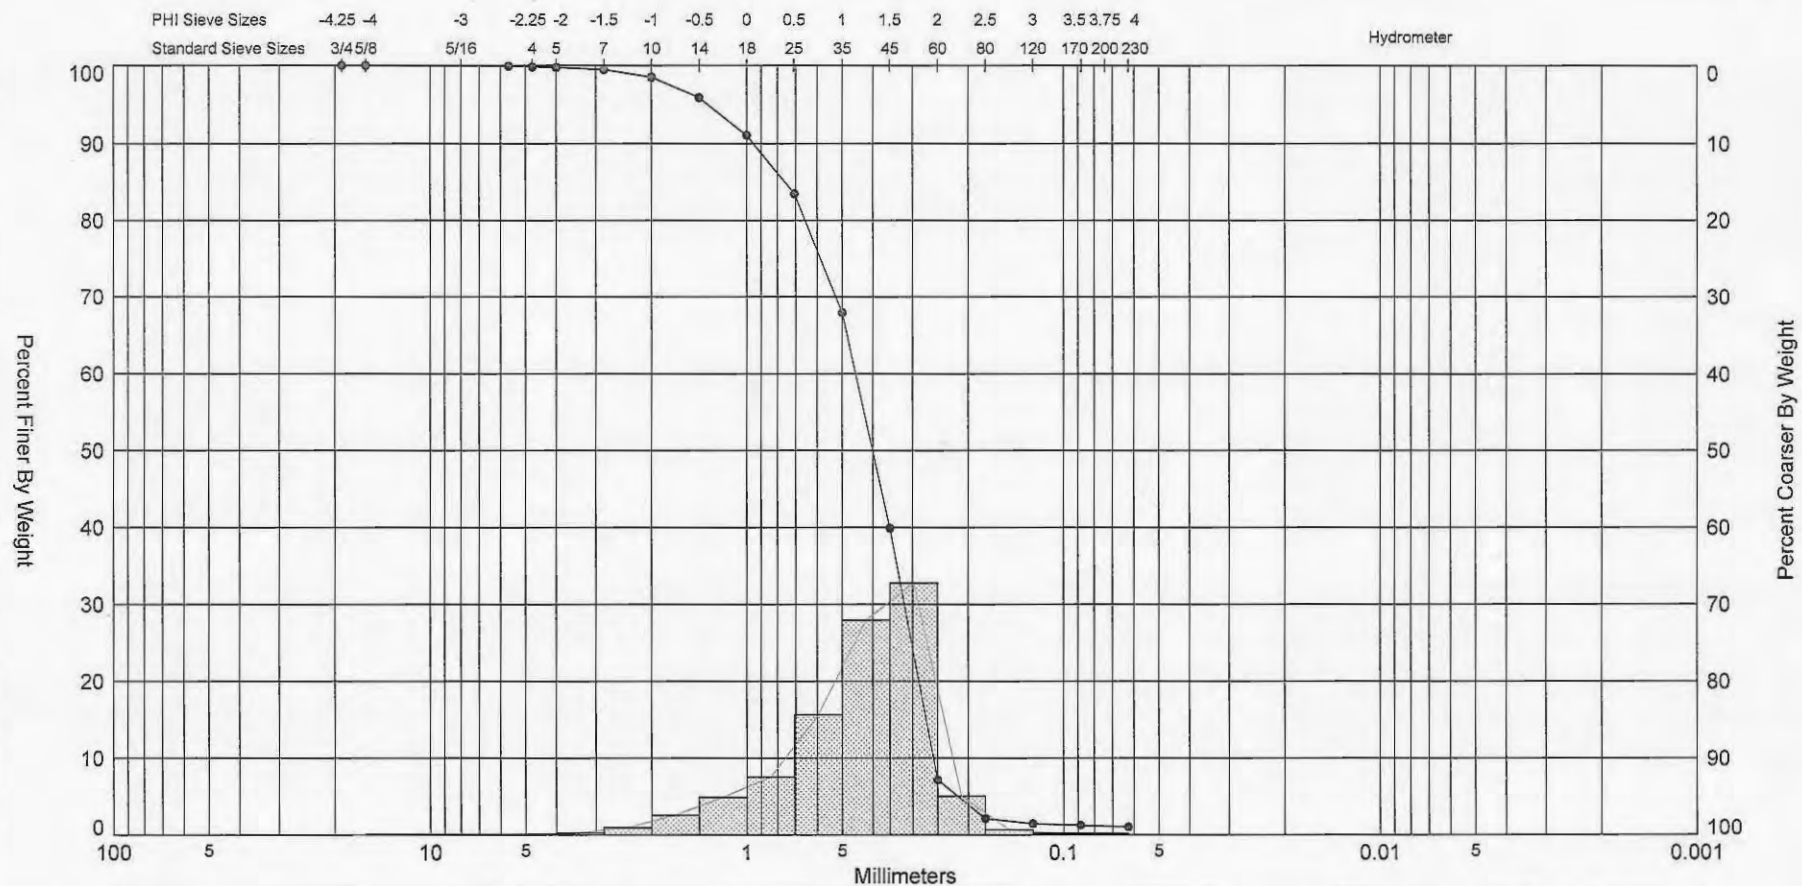
Gravel		Sand			Silt and Clay
Coarse	Fine	Coarse	Medium	Fine

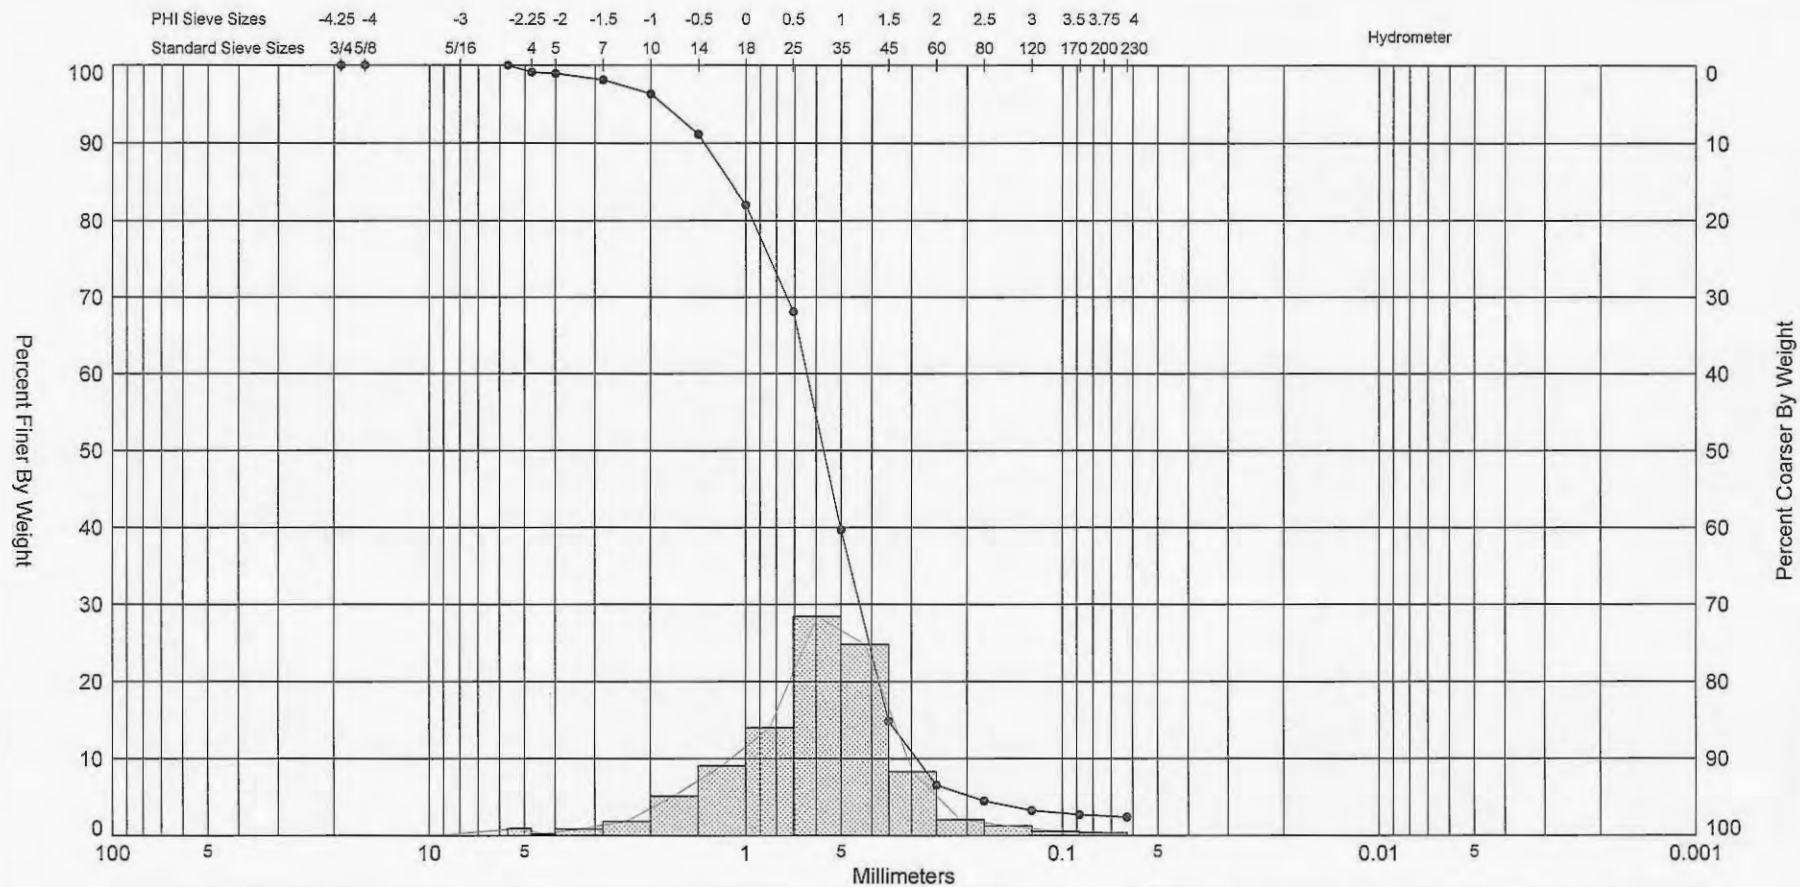
Gravel		Sand			Silt and Clay
Coarse	Fine	Coarse	Medium	Fine

Sample	Symbol	Elev. (ft)	USCS	% Fines	% Organics	% Carbonates	Median	Mean	Skew	Kurt	Sort	Sample Information	
JIVC-10-2 #S-2 (5')	—●—	-52.9	SW	#230 - 2.38		84.60	0.82	0.71	-0.47	4.55	0.89	Project Name:	Jupiter Island 10 Detail Phase
Comments: Visual Shell Content = >1%												Analysis Date:	11-22-10
Depths and elevations based on measured values												Analyzed By:	JR

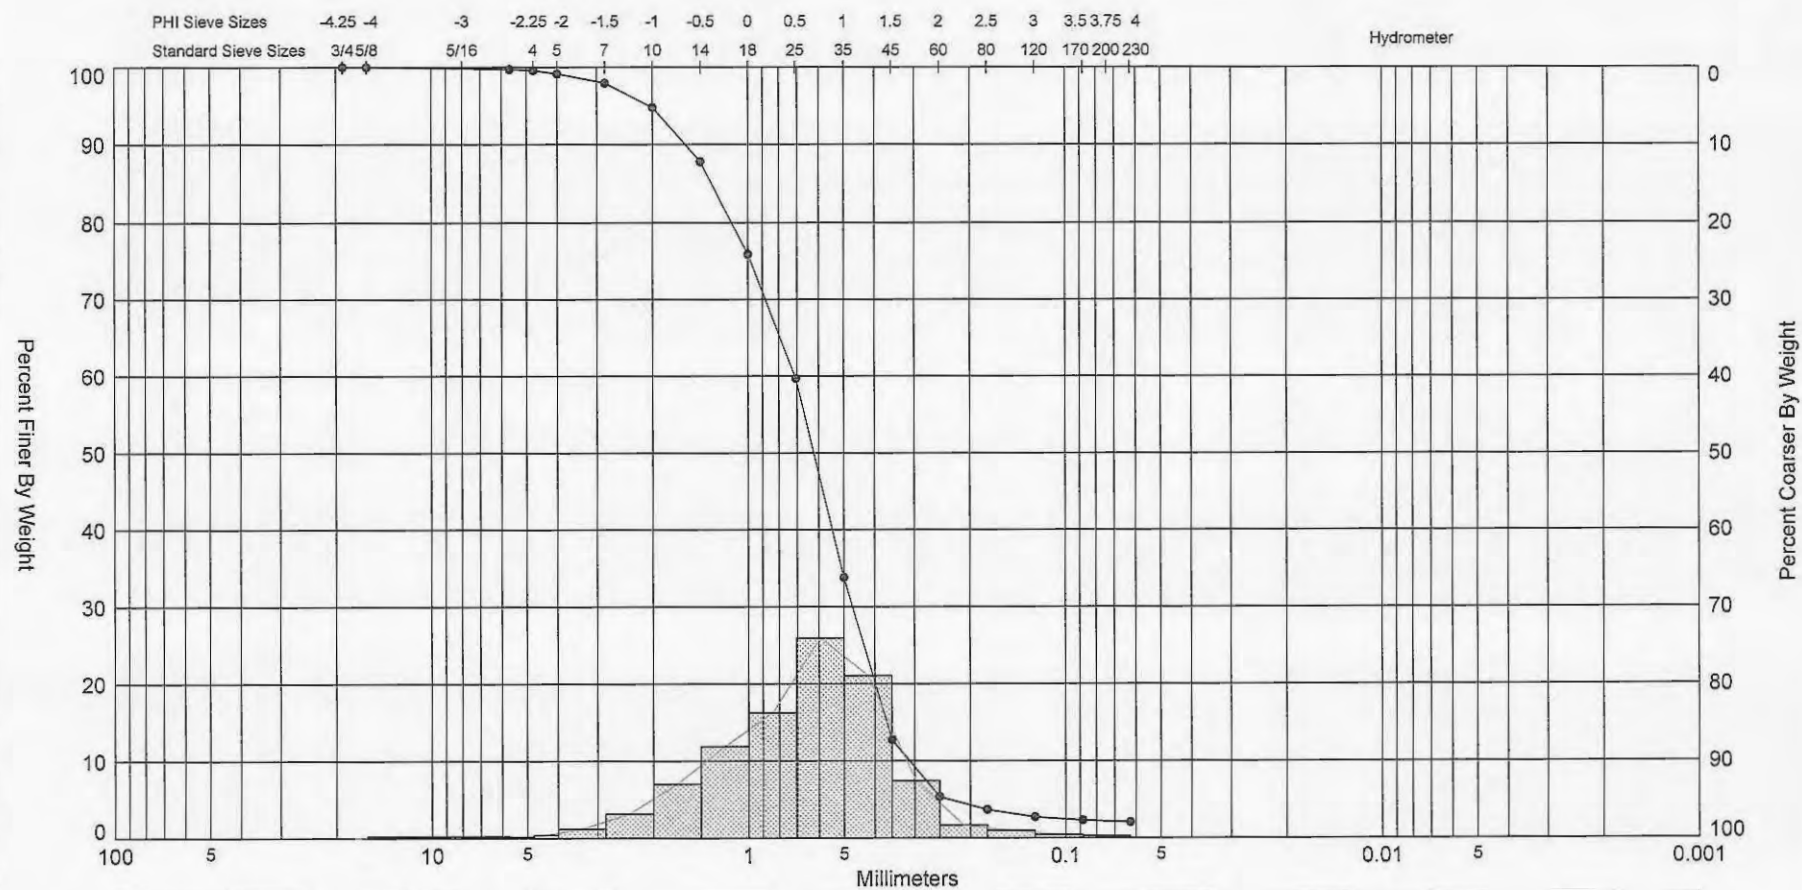
Gravel		Sand			Silt and Clay
Coarse	Fine	Coarse	Medium	Fine

Sample	Symbol	Elev. (ft)	USCS	% Fines	% Organics	% Carbonates	Median	Mean	Skew	Kurt	Sort	Sample Information	
JIVC-10-2 #S-3 (8')	—●—	-55.9	SW	#230 - 2.05			0.69	0.56	-0.38	4.1	0.92	Project Name:	Jupiter Island 10 Detail Phase
Comments: Visual Shell Content = >1%												Analysis Date:	11-11-10
Depths and elevations based on measured values												Analyzed By:	JR

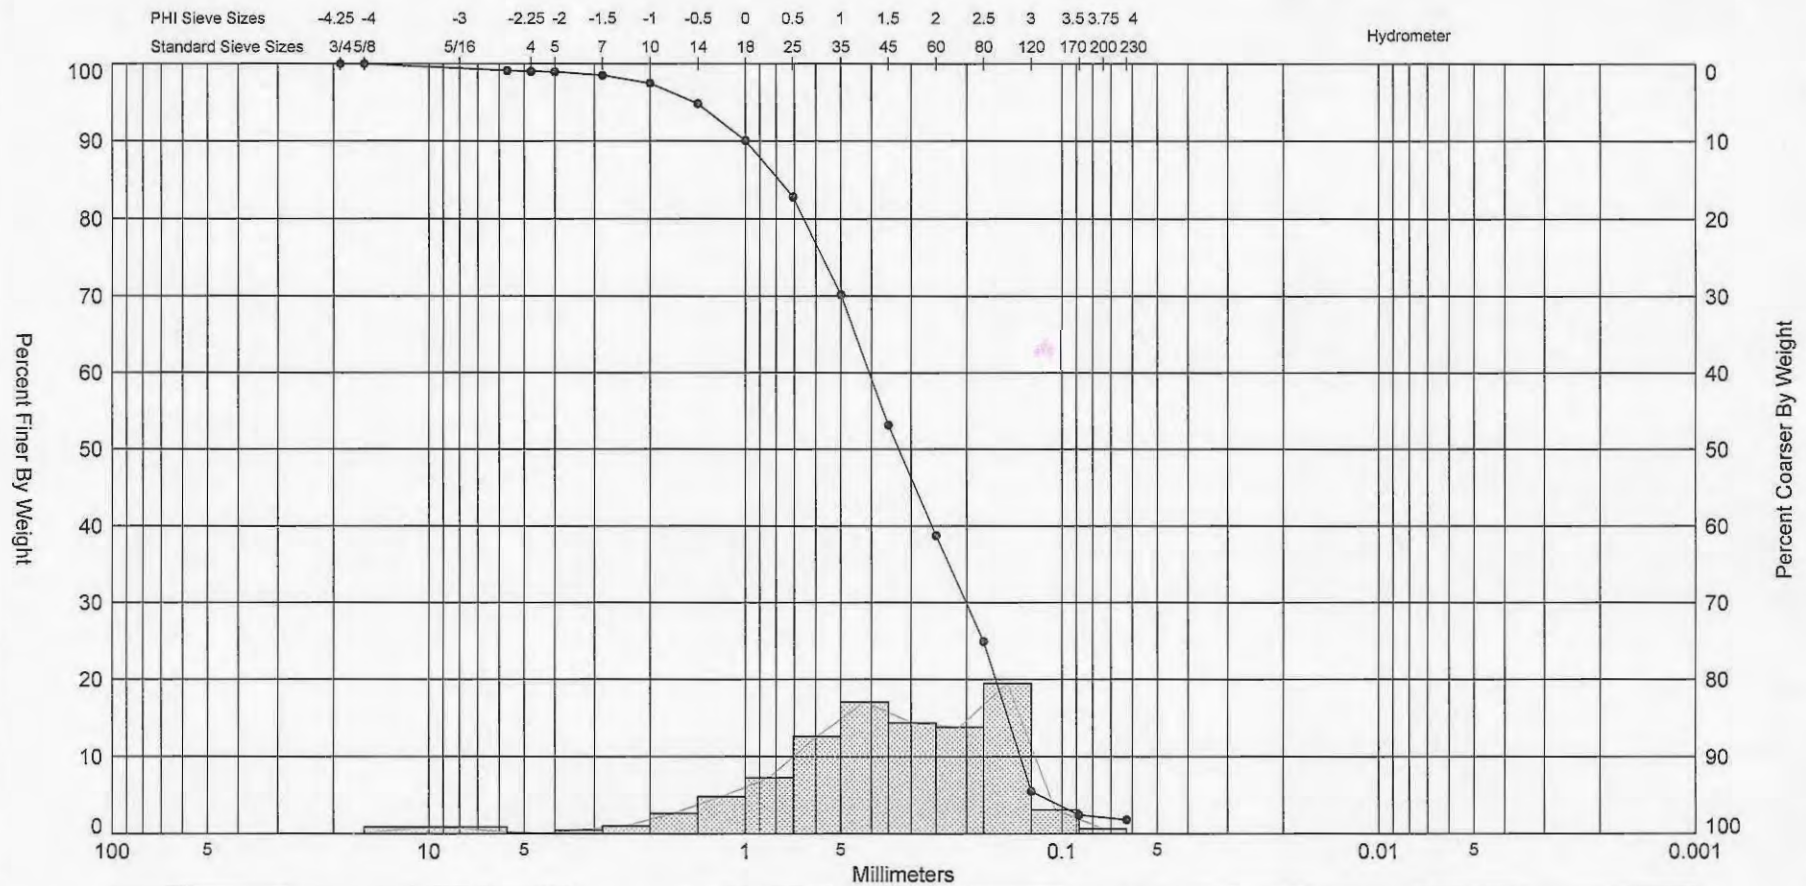
Gravel		Sand			Silt and Clay
Coarse	Fine	Coarse	Medium	Fine

Sample	Symbol	Elev. (ft)	USCS	% Fines	% Organics	% Carbonates	Median	Mean	Skew	Kurt	Sort	Sample Information	
JIVC-10-2 #S-4 (12')	—●—	-59.9	SW	#230 - 1.79		70.40	1.61	1.49	-0.92	4.49	1.17	Project Name:	Jupiter Island 10 Detail Phase
Comments: Visual Shell Content = >1%												Analysis Date:	11-05-10
Depths and elevations based on measured values												Analyzed By:	JR
