<p>AMERICAN VIBRACORE SERVICES</p> </div> <div> <p>American Vibracore Services, Inc. 1215 Wallace Drive Delray Beach, FL 33444</p> </div> </div>												Easting (X, ft):	967057.
												Northing (Y, ft):	971535.
												Horizontal System:	NAD 1983
												Vertical System:	NAVD 88

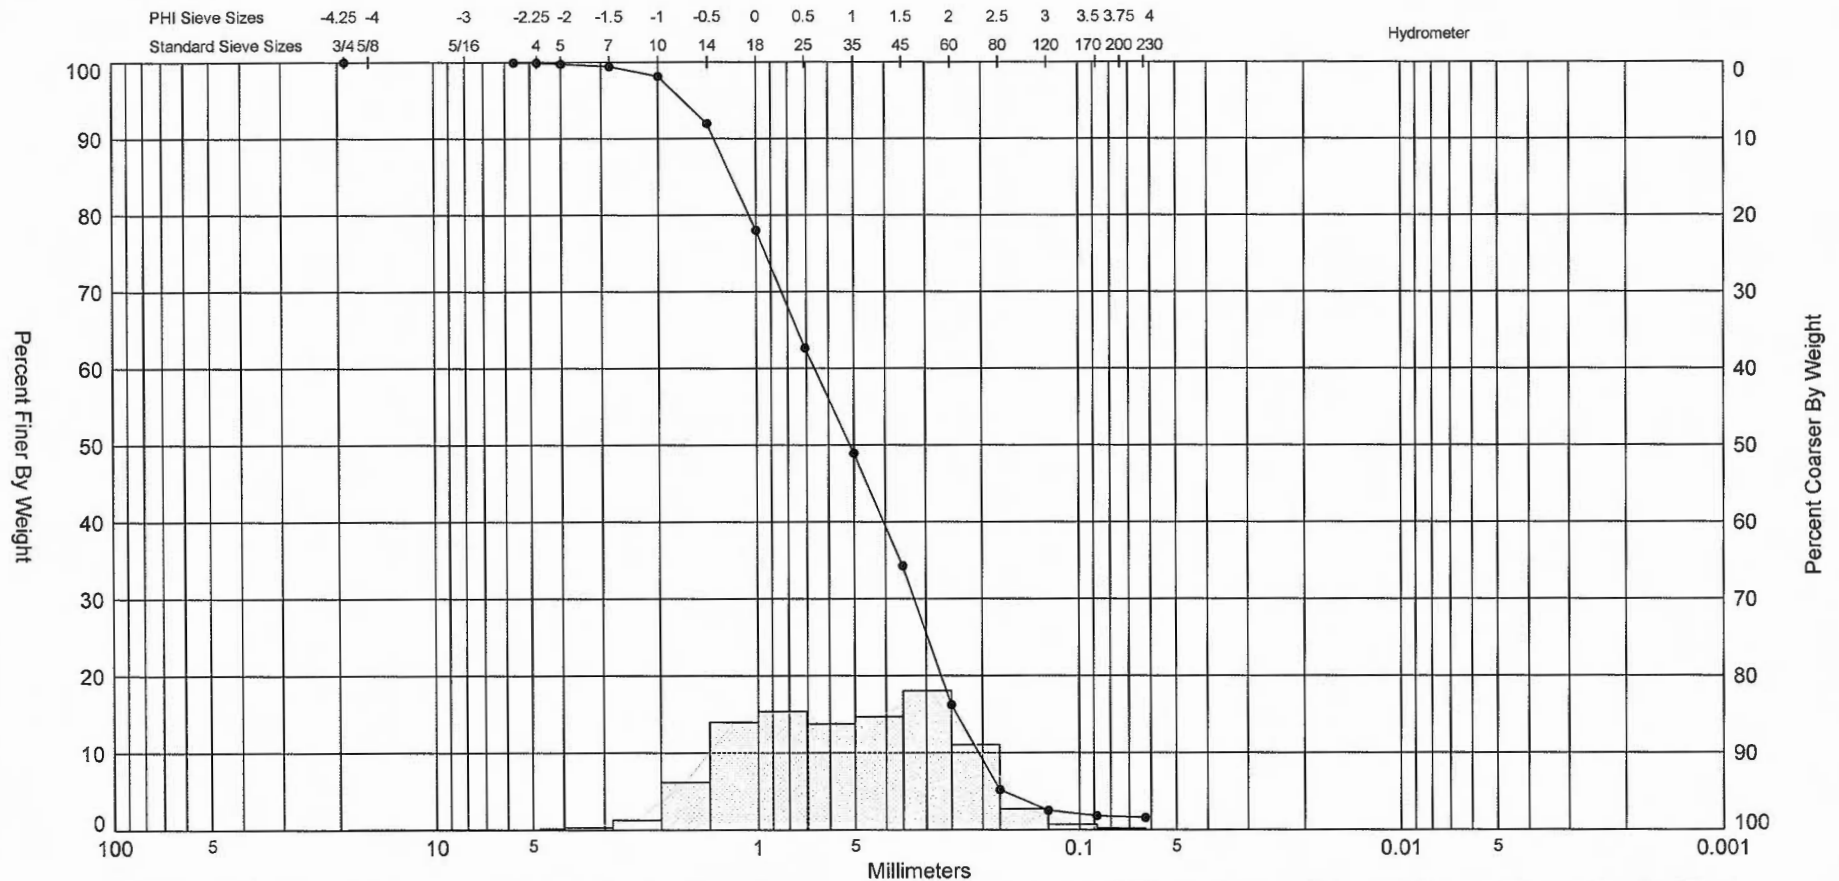
Gravel		Sand			Silt and Clay
Coarse	Fine	Coarse	Medium	Fine

Sample	Symbol	Elev. (ft)	USCS	% Fines	% Organics	% Carbonates	Median	Mean	Skew	Kurt	Sort	Sample Information	
Jl-25 #S-1 (2')	—●—	-53.0	SW	#230 - 1.57			0.96	0.9	-0.11	2.46	1.02	Project Name:	Jupiter Island 10
Comments: 10 YR 5/1 Munsell @ 10% Moisture												Analysis Date:	04-22-10
Depths and elevations based on measured values												Analyzed By:	ML
<div style="display: flex; justify-content: space-around; align-items: center;"> <div style="text-align: center;">

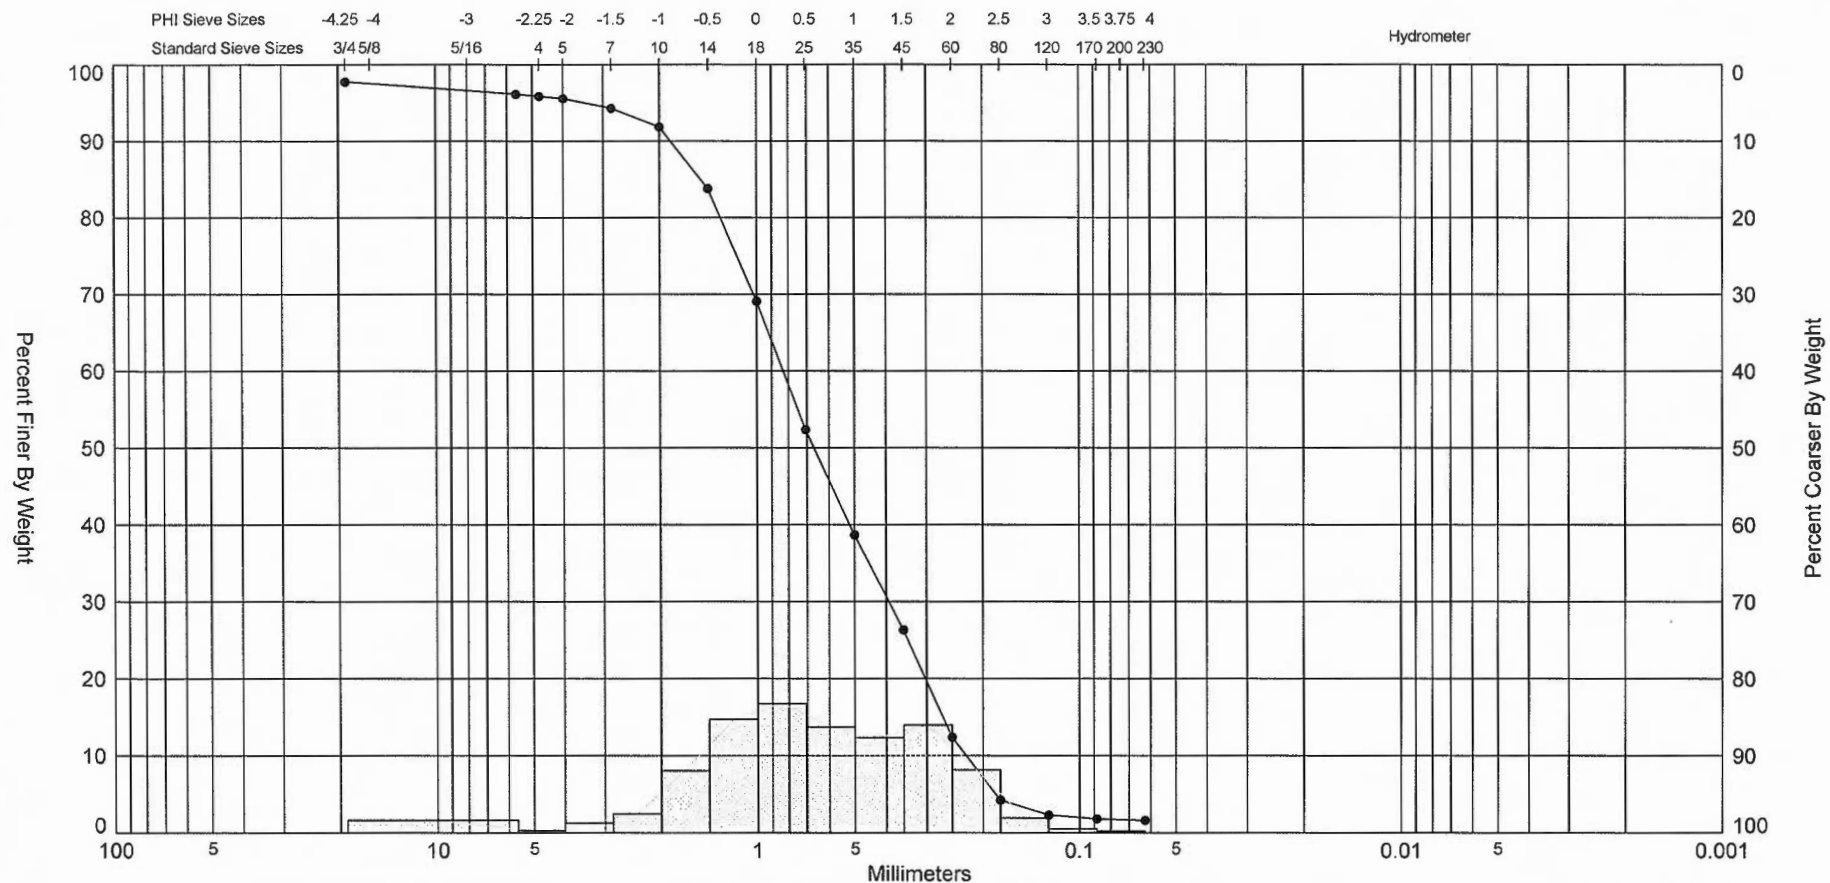
Gravel		Sand			Silt and Clay
Coarse	Fine	Coarse	Medium	Fine

Sample	Symbol	Elev. (ft)	USCS	% Fines	% Organics	% Carbonates	Median	Mean	Skew	Kurt	Sort	Sample Information	
JI-25 #S-2 (2.8')

-53.8	SW	#230 - 1.59		80.50	0.59	0.48	-0.19	3.71	1.17	Project Name:	Jupiter Island 10
Comments: 10 YR 5/1 Munsell @ 10% Moisture												Analysis Date:	04-22-10
Depths and elevations based on measured values												Analyzed By:	ML

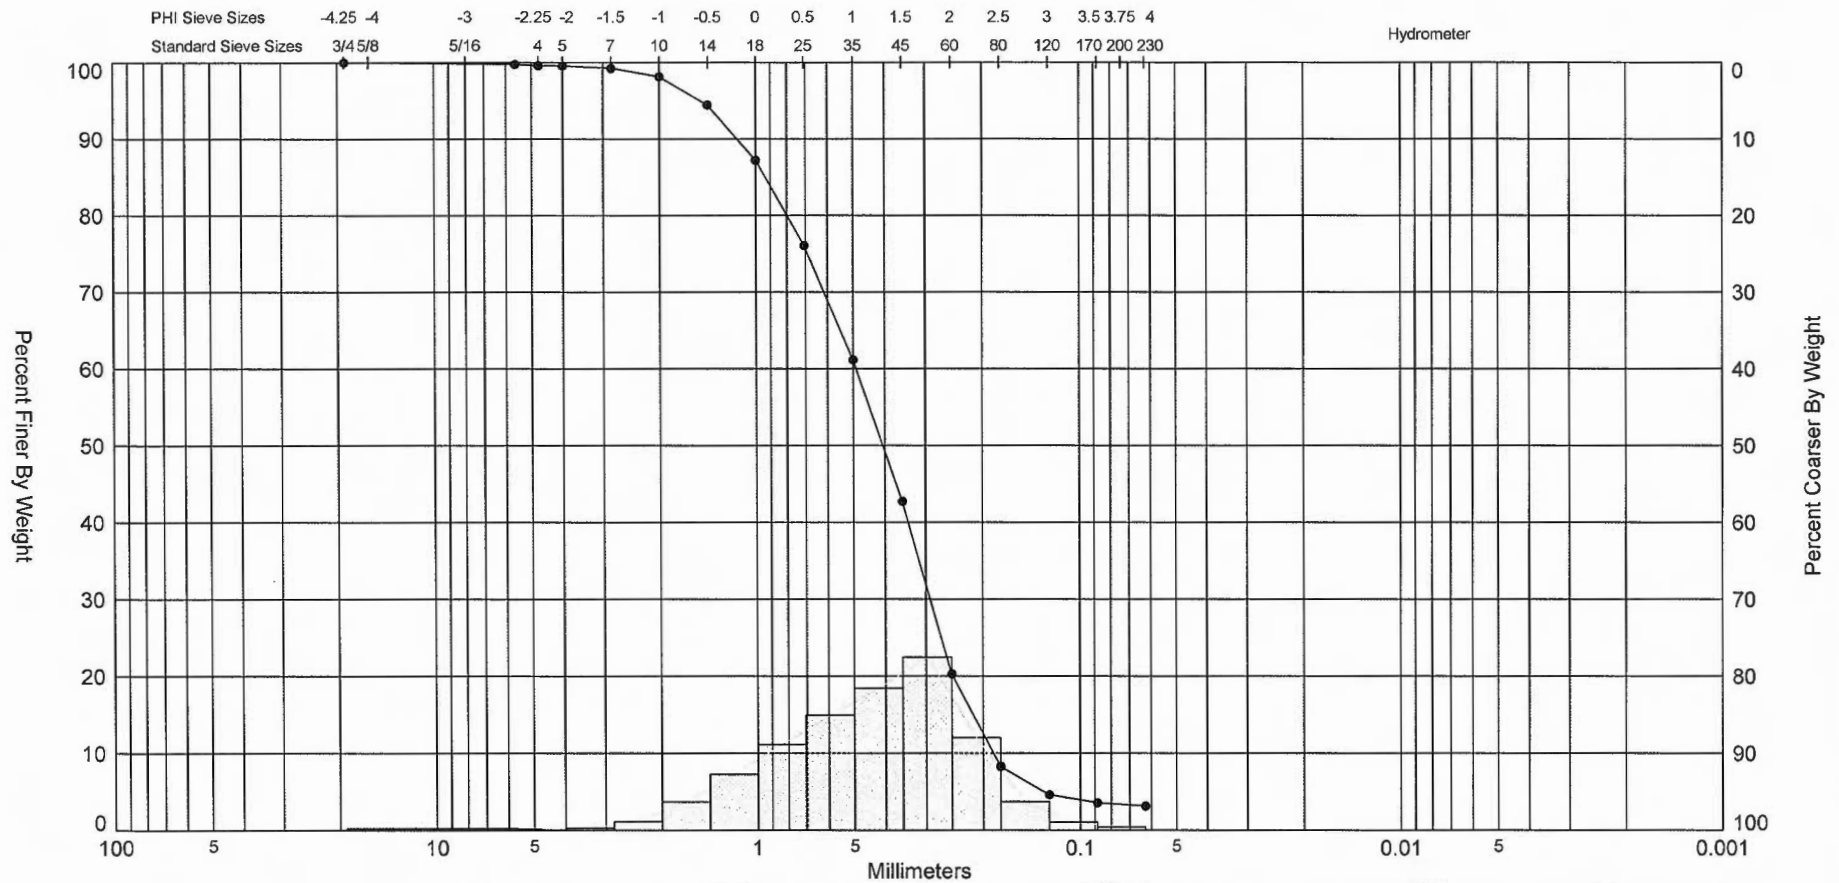
Gravel		Sand			Silt and Clay
Coarse	Fine	Coarse	Medium	Fine

Sample	Symbol	Elev. (ft)	USCS	% Fines	% Organics	% Carbonates	Median	Mean	Skew	Kurt	Sort	Sample Information	
JI-25 #S-3 (7')	—●—	-58.0	SW	#230 - 3.13			1.3	1.14	-0.56	3.83	0.99	Project Name:	Jupiter Island 10
Comments: 10 YR 4/1 Munsell @ 10% Moisture												Analysis Date:	04-22-10
Depths and elevations based on measured values												Analyzed By:	ML

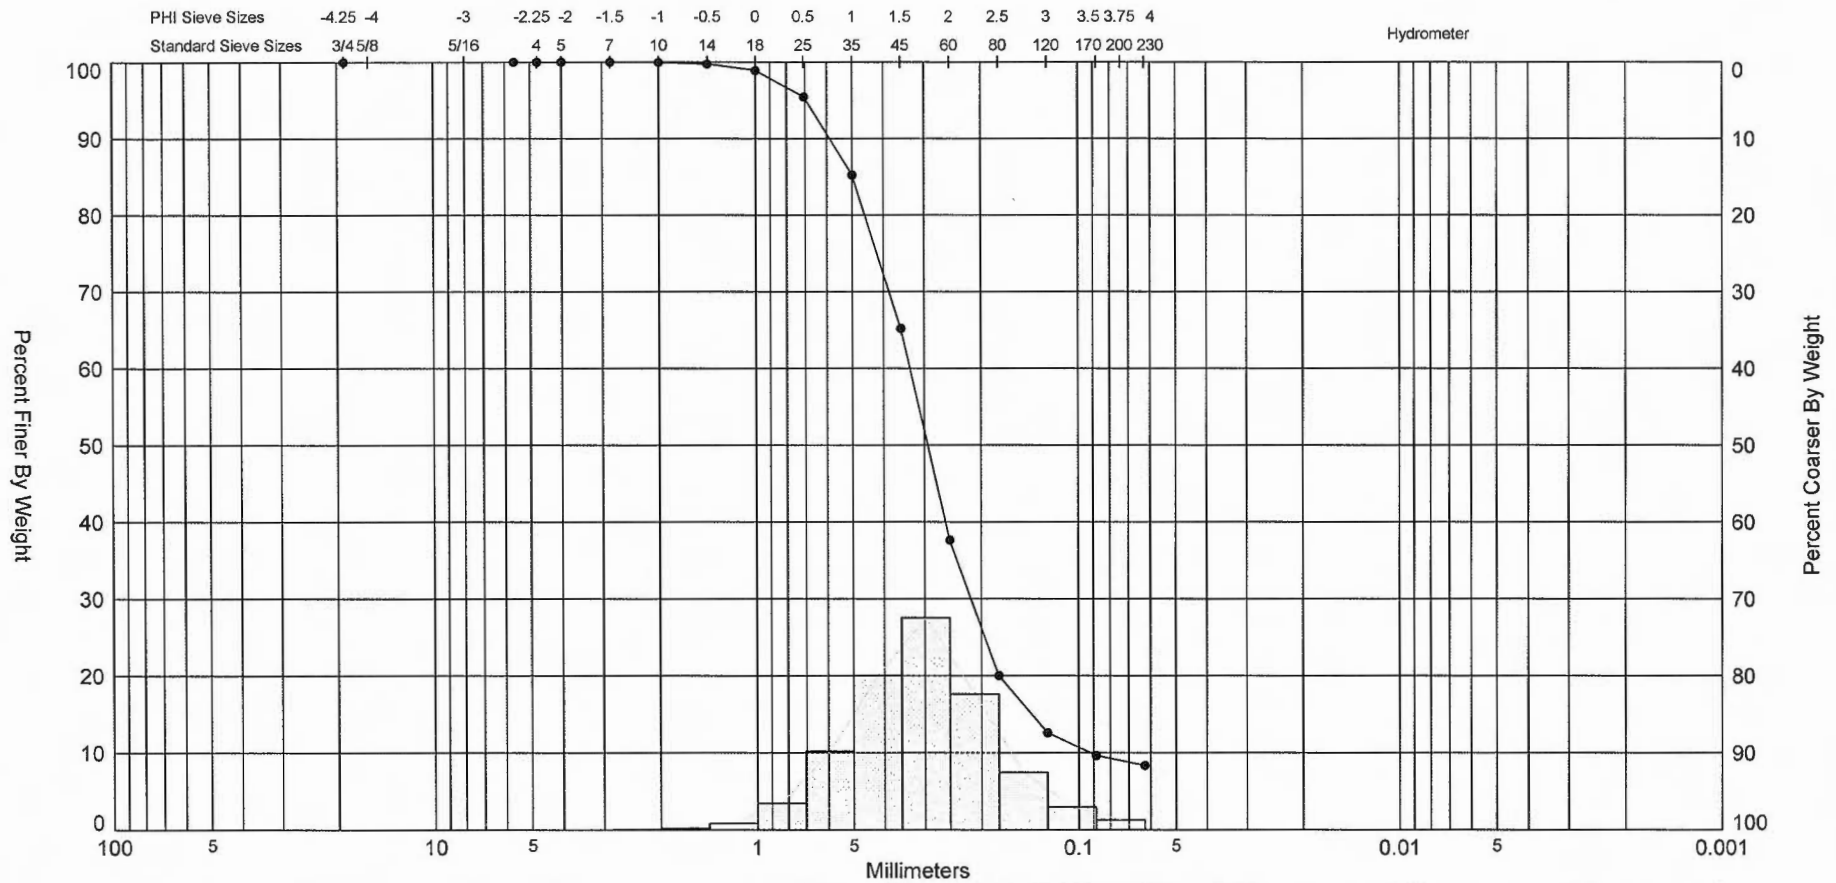
Gravel		Sand			Silt and Clay
Coarse	Fine	Coarse	Medium	Fine

Sample	Symbol	Elev. (ft)	USCS	% Fines	% Organics	% Carbonates	Median	Mean	Skew	Kurt	Sort	Sample Information	
JL-25 #S-4 (11.1')	—●—	-62.1	SP-SM	#230 - 8.33		71.50	1.78	1.7	0.05	3.38	0.75	Project Name:	Jupiter Island 10
Comments: 10 YR 4/1 Munsell @ 10% Moisture												Analysis Date:	04-23-10
Depths and elevations based on measured values												Analyzed By:	ML

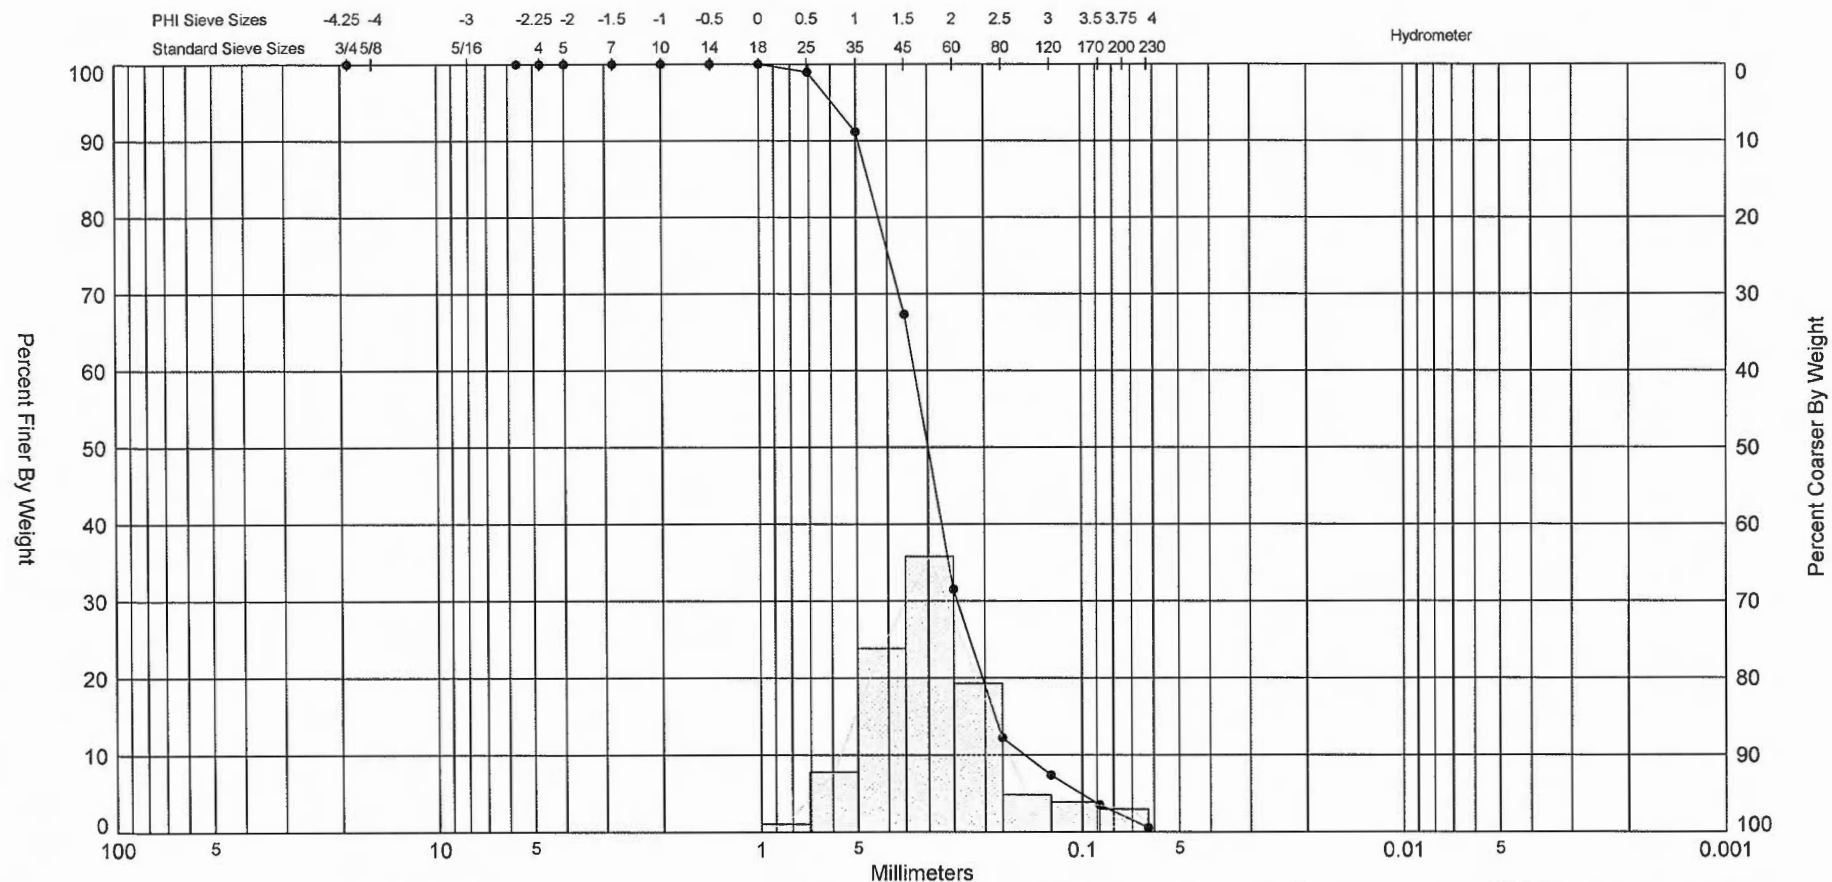
Gravel		Sand			Silt and Clay
Coarse	Fine	Coarse	Medium	Fine

Sample	Symbol	Elev. (ft)	USCS	% Fines	% Organics	% Carbonates	Median	Mean	Skew	Kurt	Sort	Sample Information	
JLI-25 PCC #S-1 (11.1')	—●—	-62.1	SP	#230 - 0.55			1.74	1.8	0.73	3.86	0.68	Project Name:	Jupiter Island 10
Comments: 10 YR 4/1 Munsell @ 10% moisture. Sample after calcium carbonate.												Analysis Date:	02-23-10
Depths and elevations based on measured values												Analyzed By:	ML
