Sample	Symbol	Elev. (ft)	USCS	% Fines	% Organics	% Carbonates	Median	Mean	Skew	Kurt	Sort	Sample Information	
JVC-10-4 #S-1 (1')		-53.5	SW	#230 - 0.61		78.80	0.89	0.74	-0.84	3.92	0.86	Project Name:	Jupiter Island 10 Detail Phase
Comments: Visual Shell Content = >1%												Analysis Date:	11-22-10
Depths and elevations based on measured values												Analyzed By:	JR

<b>AMERICAN VIBROCURE</b> SERVICES						American Vibrocure Services, Inc. 1215 Wallace Drive Delray Beach, FL 33444						Easting (X, ft):	965540.
												Northing (Y, ft):	976274.
												Horizontal System:	NAD 1983
												Vertical System:	NAVD 88

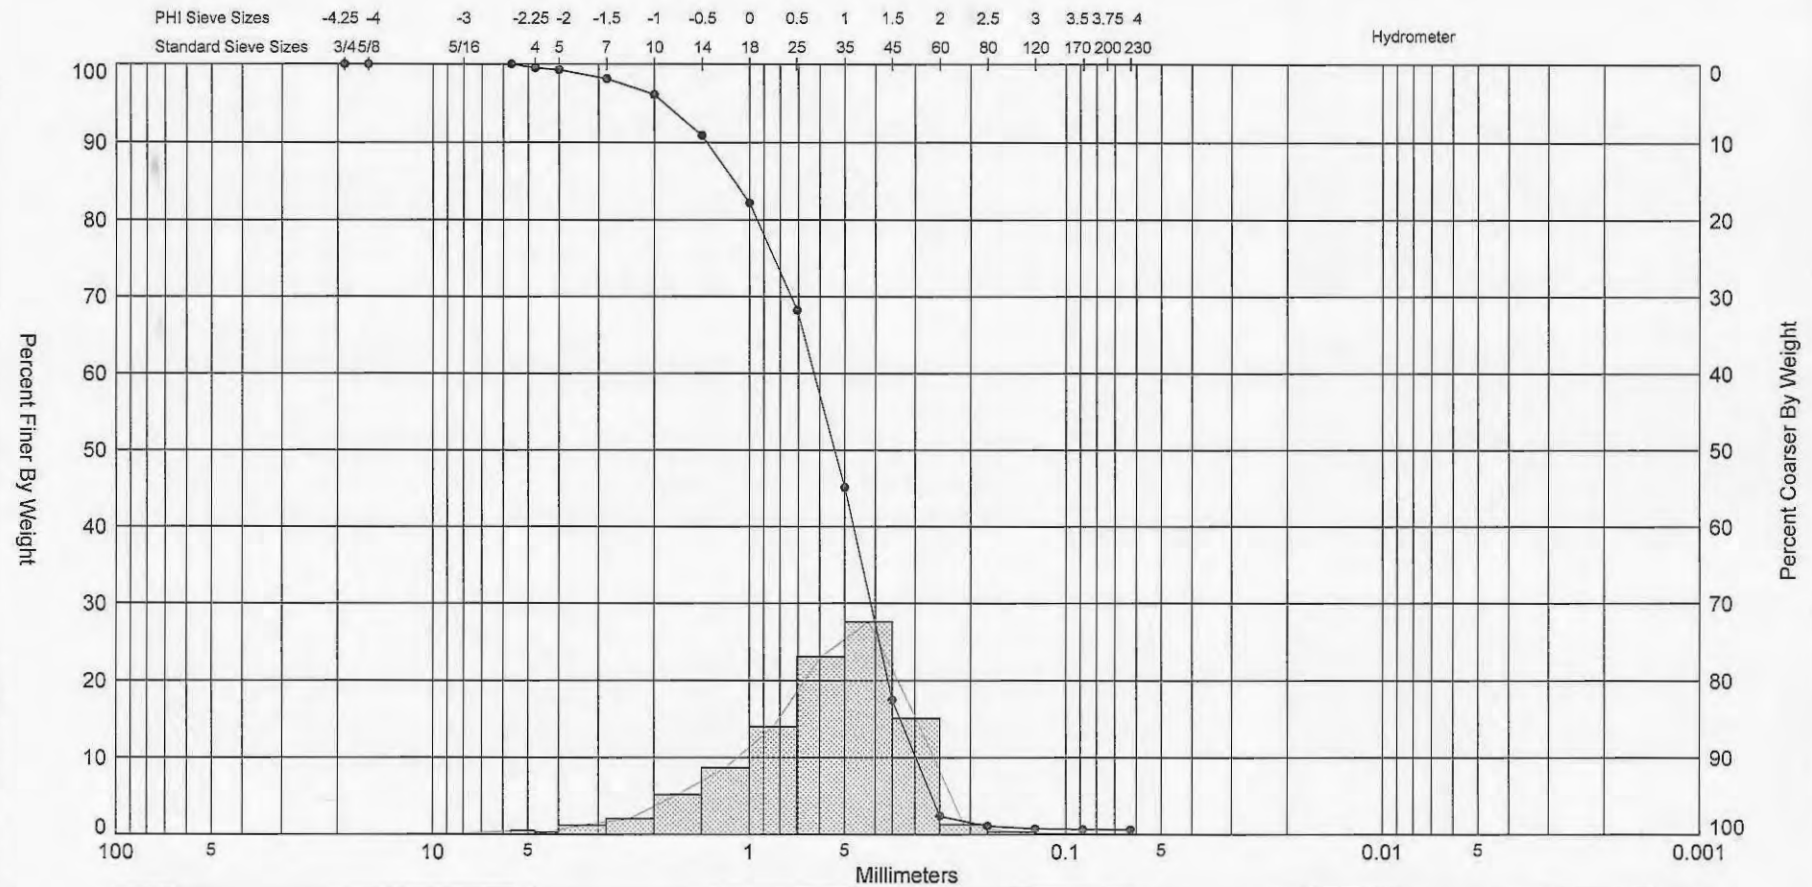
Gravel		Sand			Silt and Clay
Coarse	Fine	Coarse	Medium	Fine

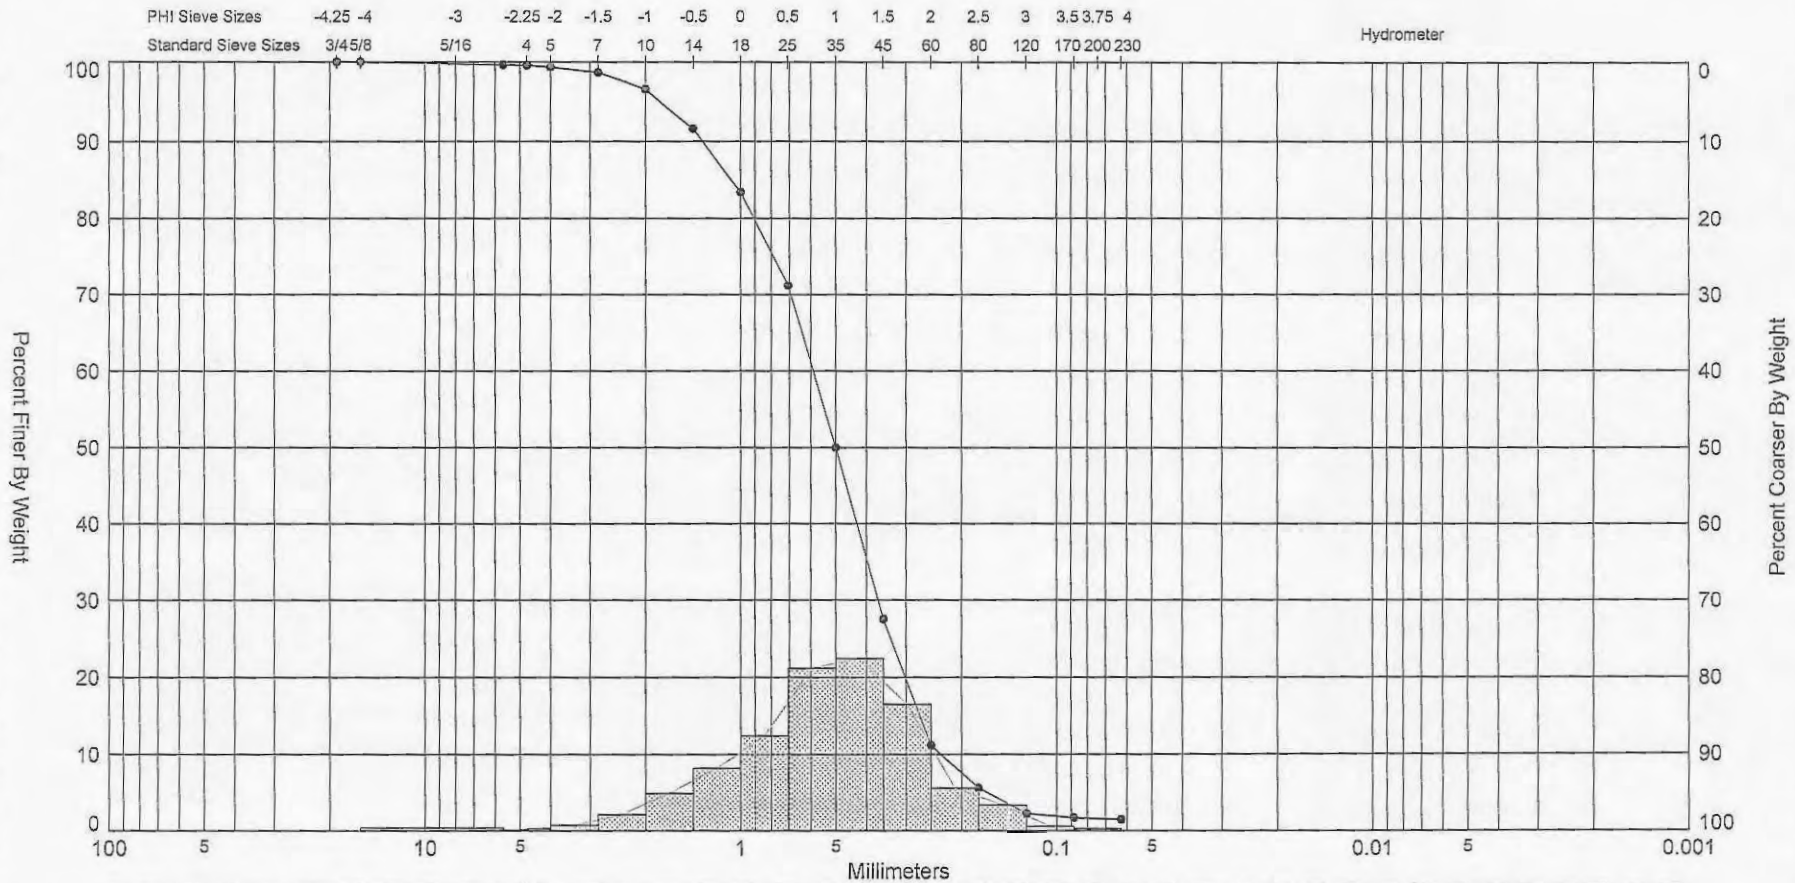
Gravel		Sand			Silt and Clay	
Coarse	Fine	Coarse	Medium	Fine

Sample	Symbol	Elev. (ft)	USCS	% Fines	% Organics	% Carbonates	Median	Mean	Skew	Kurt	Sort	Sample Information	
JIVC-10-4 #S-2 (6')	—○—	-58.5	SW	#230 - 1.44			1	0.9	-0.52	4.01	0.98	Project Name:	Jupiter Island 10 Detail Phase
Comments: Visual Shell Content = >1%												Analysis Date:	11-11-10
Depths and elevations based on measured values												Analyzed By:	JR

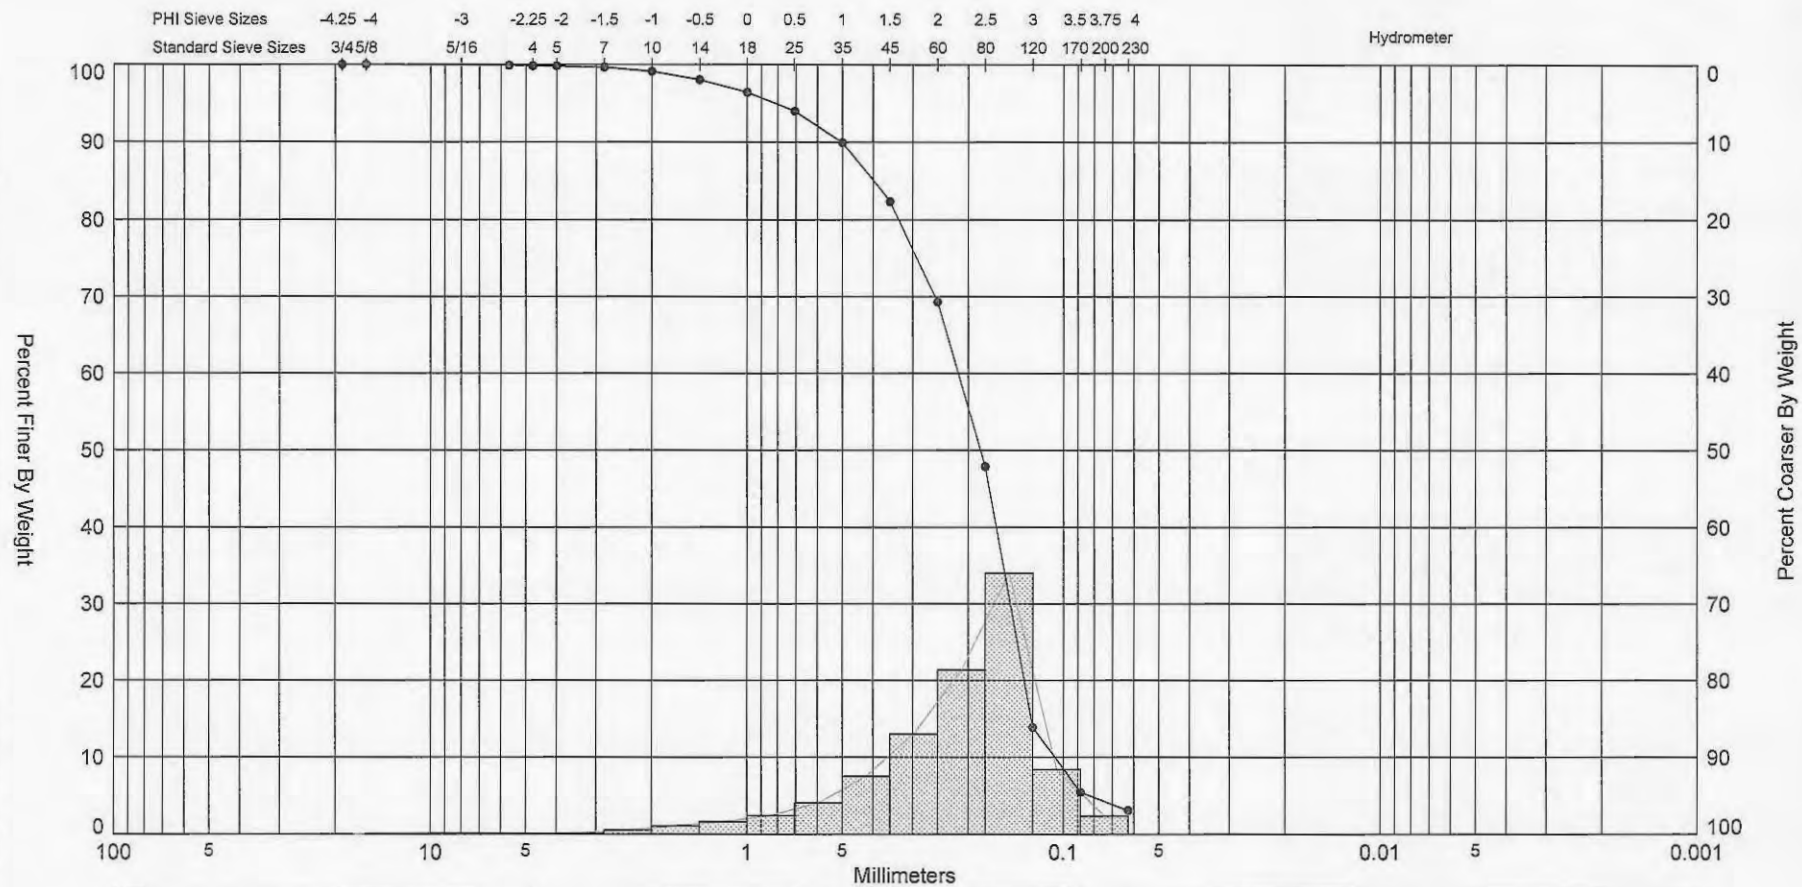
Gravel		Sand			Silt and Clay
Coarse	Fine	Coarse	Medium	Fine

Sample	Symbol	Elev. (ft)	USCS	% Fines	% Organics	% Carbonates	Median	Mean	Skew	Kurt	Sort	Sample Information	
JIVC-10-4 #S-4 (11.5')	—●—	-64.0	SW	#230 - 3.10		66.80	2.45	2.18	-1.45	6.07	0.94	Project Name:	Jupiter Island 10 Detail Phase
Comments: Visual Shell Content = >1%												Analysis Date:	11-05-10
Depths and elevations based on measured values												Analyzed By:	JR
