SIEVE ANALYSIS: SINGER\_IS.GPJ FL DEP ROSS.GDT 8/31/04

Sample	Symbol	Elev.	Comments	USCS	% Fines	Median	Mean	Skew	Kurt	Sort	Sample Information	
SI04-10 #1.0	—●—	-55.9		SP	#200 - 0.75 #230 - 0.72	1.63	1.42	-1.75	7.55	1.14	Project Name:	Palm Beach County Vibracore 2004
											Analysis Date:	07-01-04
											Analyzed By:	SEA Inc.
Scientific Environmental Applications, Inc. 5575 Willoughby Drive Melbourne, FL 32934 (321) 254-2708 Seapp1@aol.com											Easting (X):	975,129
											Northing (Y):	897,020
											Horizontal System:	NAD 1983
											Vertical System:	NAVD 29

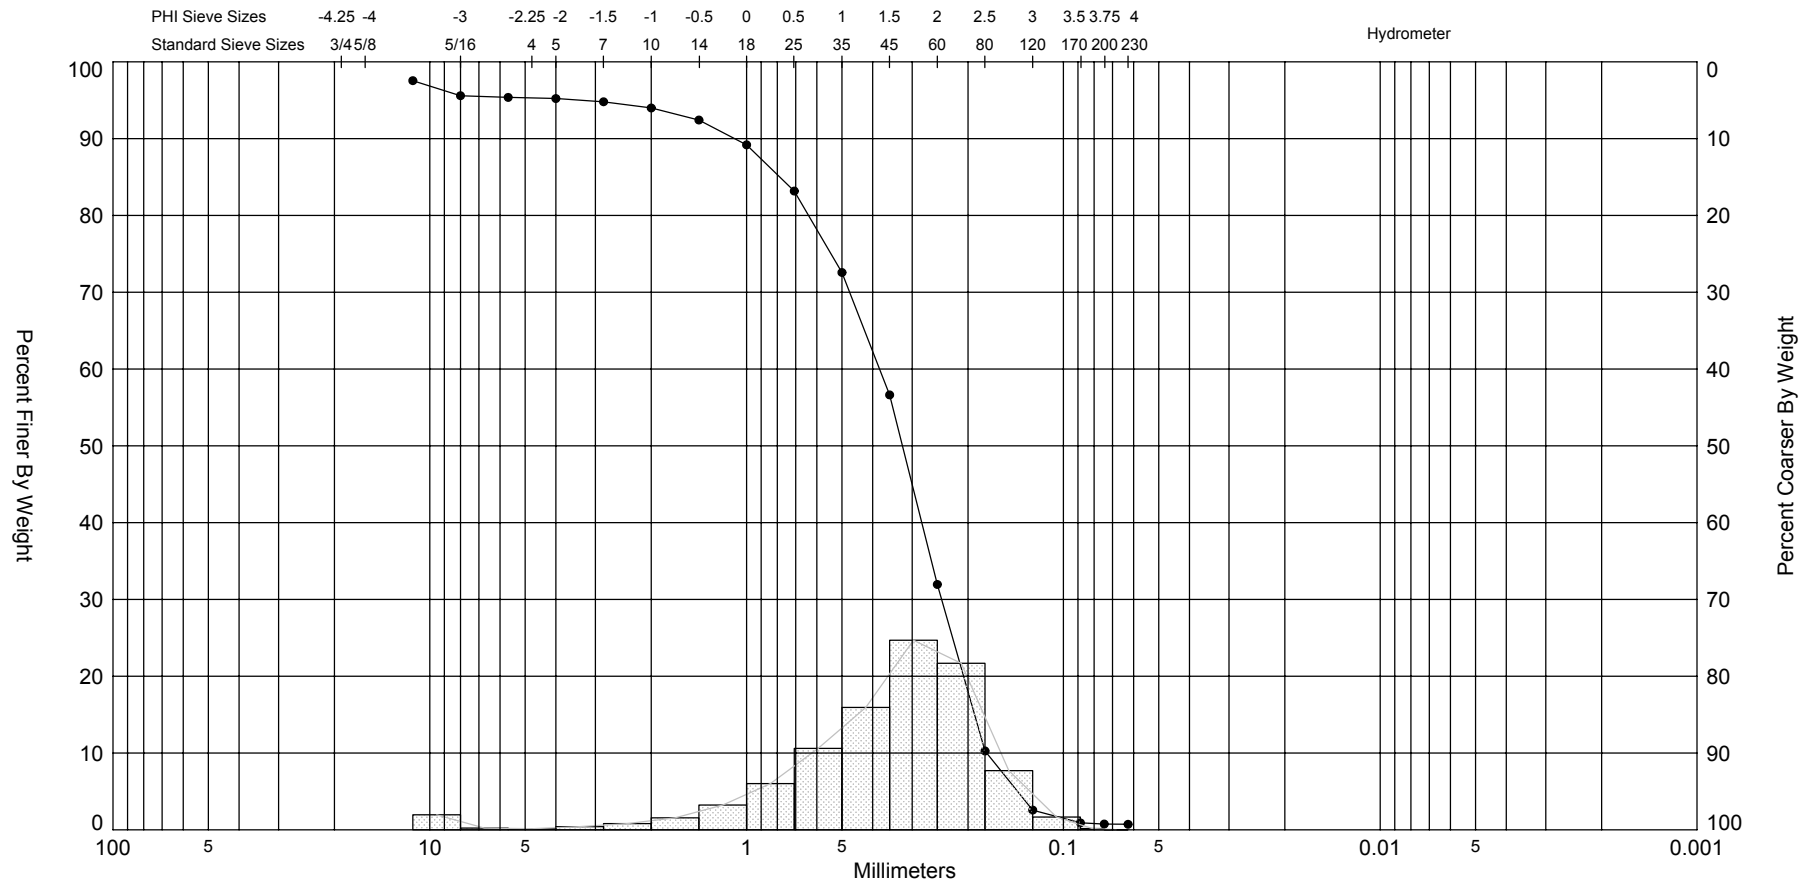
Gravel		Sand			Silt and Clay
Coarse	Fine	Coarse	Medium	Fine

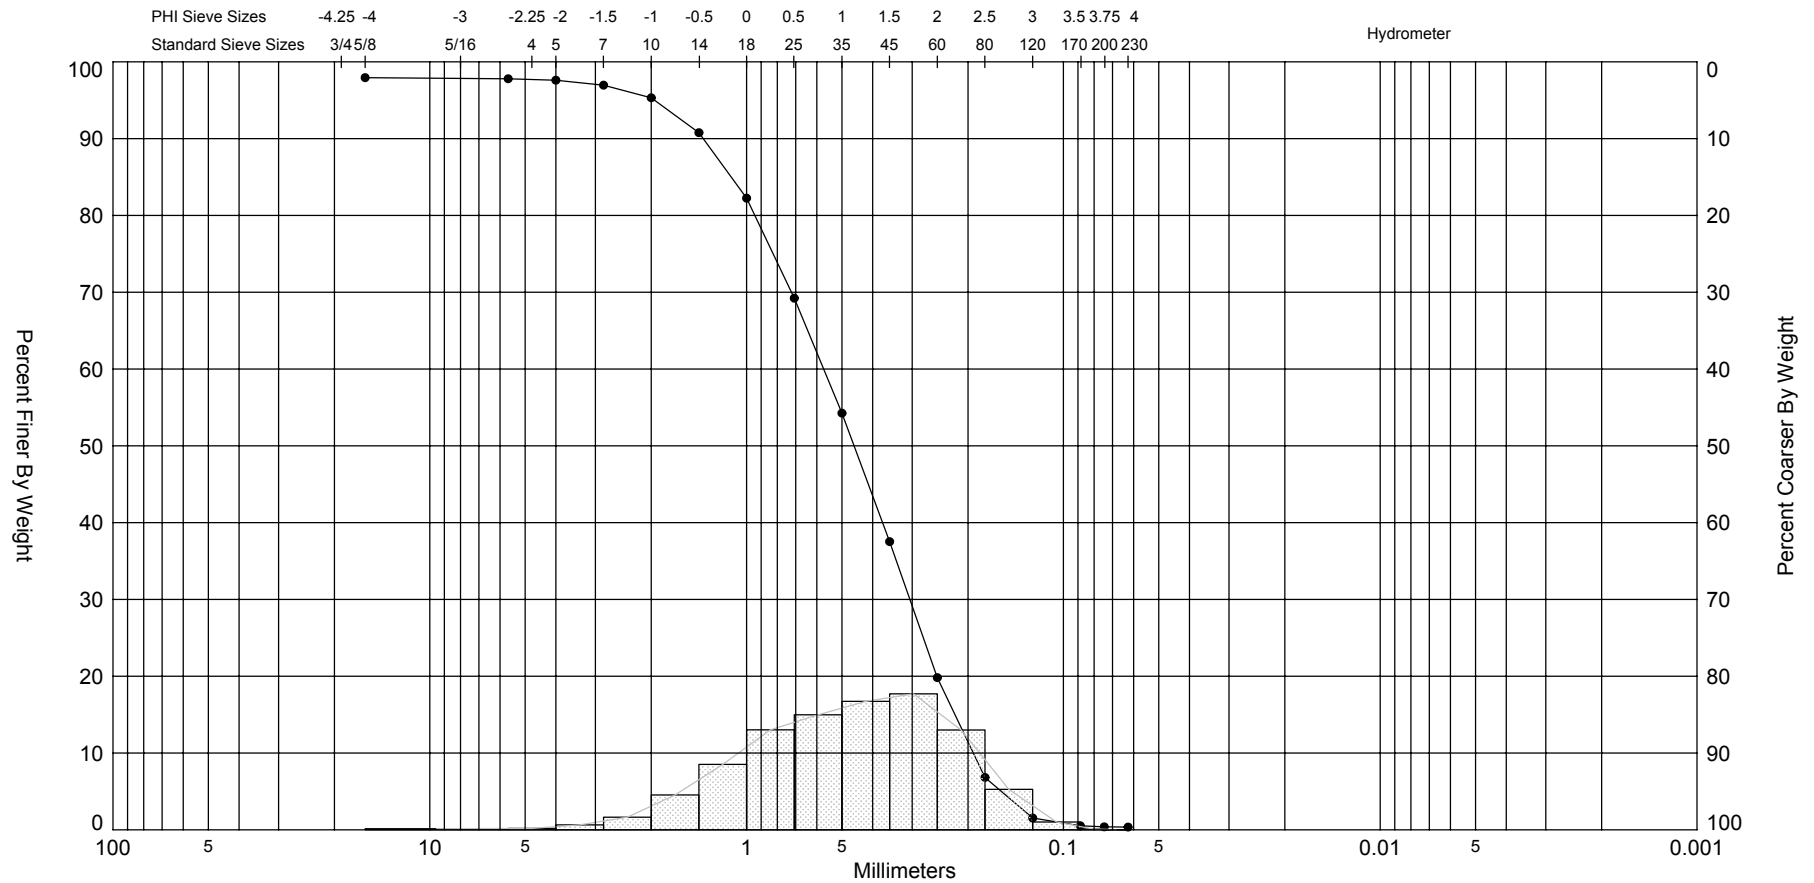
SIEVE ANALYSIS: SINGER\_IS.GPJ FL DEP ROSS.GDT 8/31/04

Gravel		Sand			Silt and Clay
Coarse	Fine	Coarse	Medium	Fine

Sample	Symbol	Elev.	Comments	USCS	% Fines	Median	Mean	Skew	Kurt	Sort	Sample Information	
SI04-10 #4.0	—●—	-58.9		SP	#200 - 0.39 #230 - 0.36	1.13	1.07	-0.38	2.95	1.04	Project Name:	Palm Beach County Vibracore 2004
											Analysis Date:	07-01-04
											Analyzed By:	SEA Inc.
Scientific Environmental Applications, Inc. 5575 Willoughby Drive Melbourne, FL 32934 (321) 254-2708 Seapp1@aol.com											Easting (X):	975,129
											Northing (Y):	897,020
											Horizontal System:	NAD 1983
											Vertical System:	NAVD 29

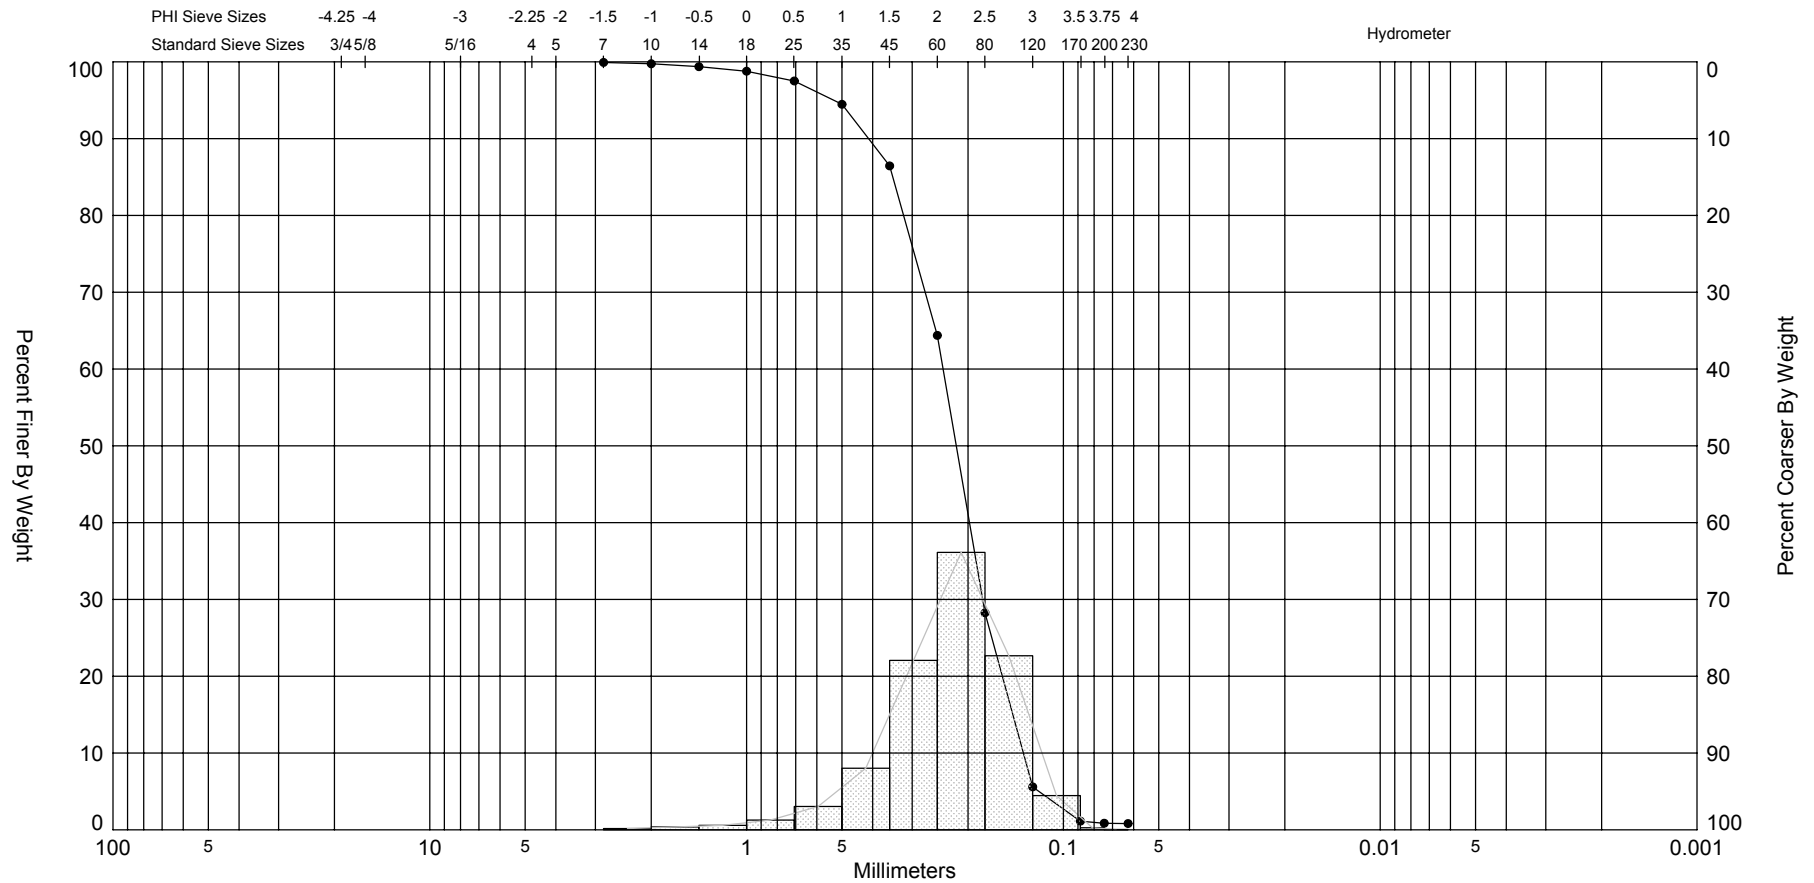
SIEVE ANALYSIS: SINGER\_IS.GPJ FL DEP ROSS.GDT 8/31/04

Sample Information	
Project Name:	Palm Beach County Vibracore 2004
Analysis Date:	07-01-04
Analyzed By:	SEA Inc.
Easting (X):	975,129
Northing (Y):	897,020
Horizontal System:	NAD 1983
Vertical System:	NAVD 29
